**CRC Report No. AVFL-28**  
**Phase II**

**GASOLINE DIRECT INJECTION (GDI)  
ENGINE WEAR TEST DEVELOPMENT**

**Final Report**

**SOUTHWEST RESEARCH INSTITUTE®**  
**San Antonio, Texas**  
**Fuels and Lubricants Research Division**

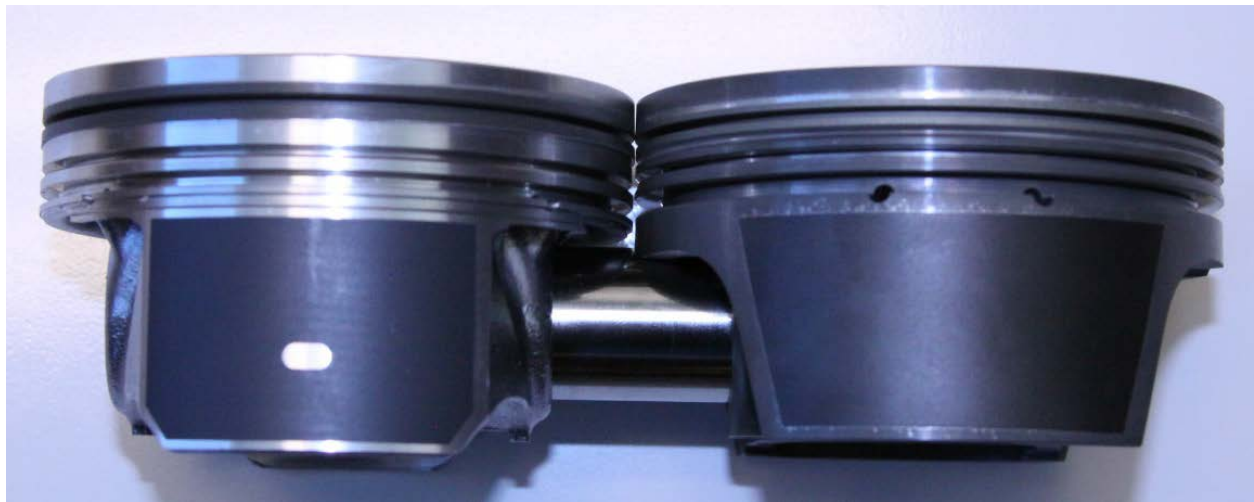
**Figure 1. Comparison of OEM piston (left) and aftermarket piston (right)**

The engine selected for this work was the Ford 2.0L EcoBoost engine used in the 2012 Ford Explorer. This engine was selected for a number of reasons, including being representative of current and future engine technology (downsizing, turbo, high BMEP), being early in its product life cycle, and guaranteed support from the manufacturer. The engine was installed in a test cell with engine control and absorbing dynamometer. The cell was chosen for its location away from high foot traffic and because it had space for the radiation detector and peripheral equipment. This engine is the same as currently used for the Low Speed Pre-Ignition (LSPI) test developed for the ILSAC GF6 oil specification, therefore, the project team had a high level of familiarity with the engine and its control systems. This engine, like many turbo charged down-sized engines, has a tendency for LSPI. In order to reduce the chance of engine damage, aftermarket pistons were chosen as they have more material below the oil control ring and therefore less prone to damage from LSPI events. Both OEM and aftermarket pistons are shown in Figure 1 for comparison.

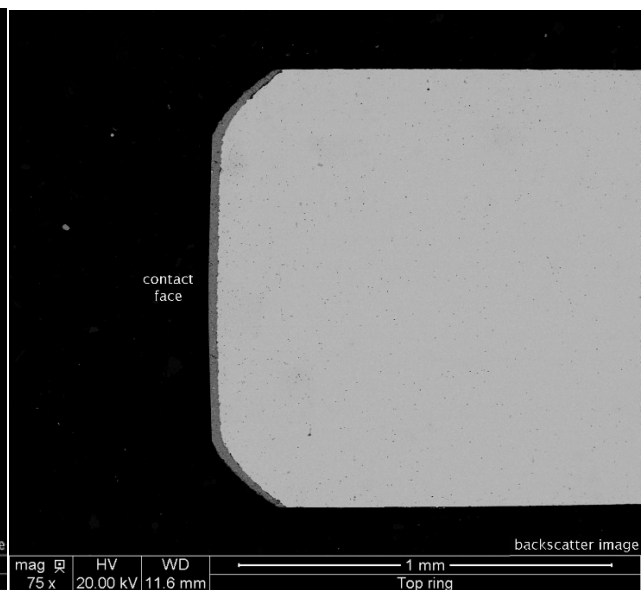
Figure 3. Top ring contact face

The top piston ring shown in Figure 2 is a rectangular cross section with rounded corners and a slight barrel on the contact face. The ring bulk material is iron and the contact face of the ring comprises a chromium based coating that extends from the top, across the face, to the bottom, as shown in Figure 3. Figure 3 also shows pockets of black material within the coating on the top ring face. These pockets are elemental molybdenum and are largely concentrated where the peripheral coating connects with the parent ring substrate. The molybdenum is likely present to improve durability and/or flexibility of the adhesion between the hard chromium coating and the base iron material. Full elemental analysis is given in Table 4.

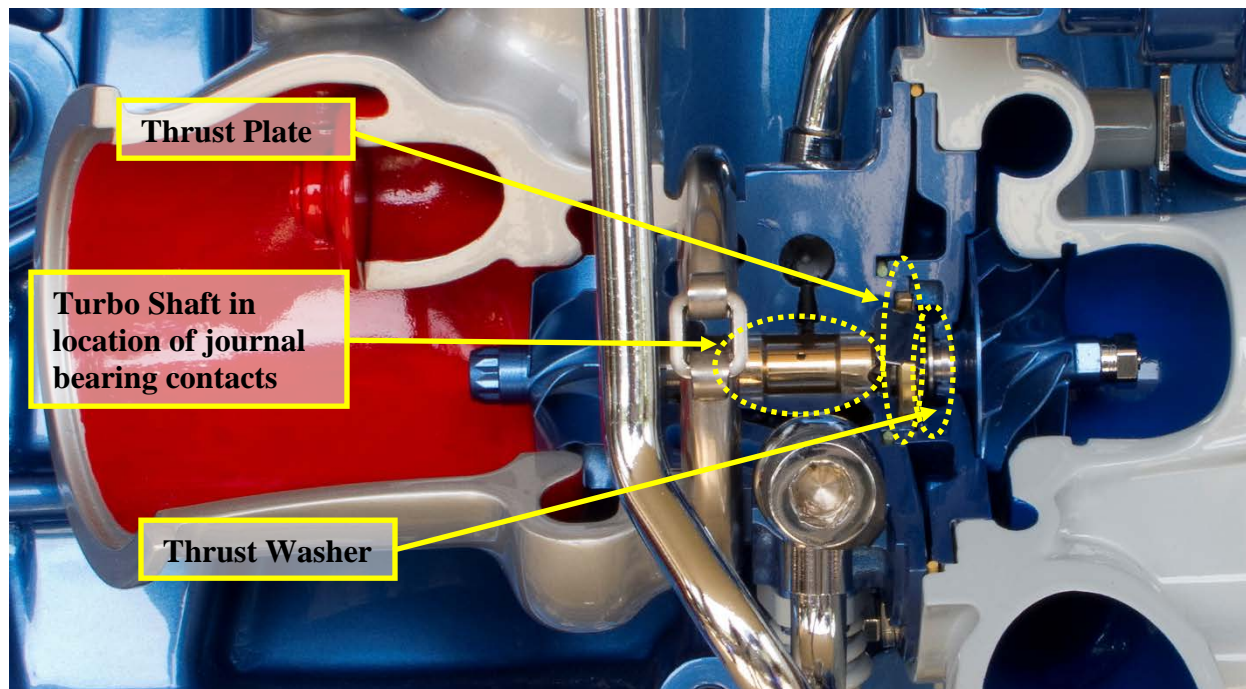
**Figure 4. Cross section of turbo showing location of parts that were activated**

There were 3 turbocharger components of interest for this phase. The thrust washer, thrust plate, and turbo shaft. The thrust washer rides against the back of the compressor wheel and is of a steel composition. The thrust plate is immediately behind the thrust washer and is made entirely of

bronze. The turbo shaft is permanently affixed to the turbine wheel and is also made of steel, although with a higher chrome content than the thrust washer. The location of each of these components is shown in a cutaway view in Figure 4.

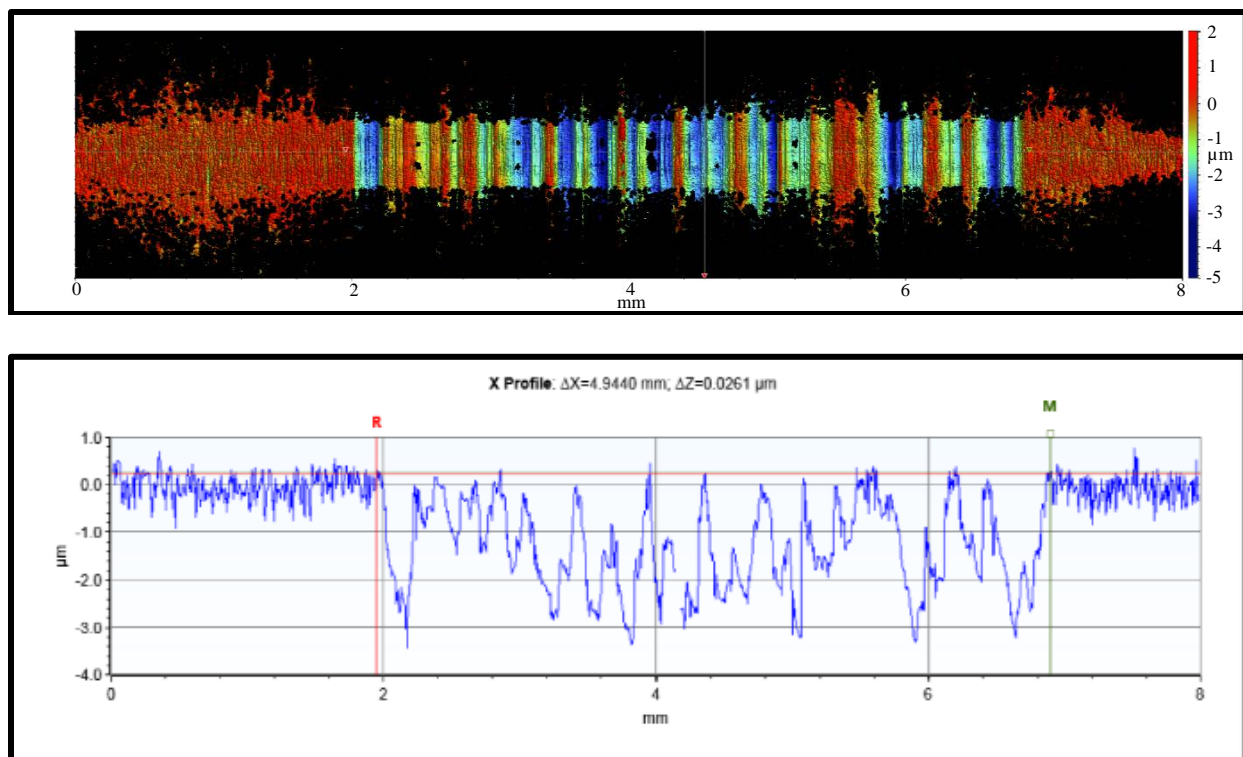
**Figure 5. Image of turbo shaft highlighting area that was activated**

The turbo shaft from a used engine was inspected at the onset of Phase II to plan and place the shaft activation. White light interferometer measurements were taken. The resultant imagery of the shaft measurements highlighted wear areas around the journal bearing interface. The compressor and turbine sides of the shaft were worn from the previous testing with the turbine side of the shaft exhibiting more wear than the compressor side. The shaft wear from the used turbo shaft is depicted in Figure 5. The top image is the 3D white light visualization of the shaft. The material height or wear depth is determined by color as defined in the scale on the right of the image. Immediately below is the x-axis profile of the shaft along the center line of the shaft (left to right). This shows wear from 2mm to 7mm along the shaft with wear as deep as 3.5 $\mu$ m in places.

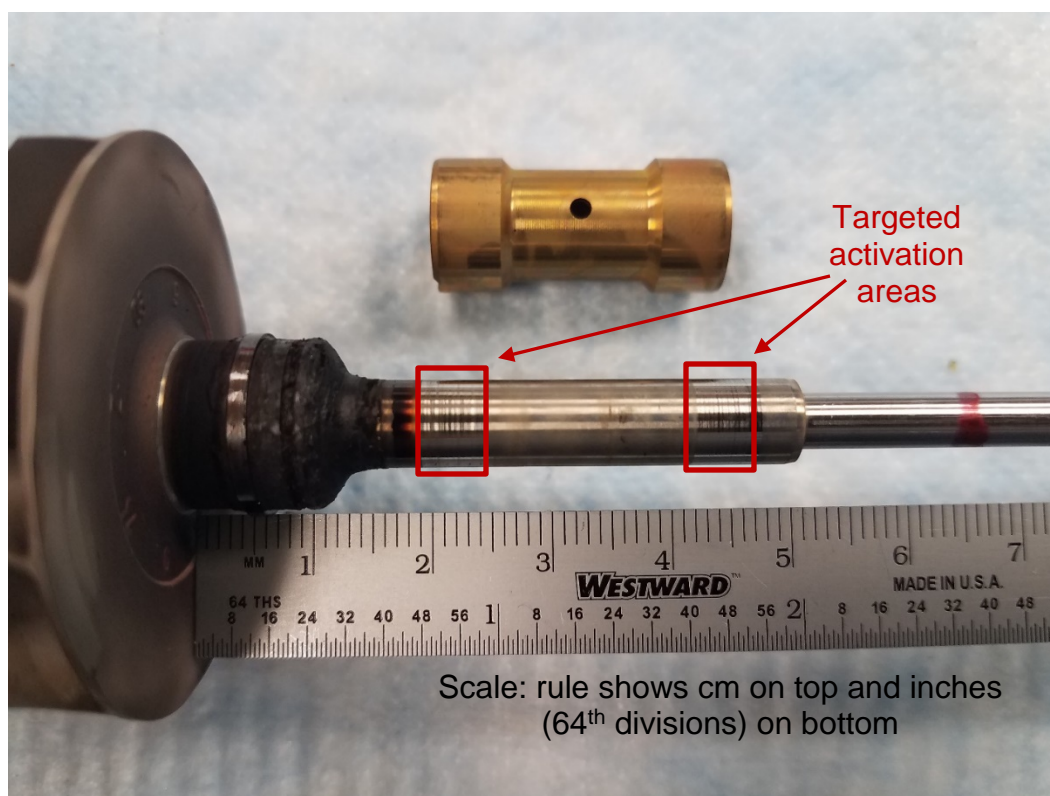
**Figure 6. Turbo shaft wear areas shown with journal bearing and scale**

Both areas of the turbo shaft (turbine and compressor sides) were included in the targeted SLA. Two circumferential activation bands of 8mm width were created to capture the shaft and journal bearing wear interaction. A total of 104 $\mu$ Ci of activity was created at the narrow bands of target area on the turbo shafts. The designed minimum wear rate to produce a 0.05% standard error on the turbo shaft surfaces was 3-4nm/hr. Figure 6 further depicts the targeted activation areas.

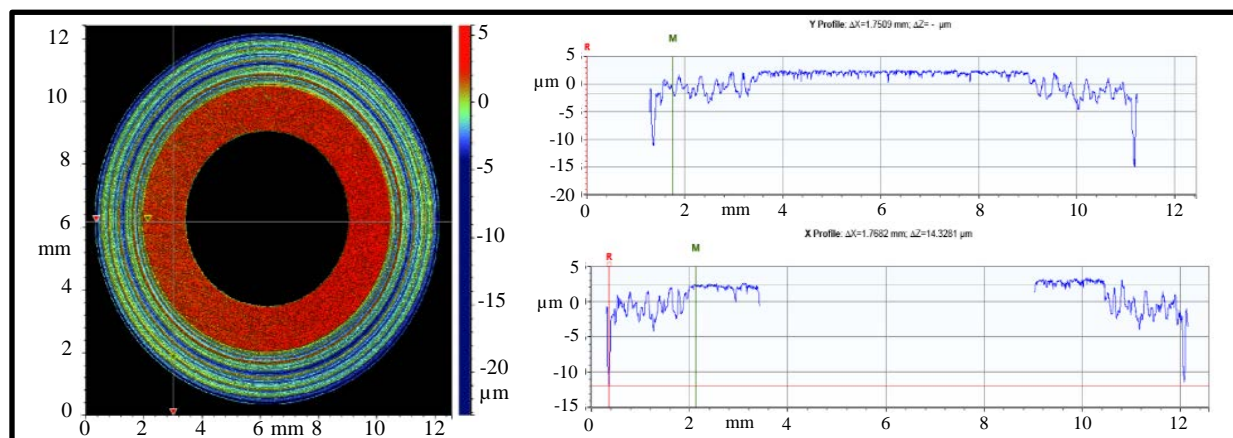
**Figure 7. Thrust washer wear pattern from used turbocharger**

A used turbocharger thrust washer was also used to plan the thrust washer activation. Figure 6 depicts the circular grooving on the used turbo thrust washer. This grooving was present on both sides of the thrust washer. Figure 7 shows one side of the thrust washer. Wear can be seen roughly  $5\text{ }\mu\text{m}$  deep around the outer  $\sim 1.5\text{ mm}$  of the washer. The size of the turbo thrust washer allowed for cost effective activation over its entire surface on both faces of the thrust washer. The turbo thrust washer was activated to produce  $200\mu\text{Ci}$  of Co-56 isotope. The specific activity of the thrust washer allows for high confidence measurements at  $1\text{ nm/hr}$  wear rates.

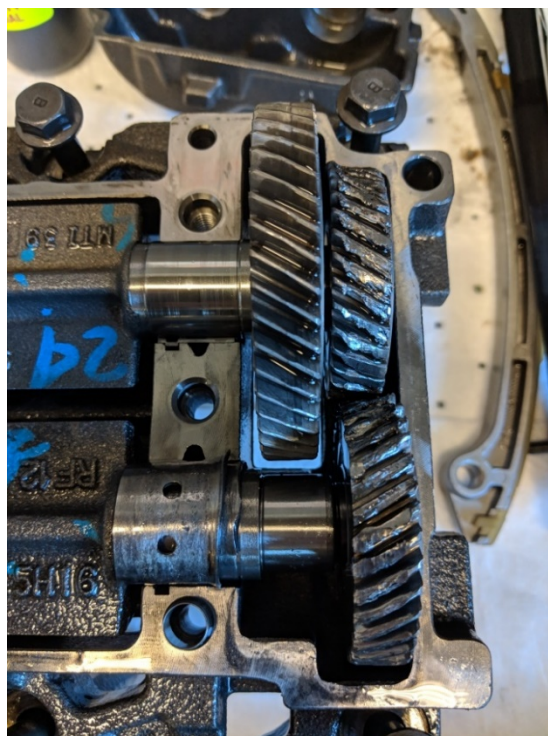
**Figure 9. Image of damage to balance shaft gears and bearings**

While running the 'transient load high speed' test sequence using the low viscosity lubricant, the engine suffered a catastrophic failure, resulting in the end of the testing. This was early in the test sequence after only 16 hours of testing. Analysis of the isotopes in the oil in Figure 8 shows that the initial component to fail was the balance shaft bearing moving from under 100 $\mu$ g of wear to over 200 $\mu$ g of wear within the first 10 minutes of the test sequence. At approximately 45 minutes into the test sequence, the balance shaft bearing wear accelerates significantly followed almost immediately by all the other measured radioactive engine parts. Note that in this graph, a direct comparison in wear between the bulk (in  $\mu$ g) and the surface layer (in nm) activated parts cannot be made; the aim of this data processing was to confirm which engine component failed first. Figure 9 shows the failed bearings.

It was concluded that this failure was due to the balance shafts being a non-serviceable part. As the shell bearings had been removed from the assembled part, sent for irradiation, and then reassembled they had already been crushed on initial assembly. This likely resulted in them not seating correctly on the assembly prior to install in the engine.

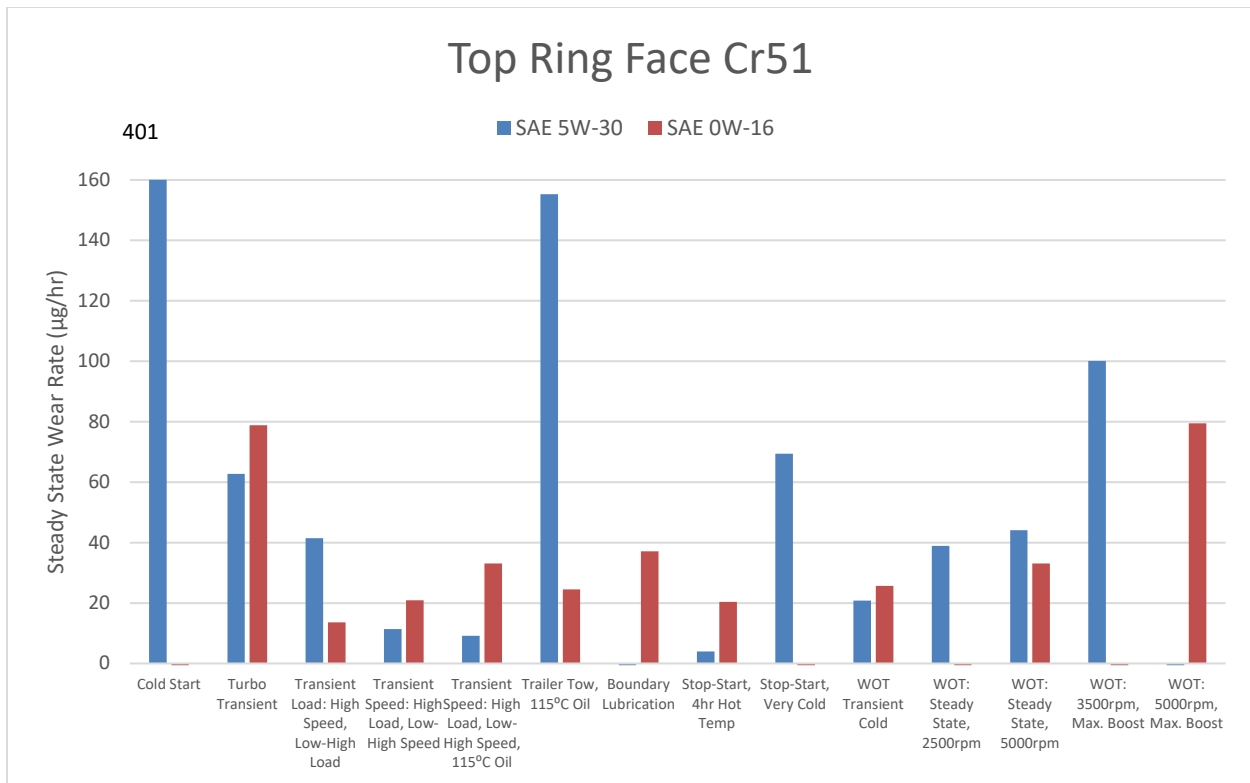
**Figure 10. Top ring face wear for test cycles showing greater than 20µg/hr on either oil.**

Wear values for each irradiated engine part were compiled for all of the test conditions, comparing the SAE 5W-30 and SAE 0W-16 lubricants. Figures 10-14 depict the wear trend for the top ring face, top ring side, turbo spindle, turbo thrust plate, turbo thrust washer and crankshaft bearings for both lubricants over the full test matrix. For clarity, only those results giving measurable wear values with consideration to the measurement technique have been included in the graphs and these values are noted on the graph titles. Table 10 shows a matrix of irradiated engine component vs. engine test sequence giving a concise overview of noticeable wear. Wear values included in Figures 10-15 are shown as gray cells.

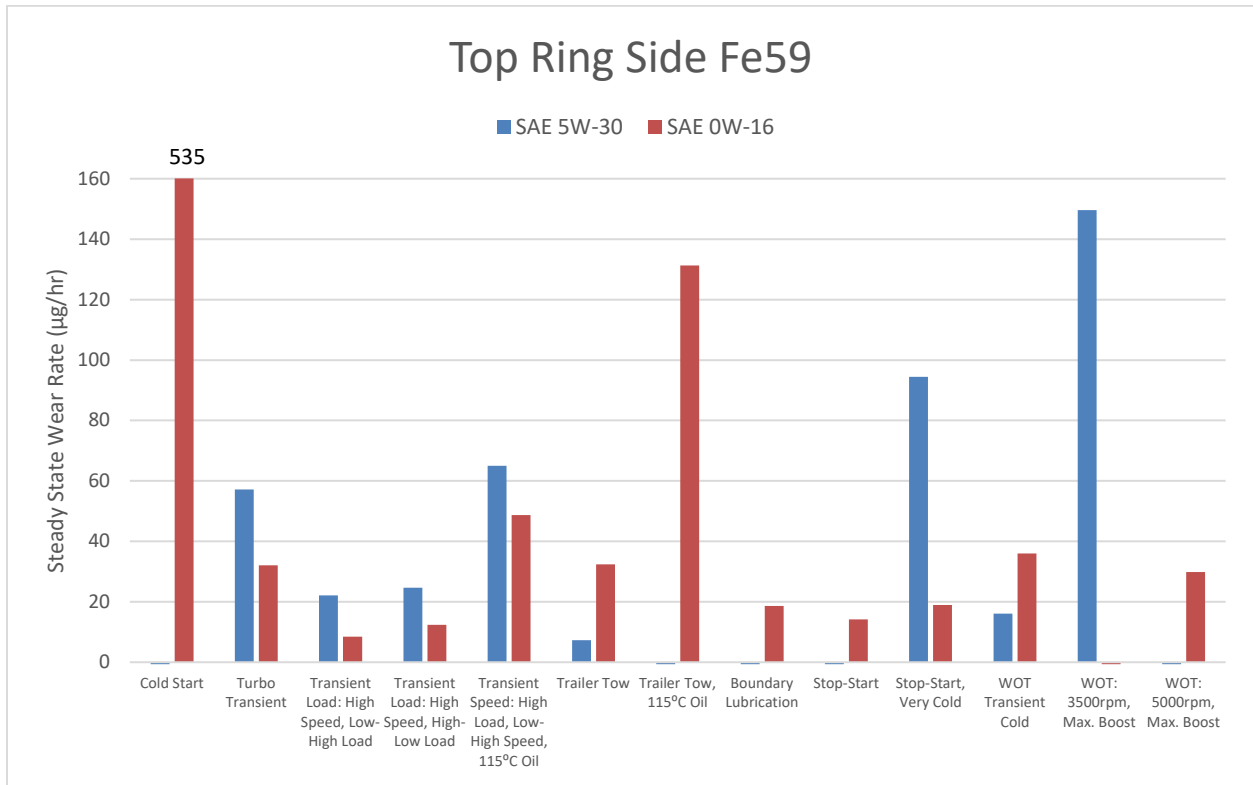
**Figure 11. Top ring side (Fe59) wear for test cycles showing greater than 8µg/hr on either oil.**

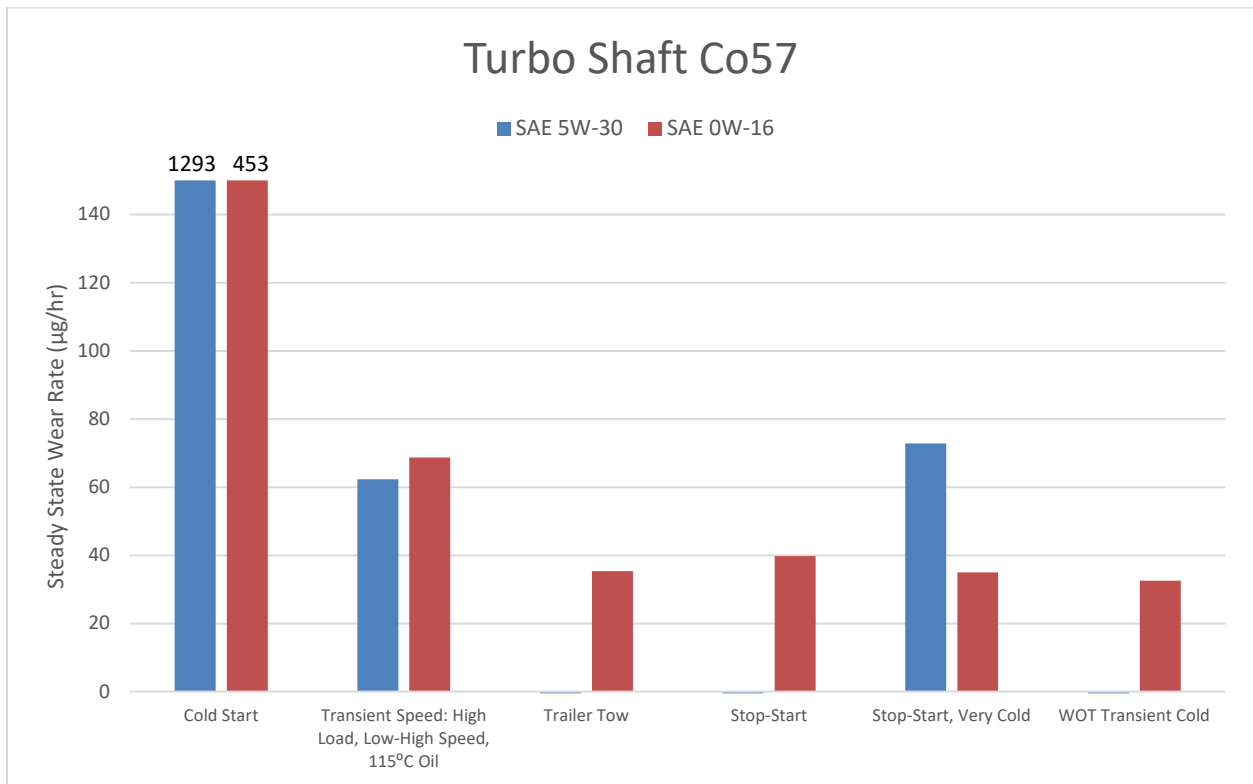
**Figure 12. Turbo shaft wear for test cycles showing greater than 18µg/hr on either oil.**

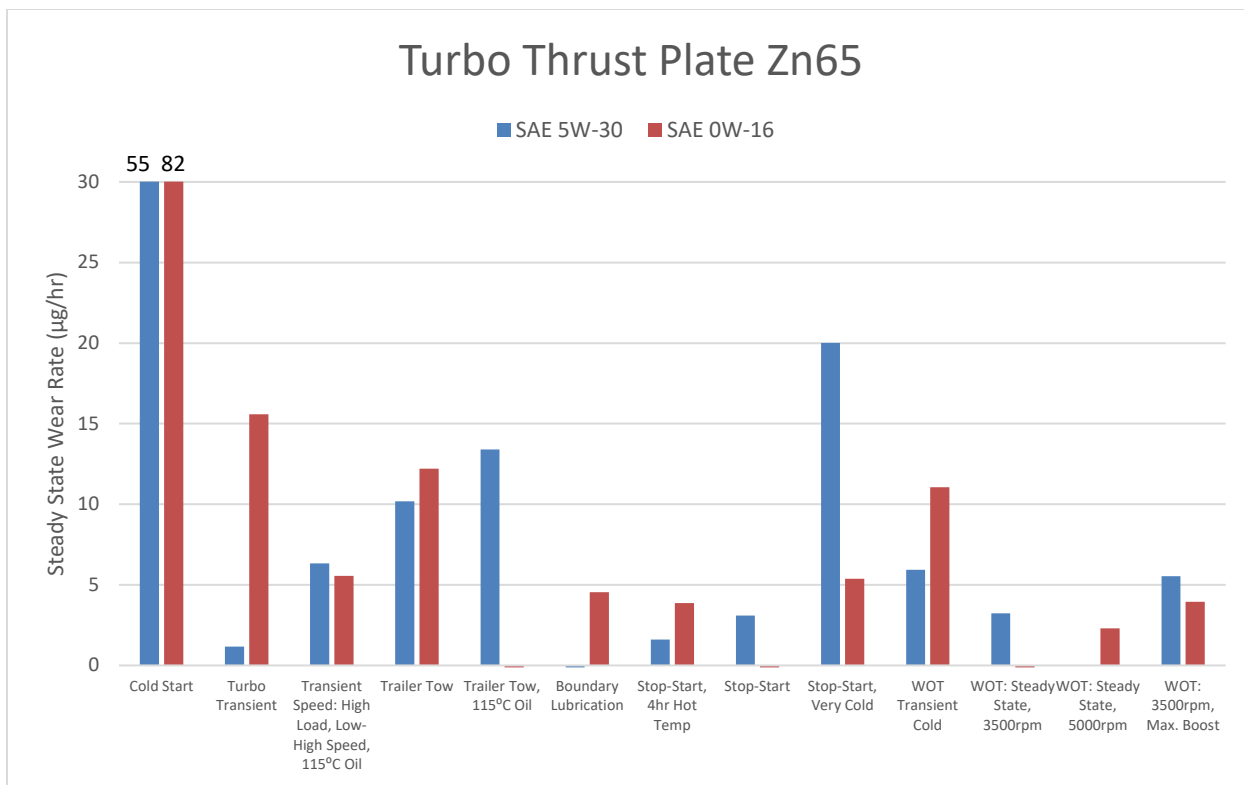
**Figure 13. Turbo thrust plate wear for test cycles showing greater than 0.3µg/hr on either oil.**

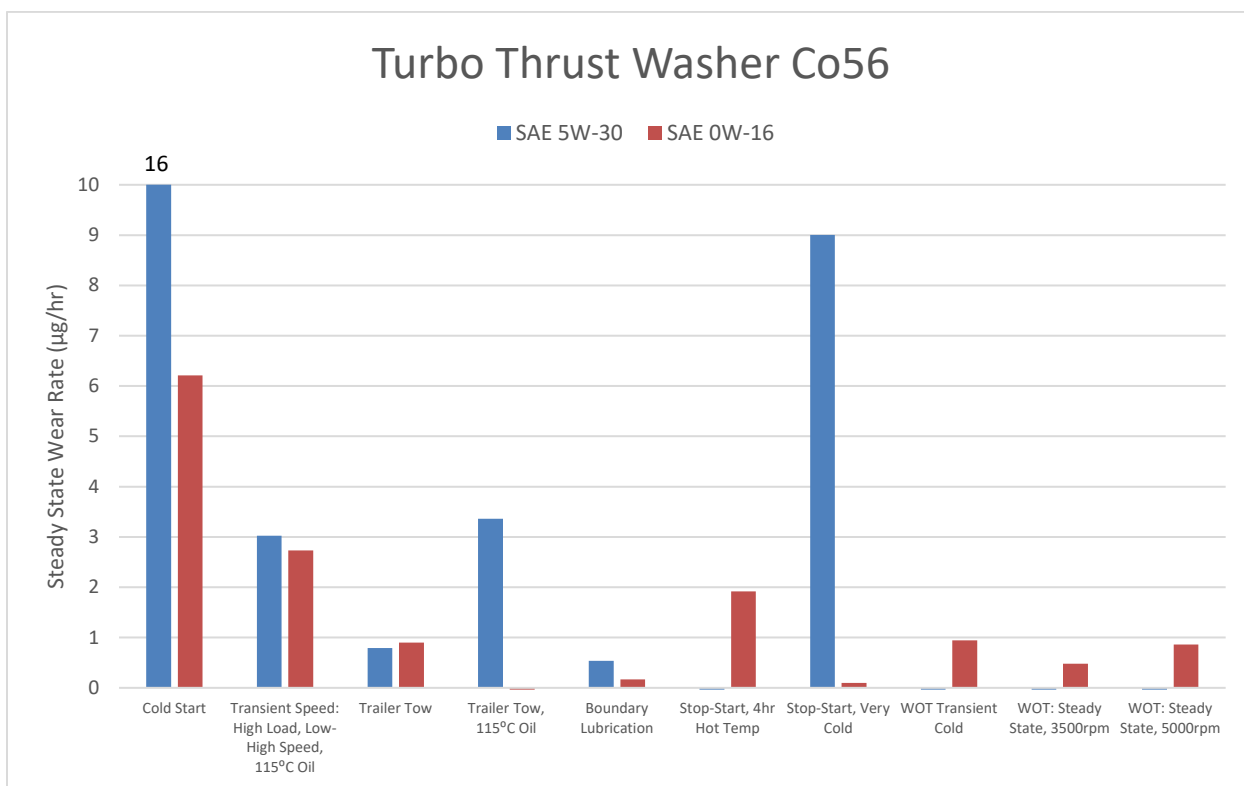
**Figure 14. Turbo thrust washer wear for test cycles showing greater than 0.3µg/hr on either oil**

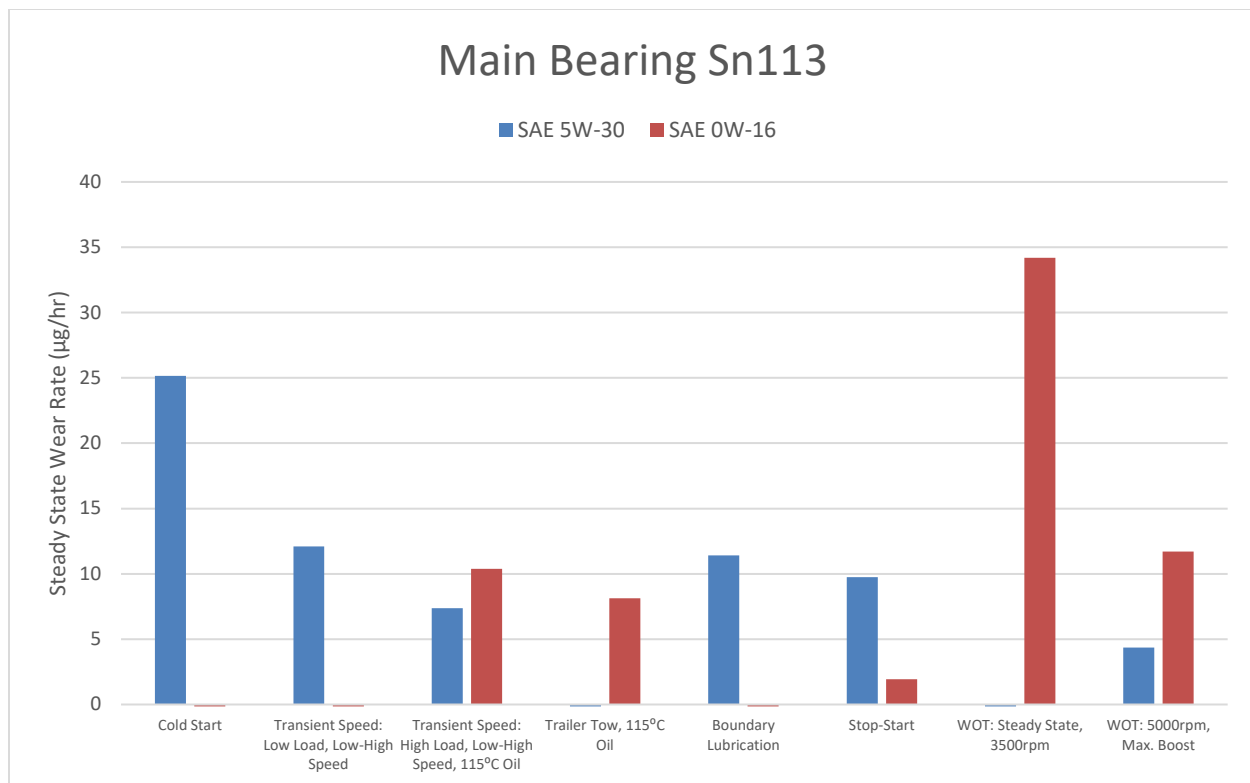
**Figure 15. Main bearing (Sn113) wear for test cycles showing greater than 8µg/hr on either oil.**

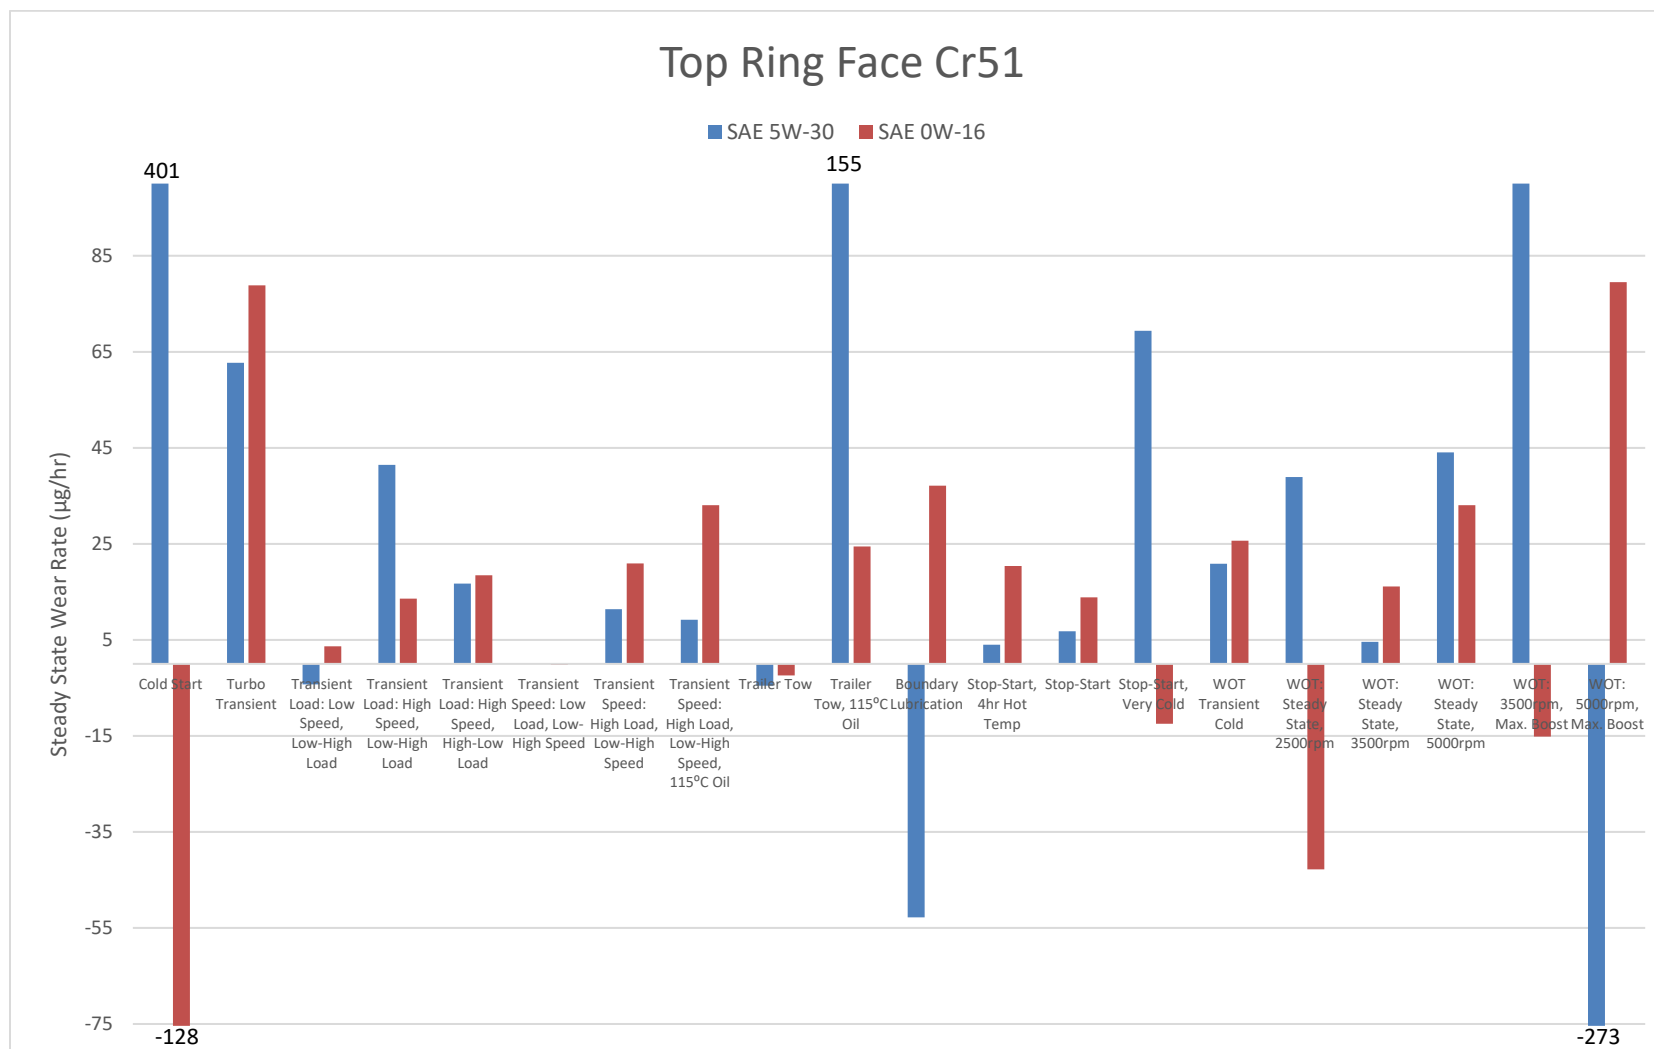
**Figure D1. Top Ring Face Wear for Complete Test Matrix in Chronological Testing Order**

In a number of the tests, negative wear rates were recorded. This is not an unusual occurrence when using RATT<sup>®</sup> to measure real time wear of components. It is usual for this to occur in test conditions where the radioactive wear particles are lost at a faster rate than they are created. In almost all these circumstances it is reasonable to assume that the wear rates must be low, because if they are not, an increase in wear particles would be detected.

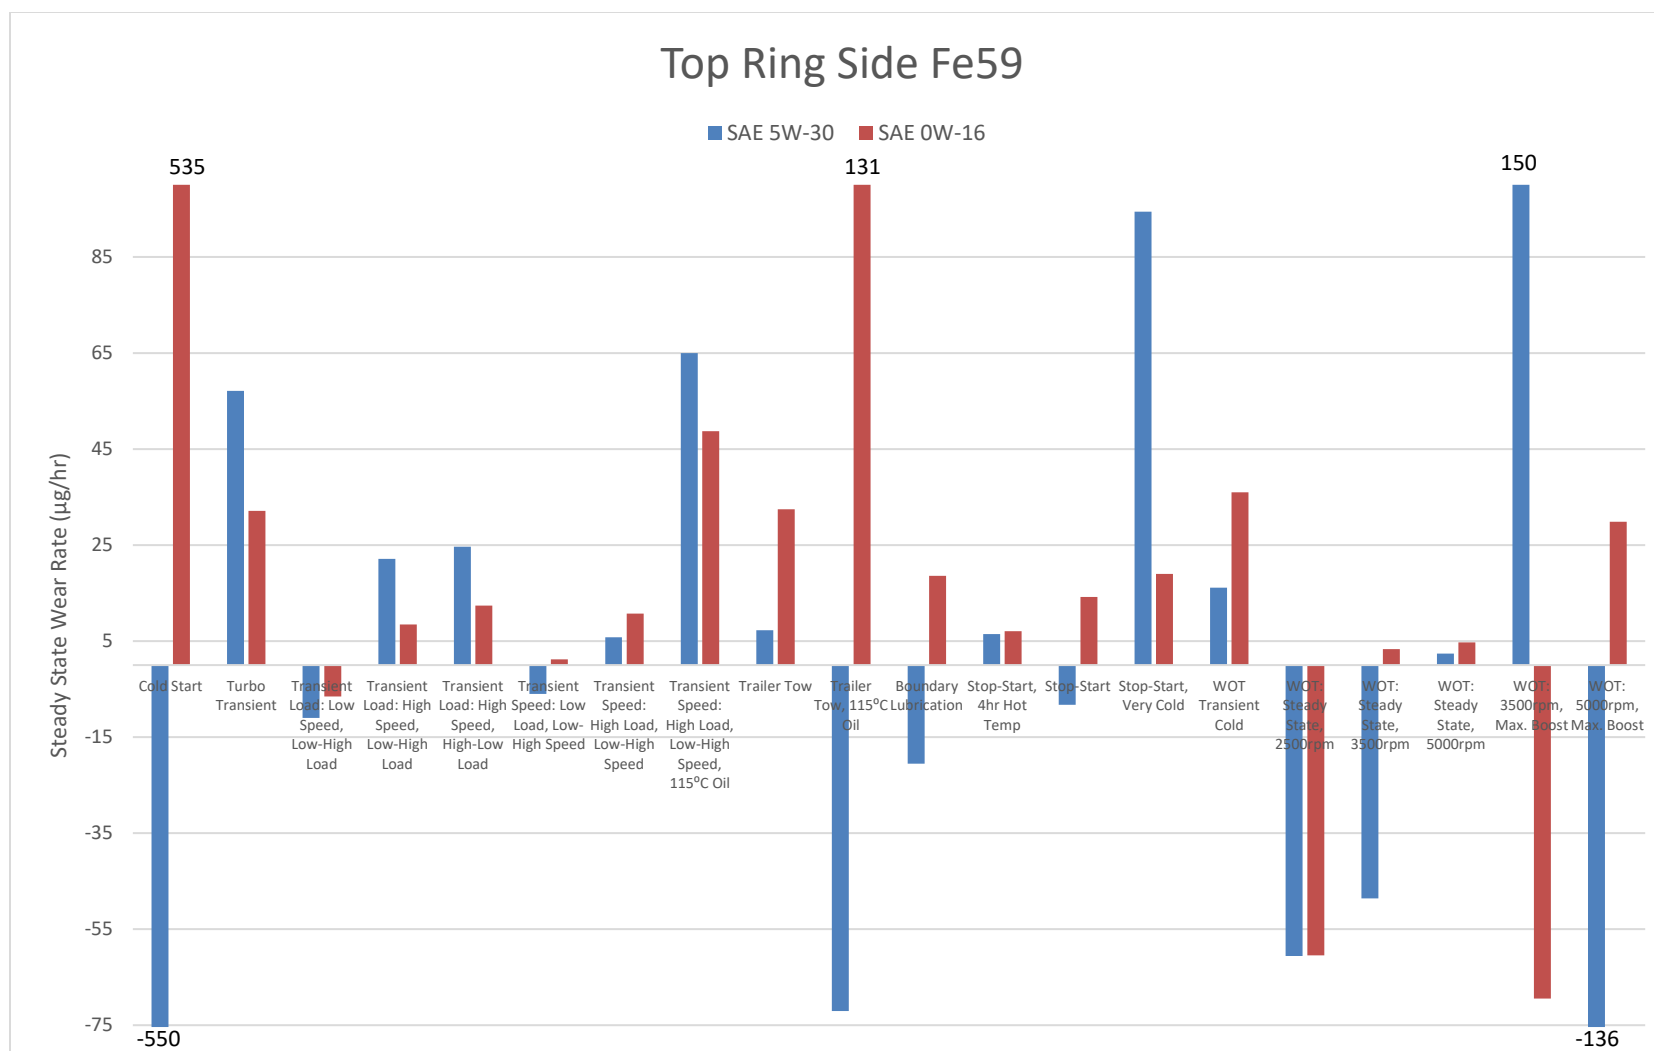
**Figure D2. Top Ring Side Wear Summary for Complete Test Matrix in Chronological Testing Order**

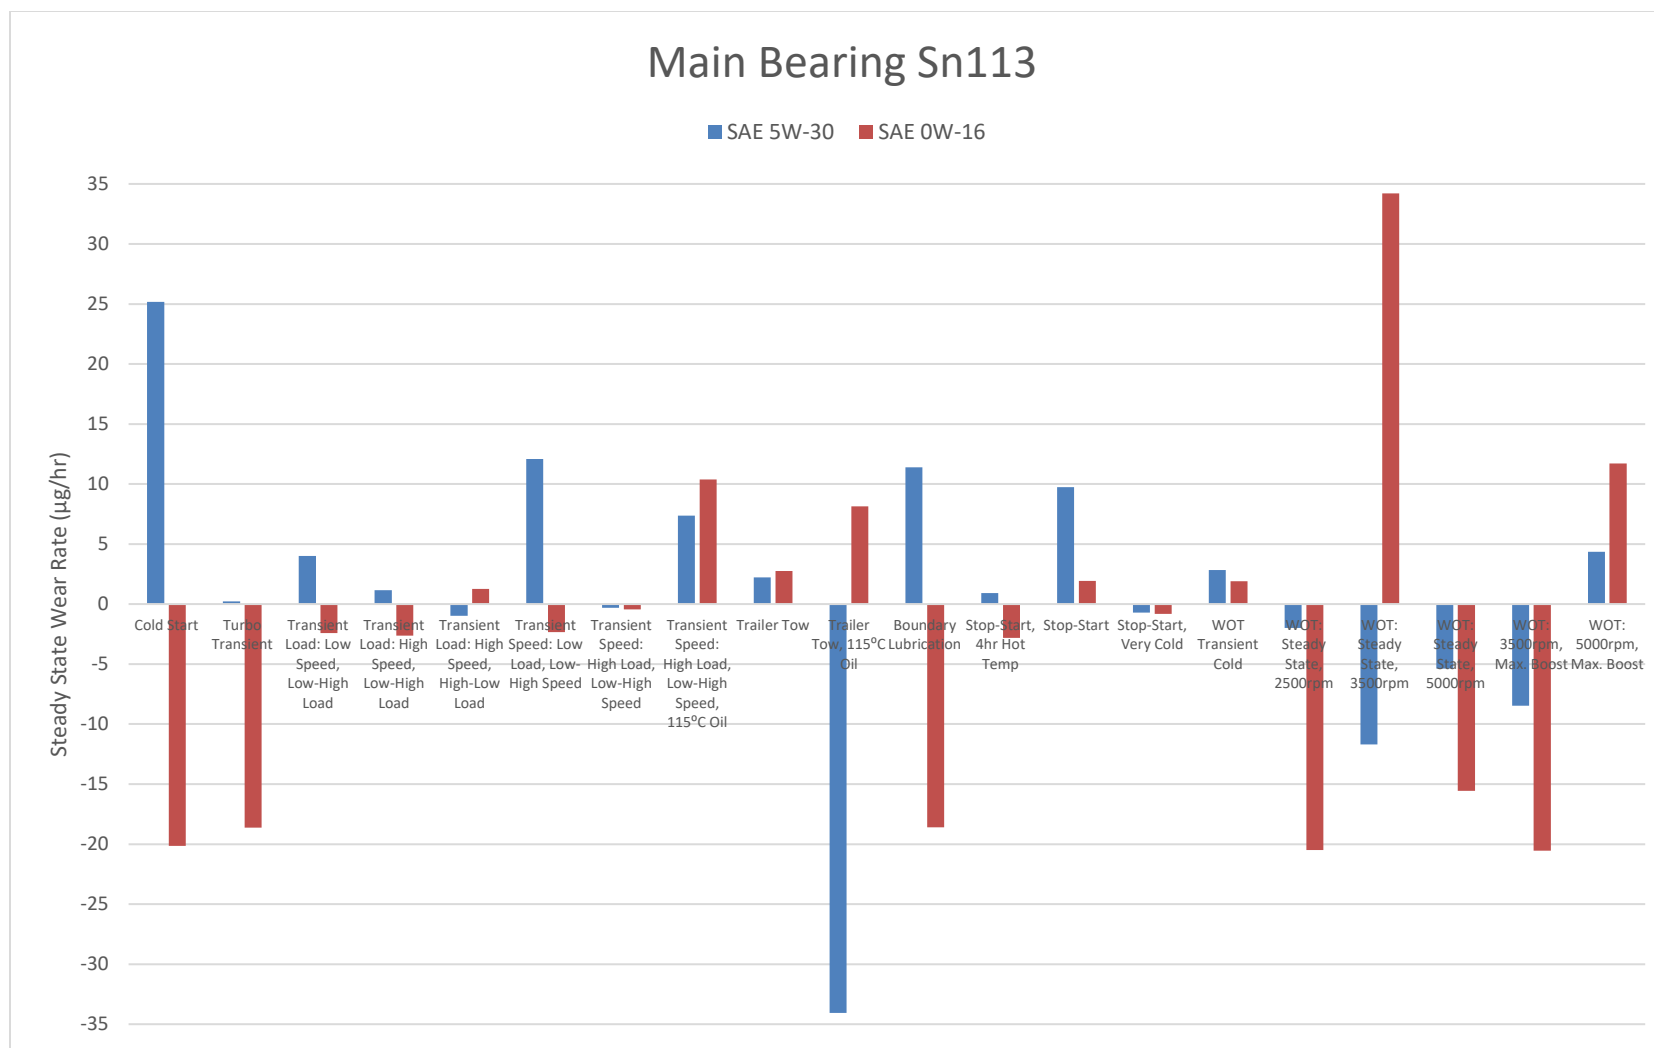
**Figure D3. Main Bearing Wear Summary for Complete Test Matrix in Chronological Testing Order**

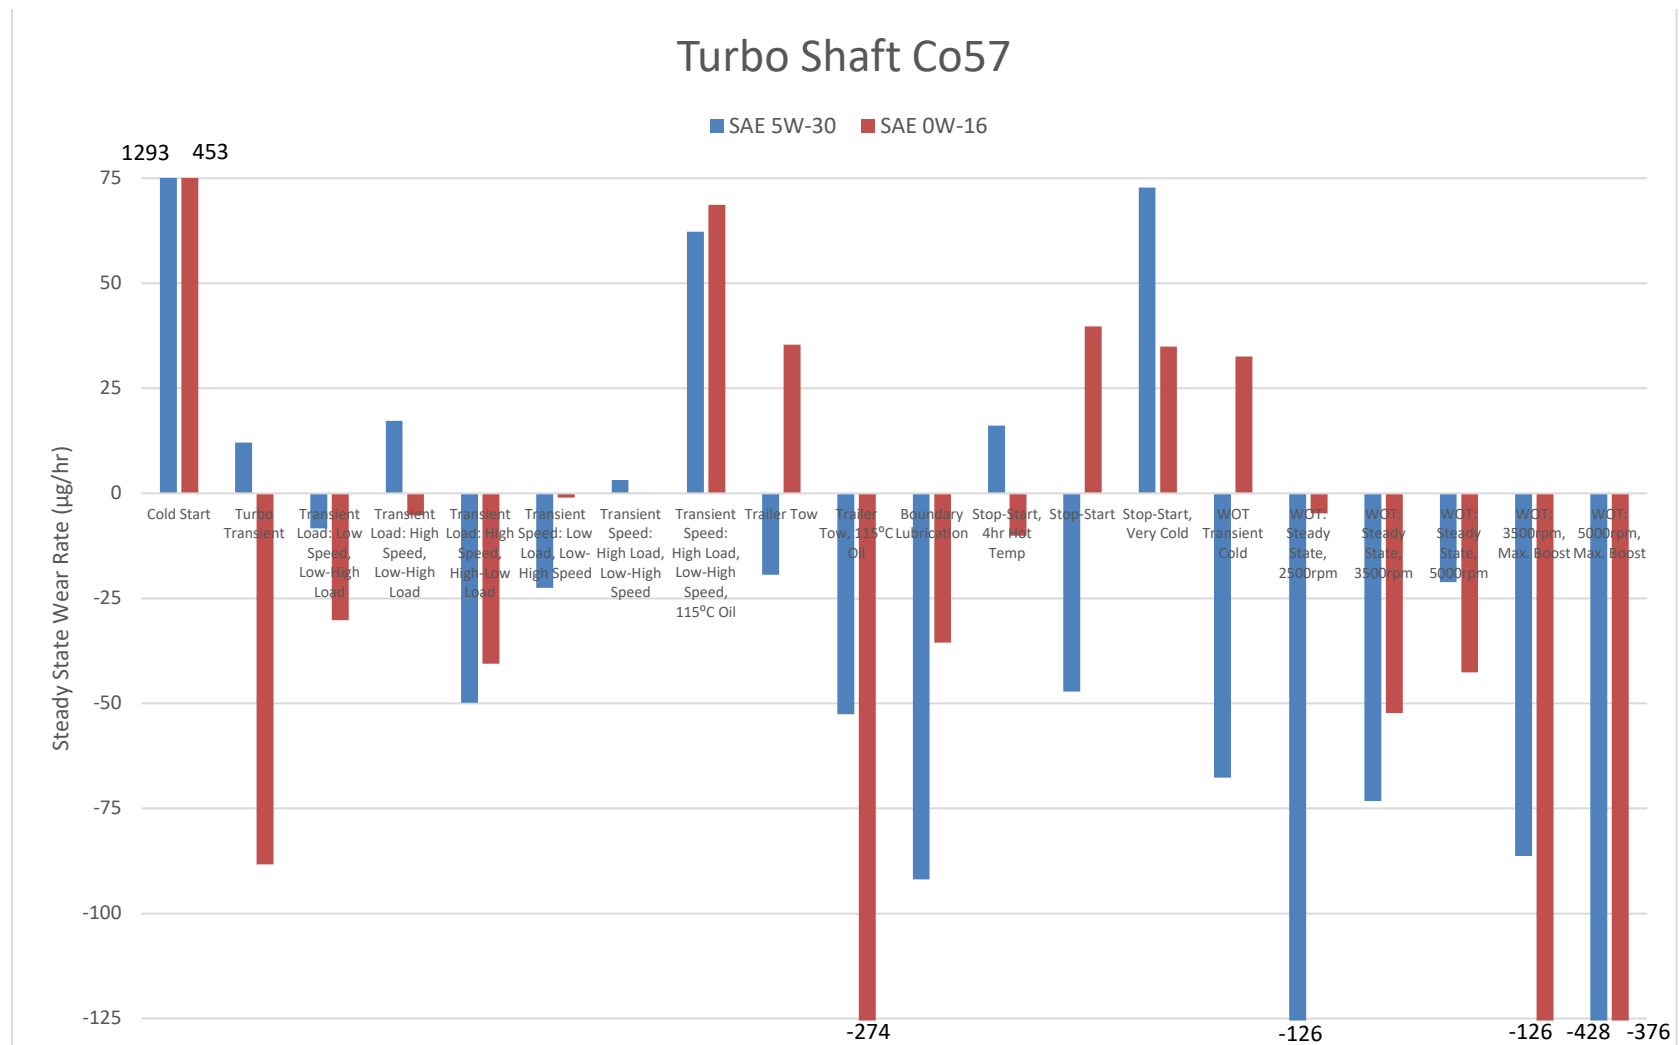
**Figure D4. Turbo Shaft Wear Summary for Complete Test Matrix in Chronological Testing Order**

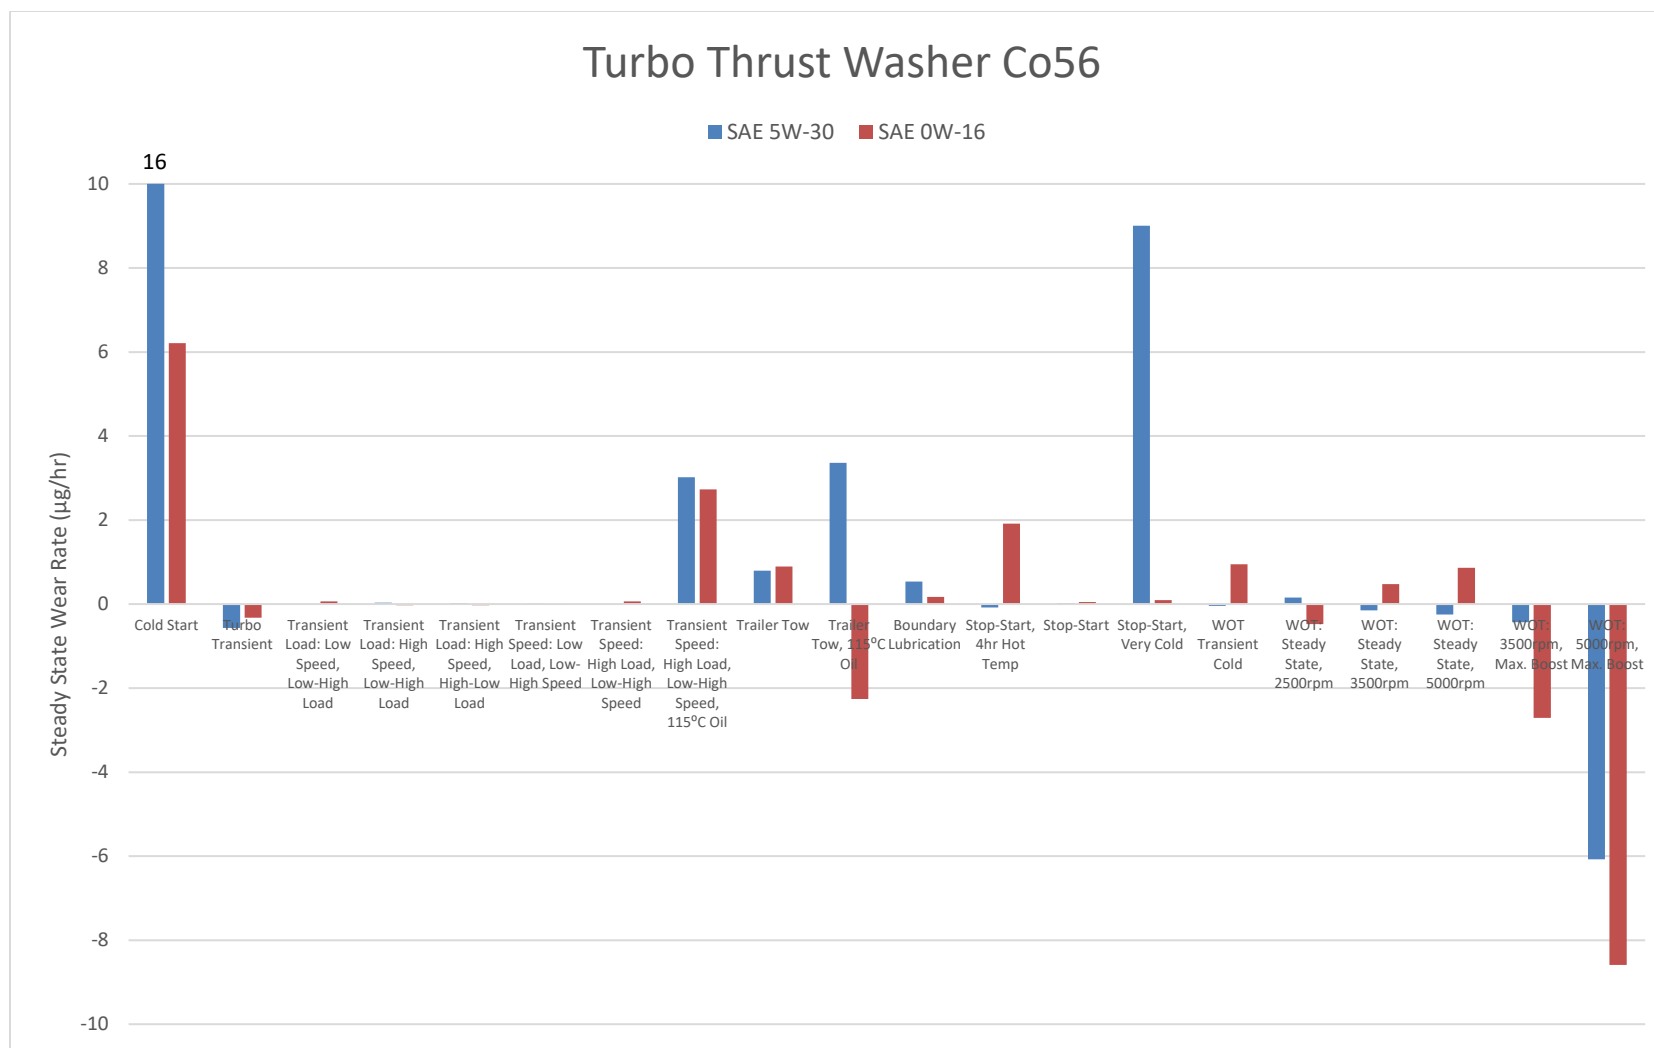
**Figure D5. Turbo Thrust Washer Wear Summary for Complete Test Matrix in Chronological Testing Order**
