**CRC Report No. AVFL-28**  
**Phase II**

**GASOLINE DIRECT INJECTION (GDI)  
ENGINE WEAR TEST DEVELOPMENT**

**Final Report**

**SOUTHWEST RESEARCH INSTITUTE®**  
**San Antonio, Texas**  
**Fuels and Lubricants Research Division**

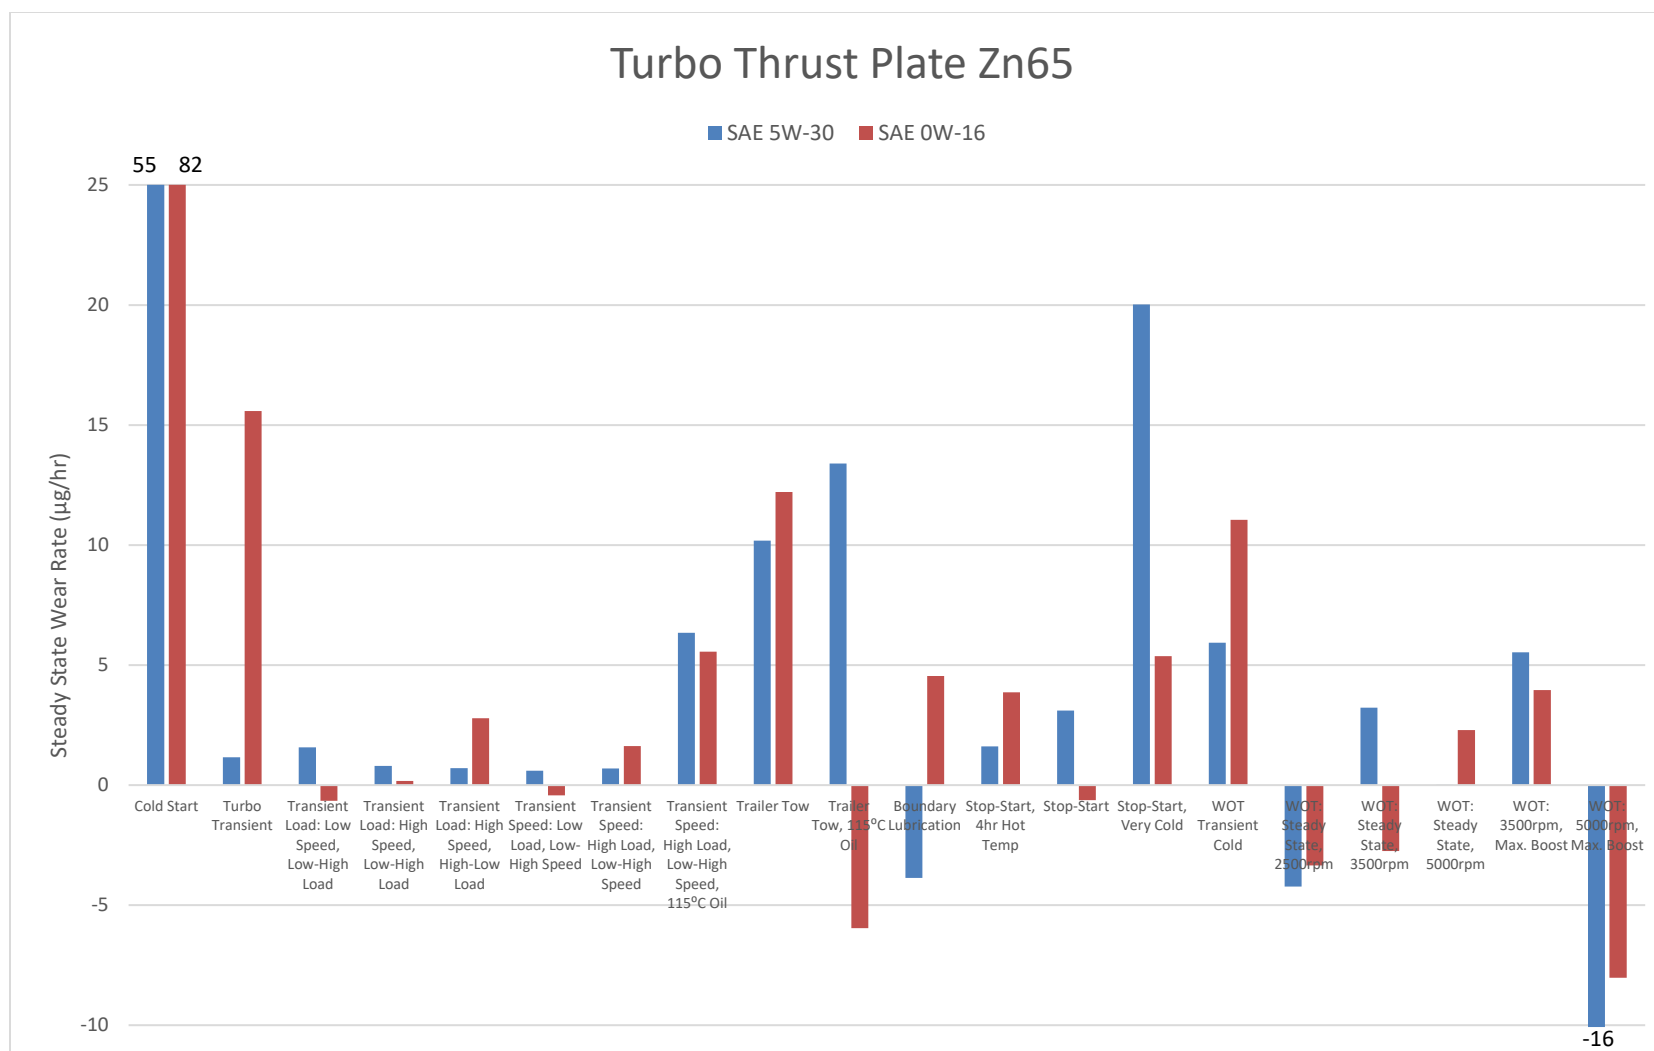
**Figure D6. Turbo Thrust Plate Wear Summary for Complete Test Matrix in Chronological Testing Order**

In a number of the tests, negative wear rates were recorded. This is not an unusual occurrence when using RATT<sup>®</sup> to measure real time wear of components. It is usual for this to occur in test conditions where the radioactive wear particles are lost at a faster rate than they are created. In almost all these circumstances it is reasonable to assume that the wear rates must be low, because if they are not, an increase in wear particles would be detected.

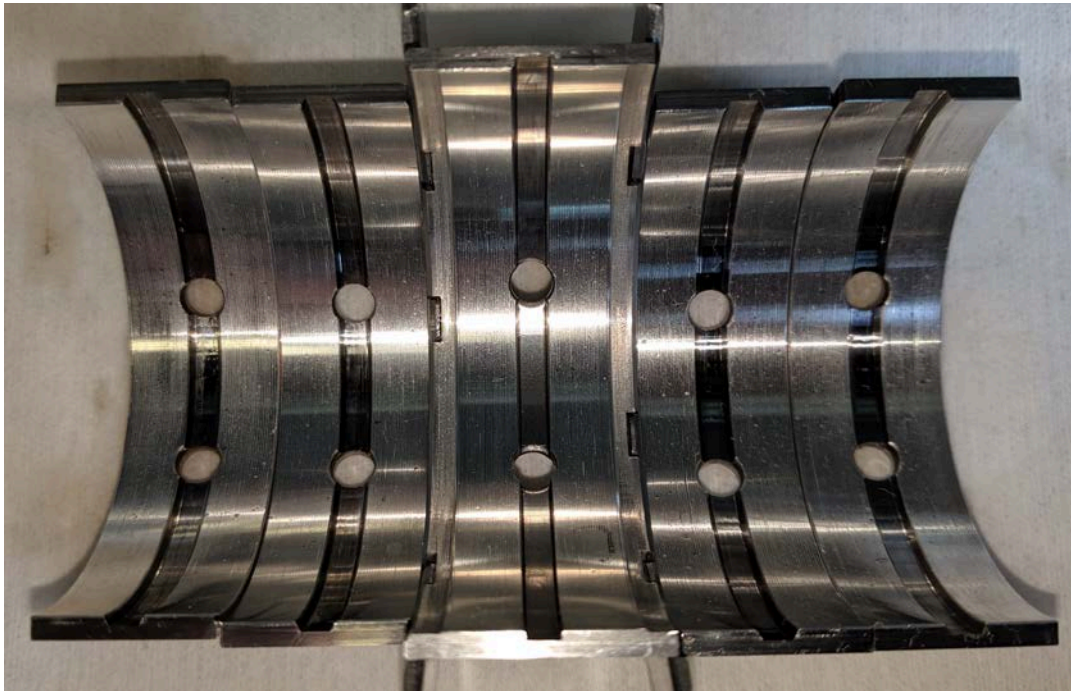
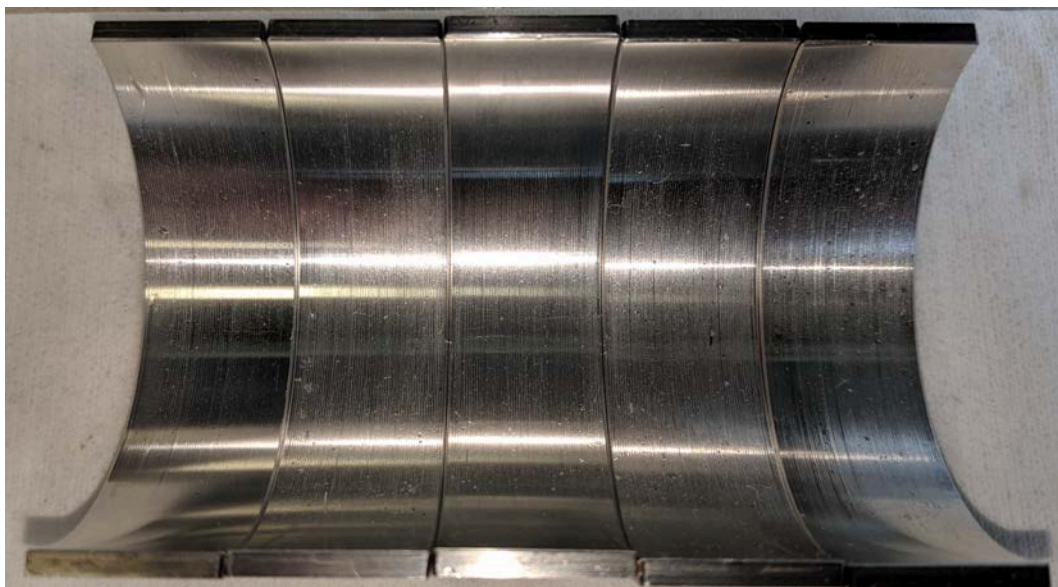
Figures G1-2 show the EOT main bearings. Since this testing program ran without an oil filter, higher than expected levels of embedded particles were present. Overall levels of normal bearing wear were low as corroborated by the radiation data.

**Figure G1. Main Bearings – Upper Halves**

**Figure G2. Main Bearings – Lower Halves**

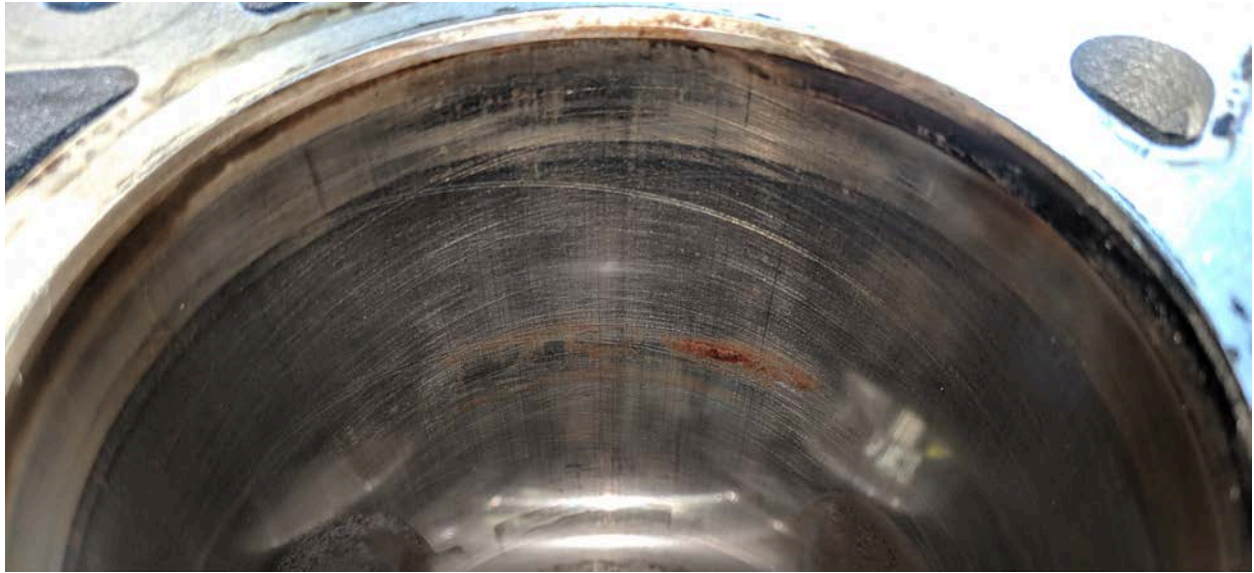
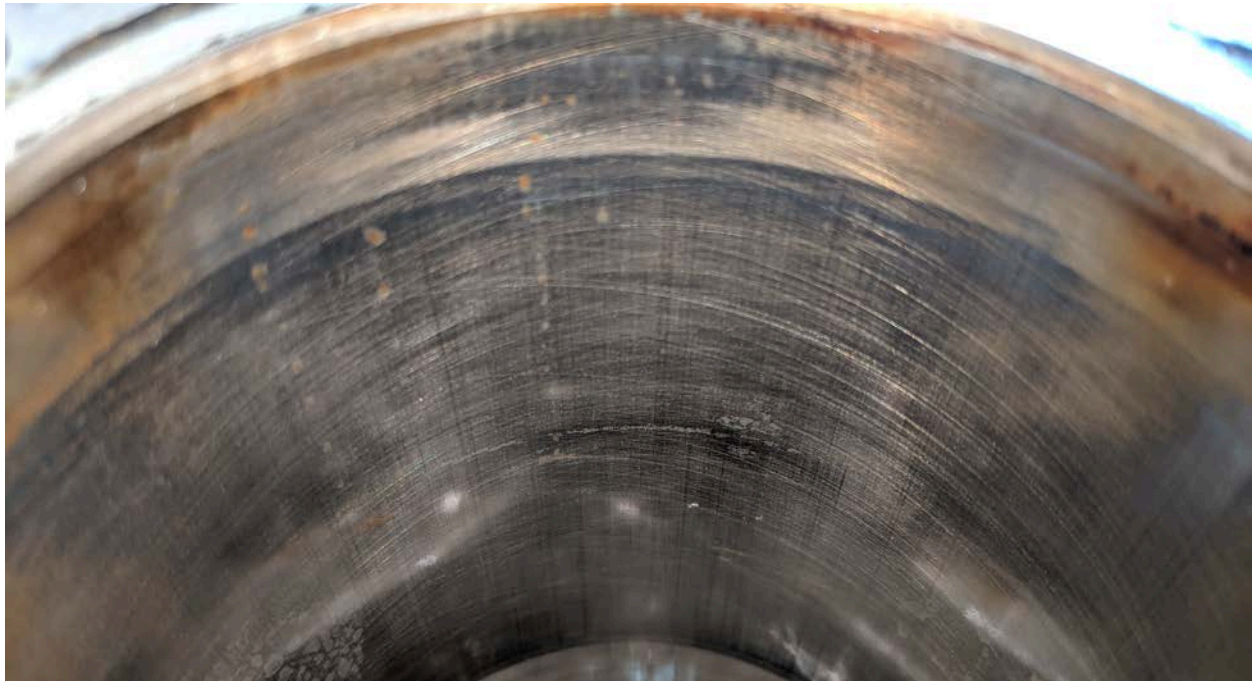
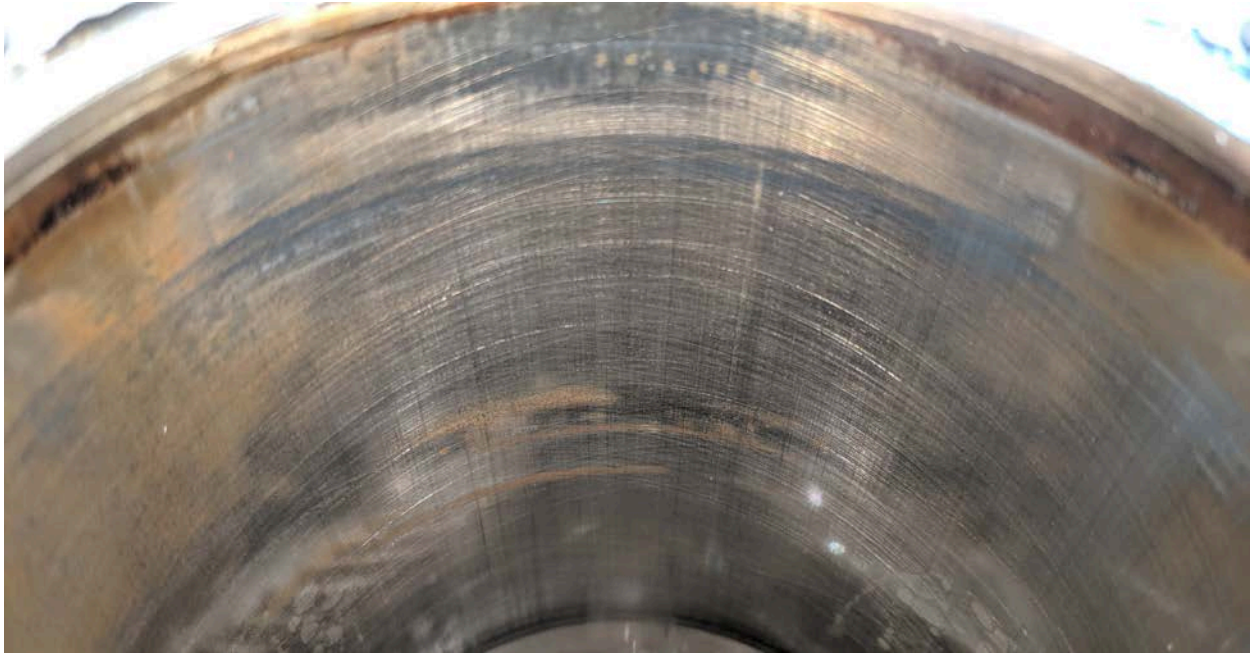
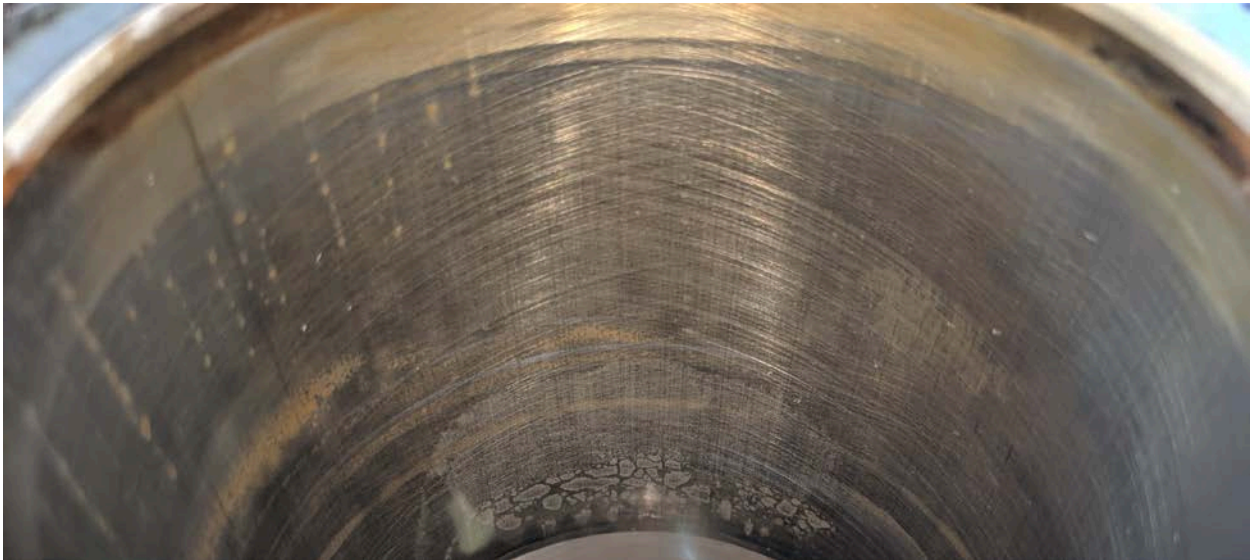
Aside from some mild post-test corrosion the cylinder liners were free from excessive wear. Figures G3-6 show the thrust side.

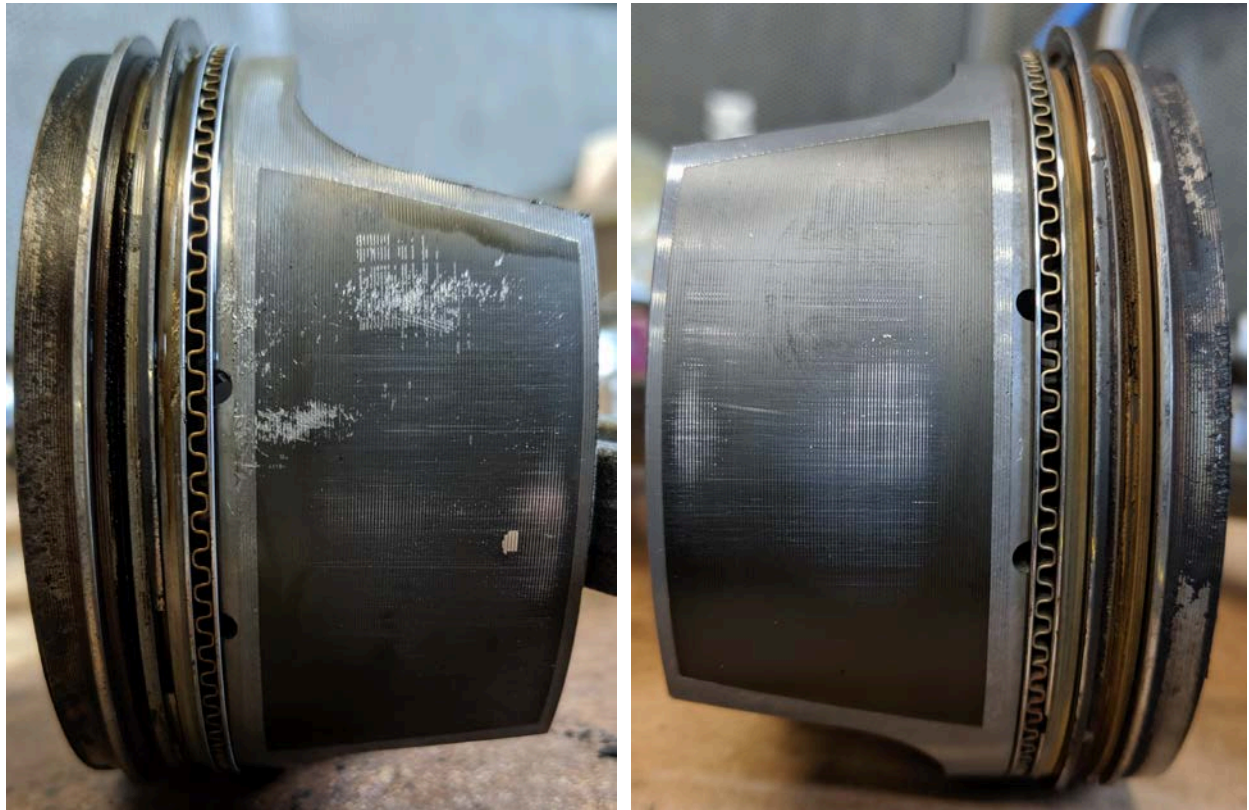
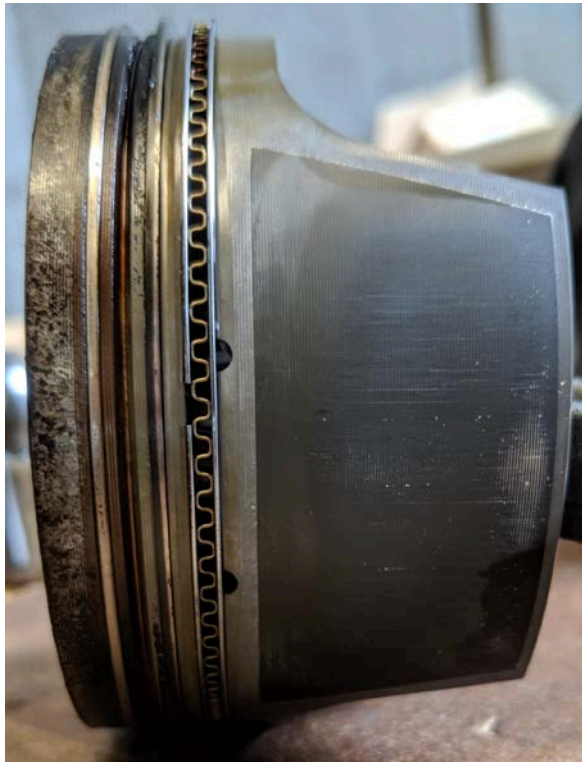
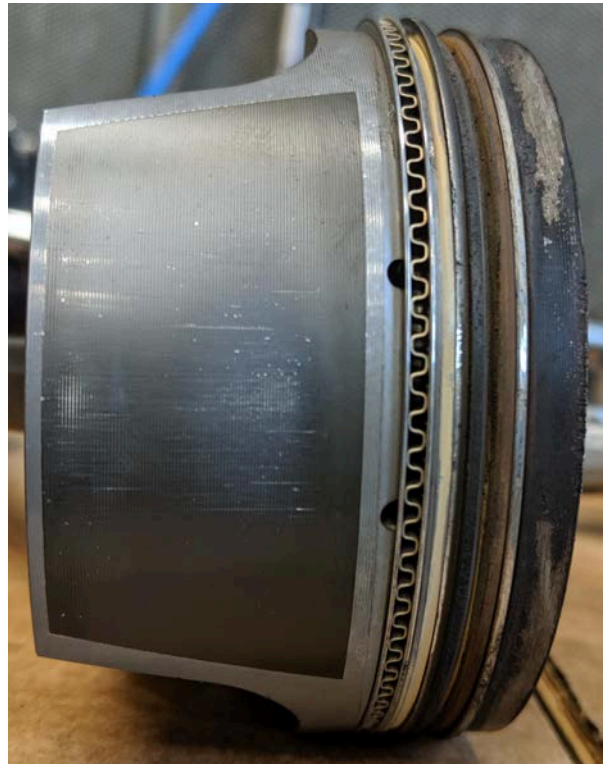
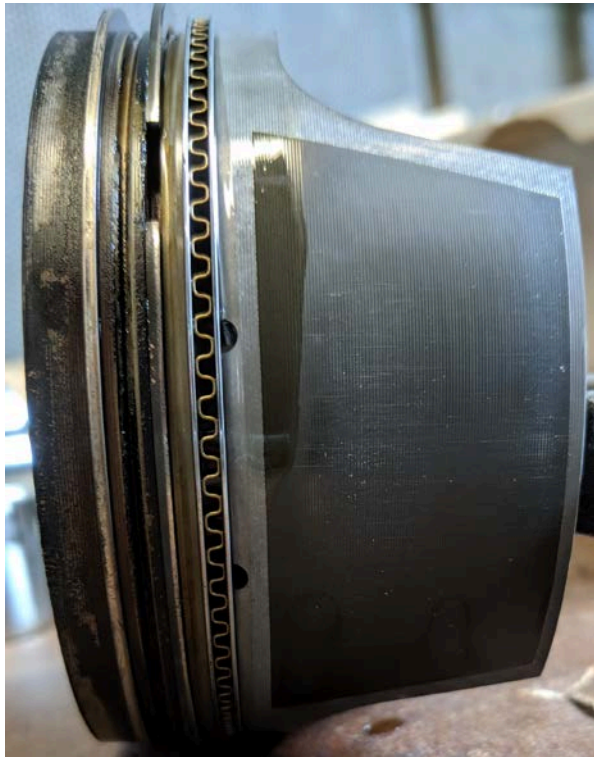
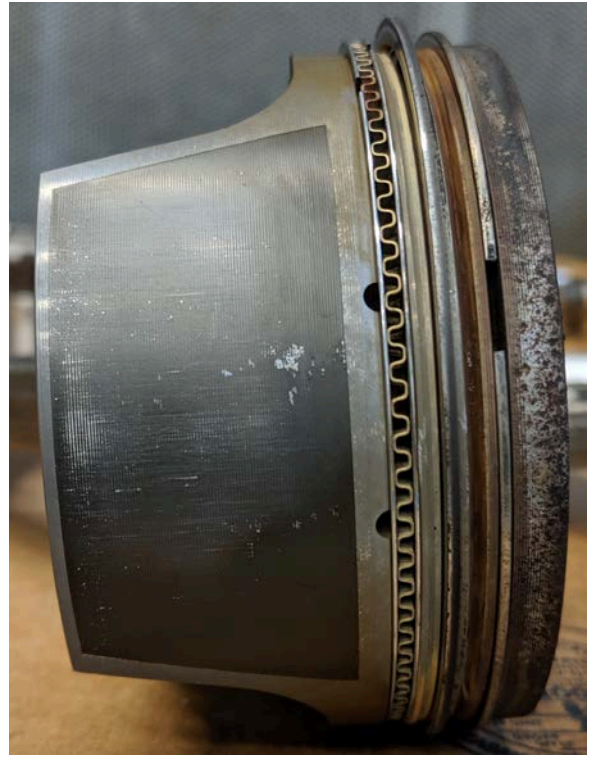
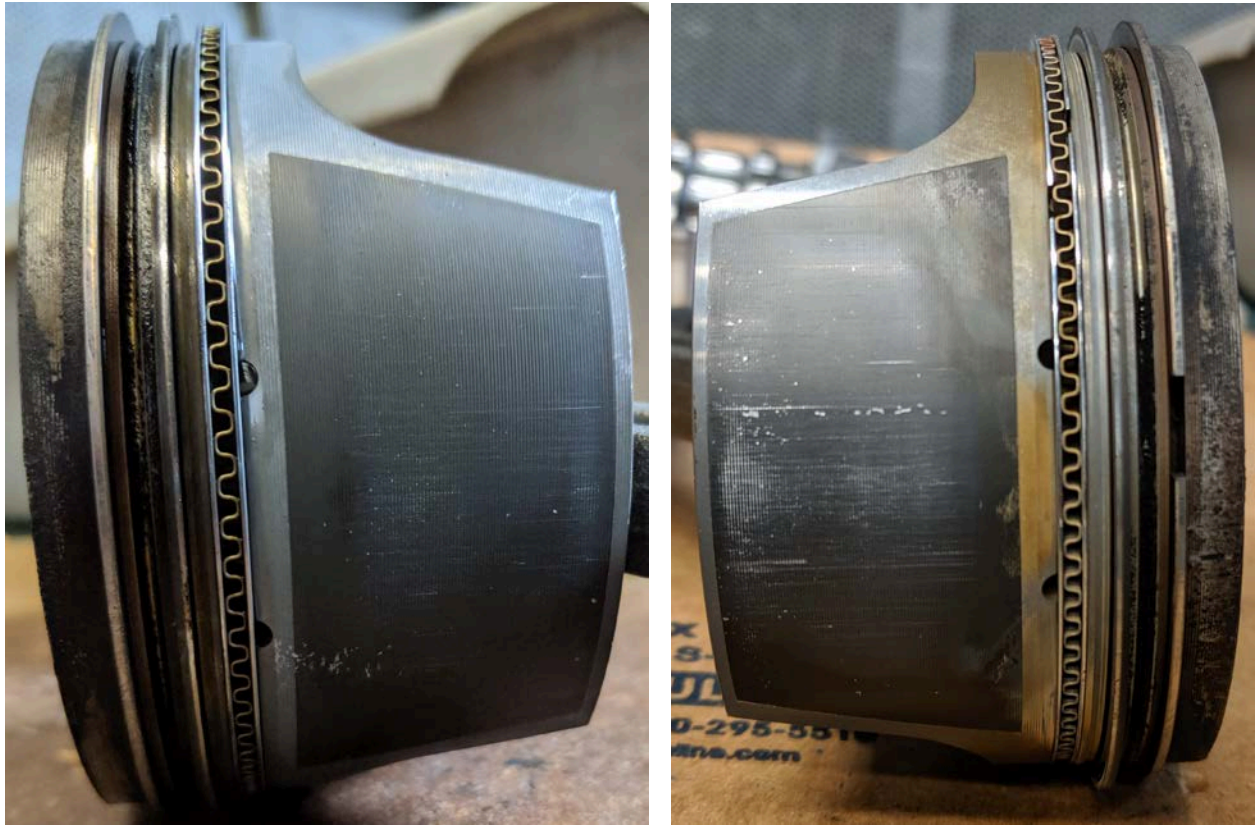
Figures G7-10 show the pistons. Aside from some scratches on the skirt area, no unusual wear was observed. Post-test inspection of the ring pack showed all rings were free with minimal carbon buildup.

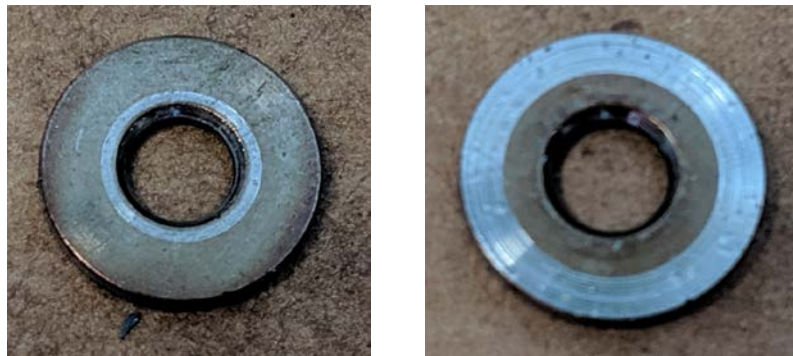
**Figure G11. Turbo Thrust Washer: Compressor Side (Left), Plate Side (Right).**

Figures G11-19 show the irradiated turbo components after testing. Wear areas were imaged for 3-D analysis for a better understanding of the amount of wear on each part.

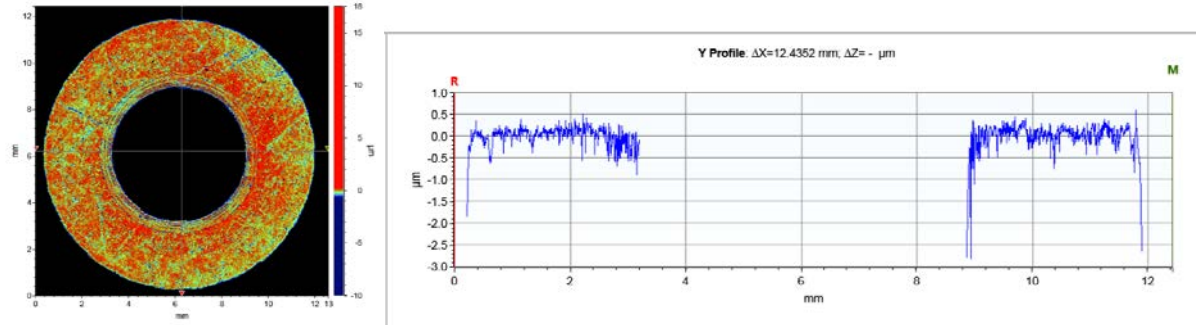
The turbo thrust washer compressor side showed less than 0.5 microns of wear.

**Figure G12. Turbo Thrust Washer: 3D Compressor Side**

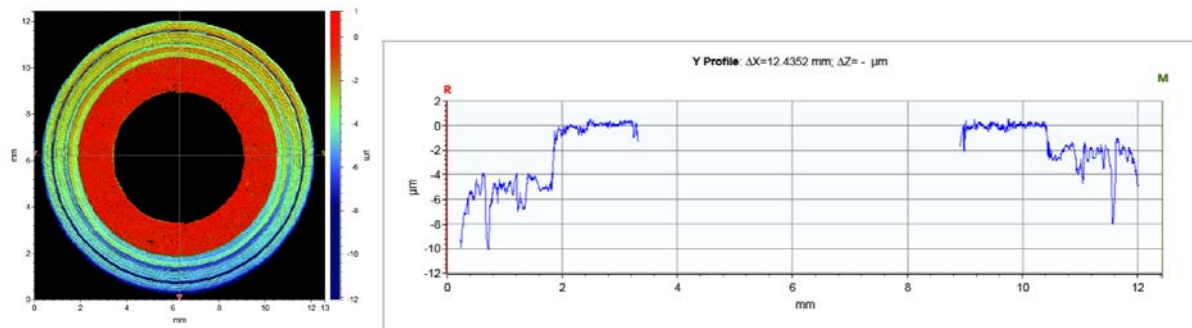
The turbo thrust washer plate side showed about 10 microns of wear at the deepest groove.

**Figure G13. Turbo Thrust Washer: 3D Plate Side**

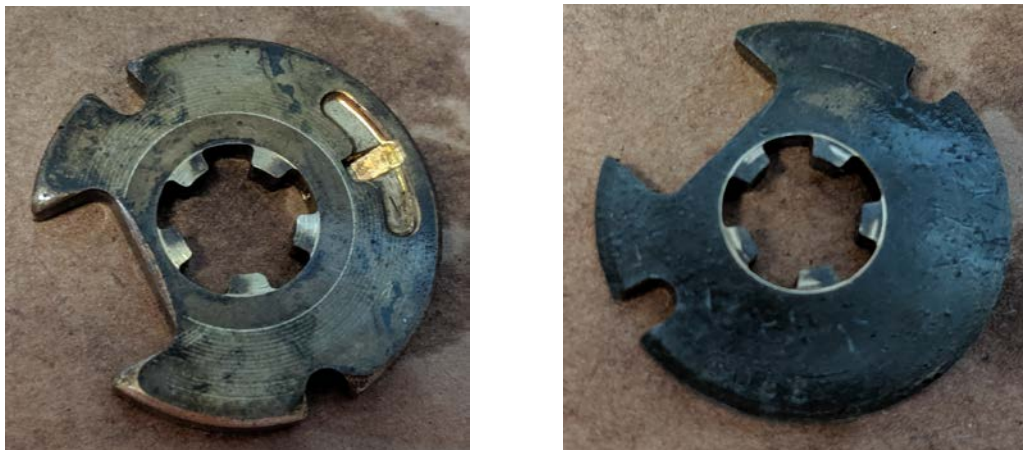
**Figure G14. Turbo Thrust Plate: Washer Side (Left), Journal Bearing Side (Right).**

The washer side of the turbo thrust plate had maximum wear on each tooth face of approximately 35 microns.

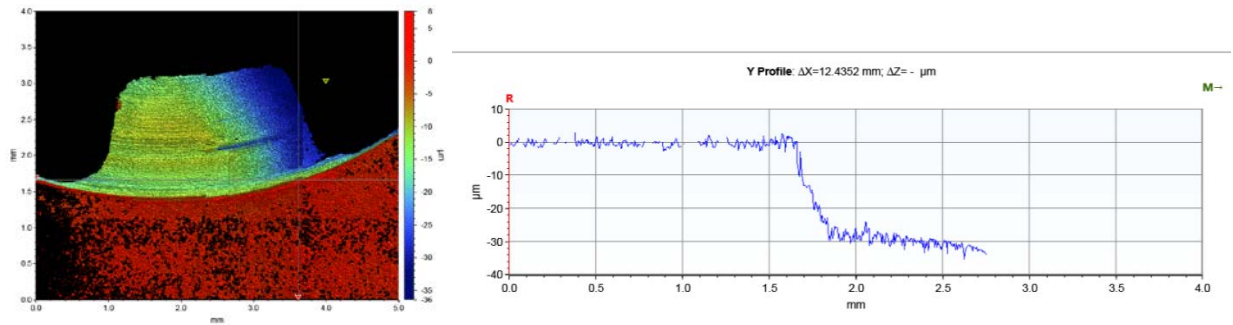
**Figure G15. Turbo Thrust Plate: 3D Washer Side**

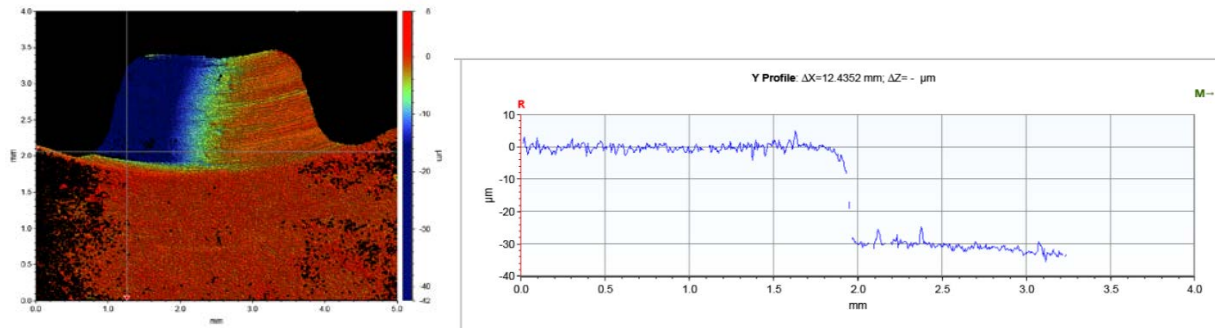
The journal bearing side of the turbo thrust plate had maximum wear on each tooth face of approximately 35 microns.

**Figure G16. Turbo Thrust Plate: 3D Journal Bearing Side**

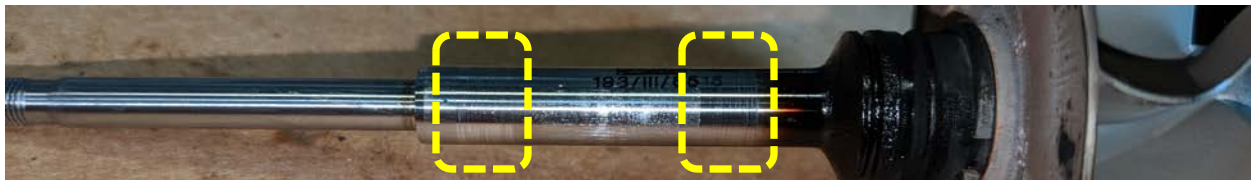
**Figure G17. Turbo Shaft – journal wear areas highlighted in yellow.**

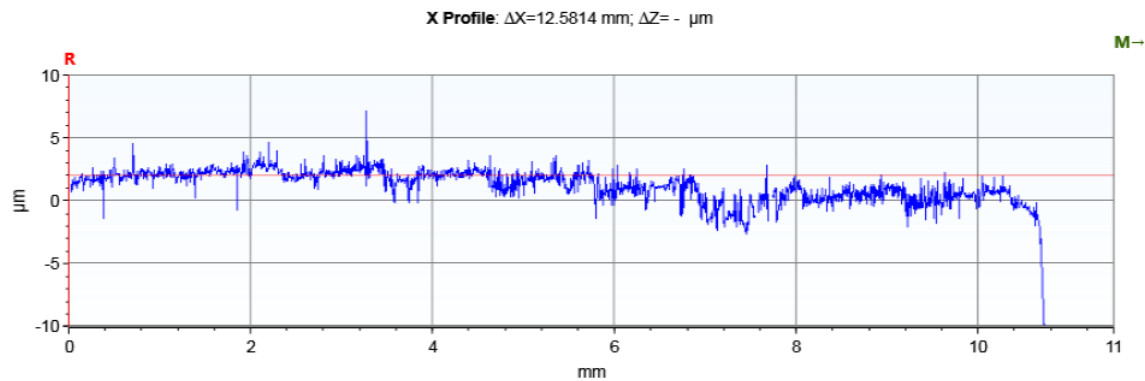
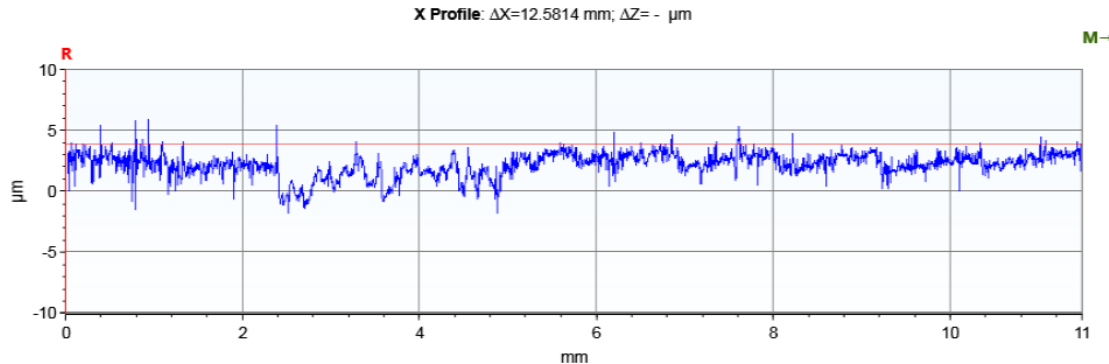
3D profilometry on the turbo shaft wear areas showed only a few microns of wear on the deepest grooves. Overall the wear on the turbine side seemed higher than on the compressor side.

**Figure G18. Turbo Shaft Profile: Compressor Side**

**Figure G19. Turbo Shaft Profile: Turbine Side**

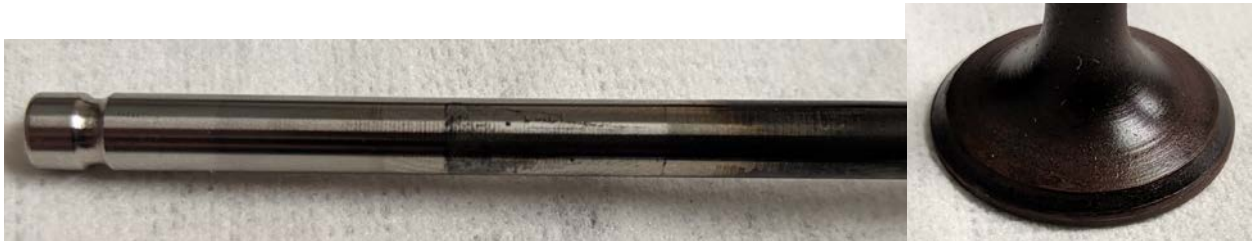
Figure G39 shows the exhaust valve #3 (or 2A depending on the numbering system). All of the valves looked similar and showed no measureable wear. The exhaust valve does have discoloration and surface deposits, but they are not severe.

**Figure G39. Exhaust Valve #3 Stem and Tulip**

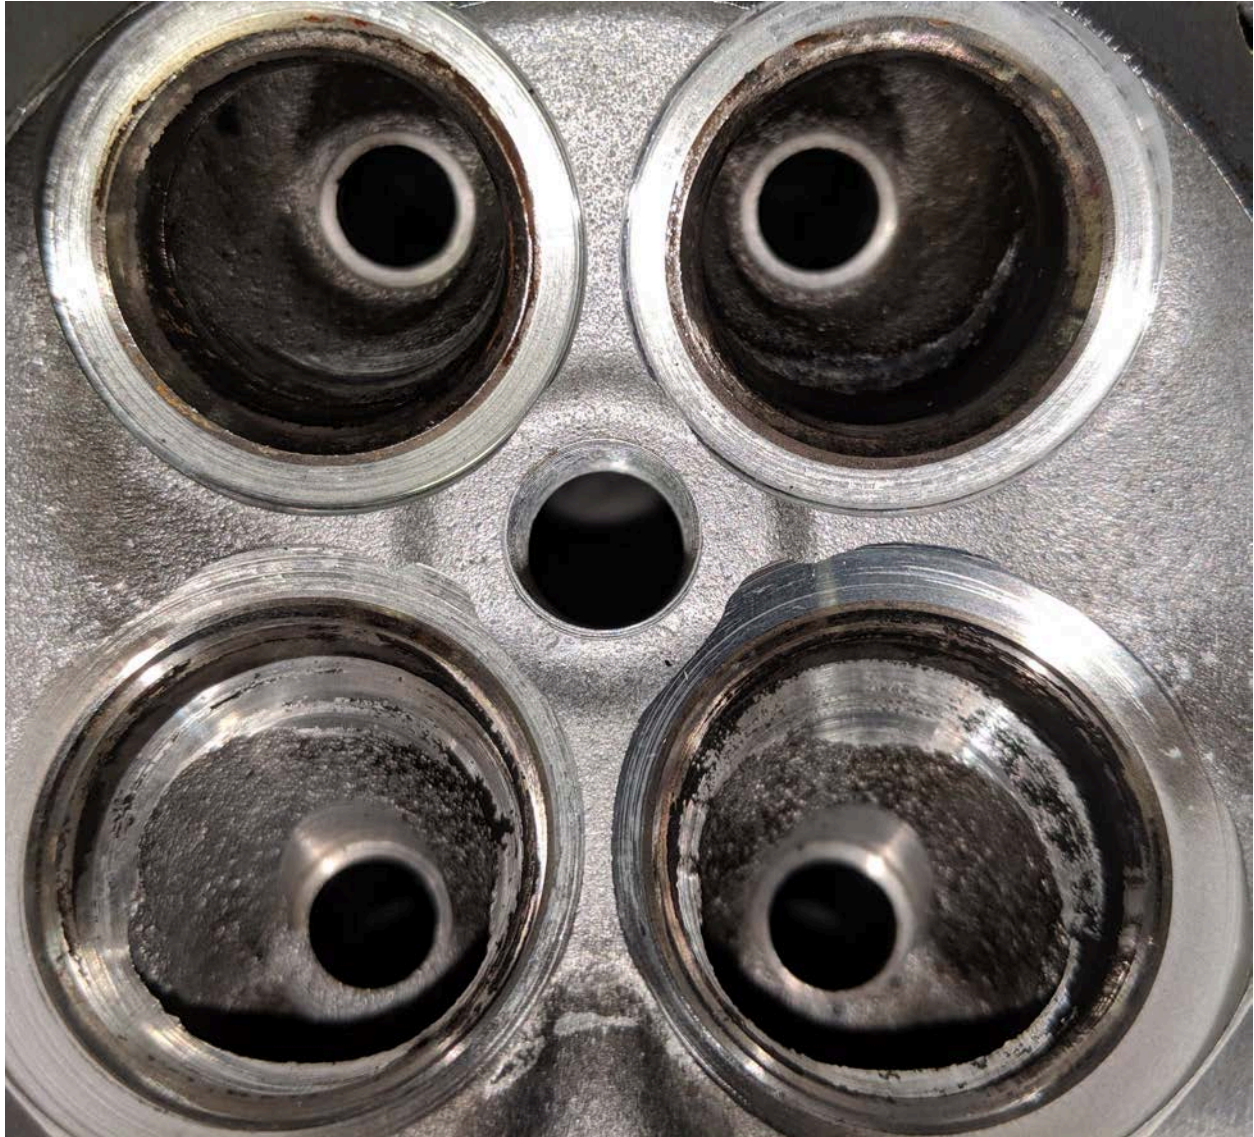
Figure G40 shows the combustion chamber #4 on the head. This picture was taken after solvent cleaning to remove loose deposits. The exhaust ports are on top and the intake on the bottom. There is some mild corrosion of the seats inside the combustion chamber and some hard deposits on the seats in the port area. The sealing surfaces look normal with no measureable recession or wear. The other 3 combustion chambers of the head looks similar to this picture.

**Figure G40. Combustion Chamber / Head Area #4**
