# **OPERABILITY AND COMPATIBILITY CHARACTERISTICS OF ADVANCED TECHNOLOGY DIESEL FUELS**

**FINAL REPORT**

**SWRI Project No. 03-02476**

**CRC Project No. AVFL-2**

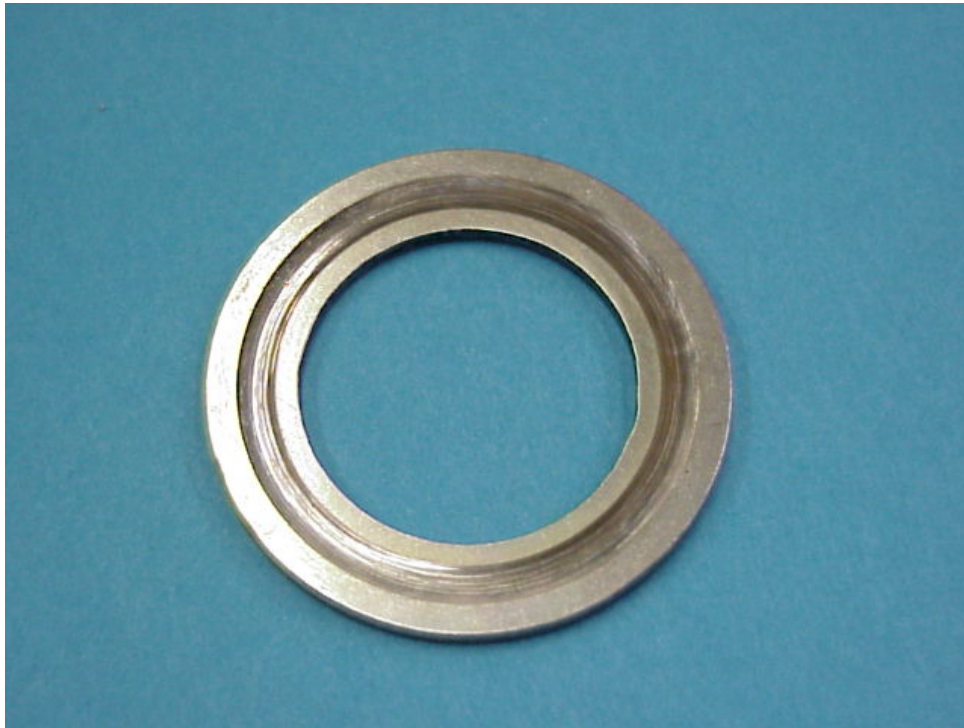
Figure 1-2. Governor Thrust Washer Wear Groove with CA Fuel

The pump disassembly, inspection, and rating of critical components is shown in Table 1-5. A wear level of 5 indicates a component that has failed, seized, or that would be replaced during rebuild because it is worn out of tolerance. The average wear levels suggest more wear was apparent throughout the pumps that operated on the CA fuel. The governor thrust washers from the CA pump revealed a severe circumferential wear groove as shown in Figure 1-2. Upon further inspection of the fuel injection pumps with fuel CA, a dark brown varnish deposit was pervasive throughout the pumps. One area where the deposit was heavy was the orifice that supplies the pressure for the advance piston and subsequently the housing. Deposits in this area affect housing pressure, advance, and return flow. Deposits were also seen on the advance piston. The housing pressure is supplied from a bleed off the advance piston. Figure 1-3 reveals the heavy deposits seen on pump components from the CA fuel test.

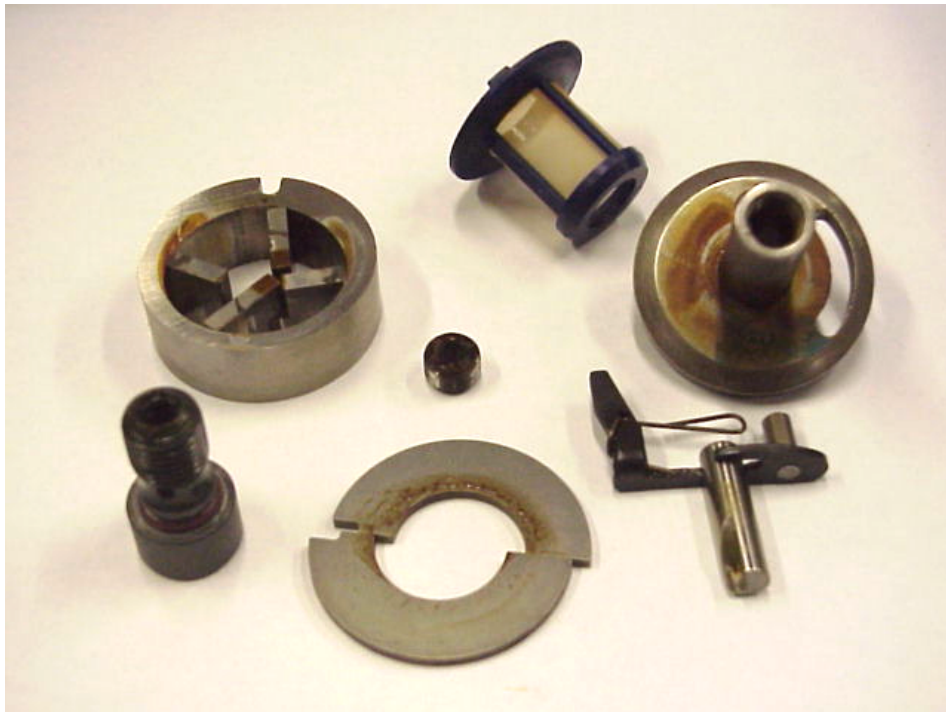
Figure 1-3. Heavy Deposits from CA Fuel from a Stanadyne Pump

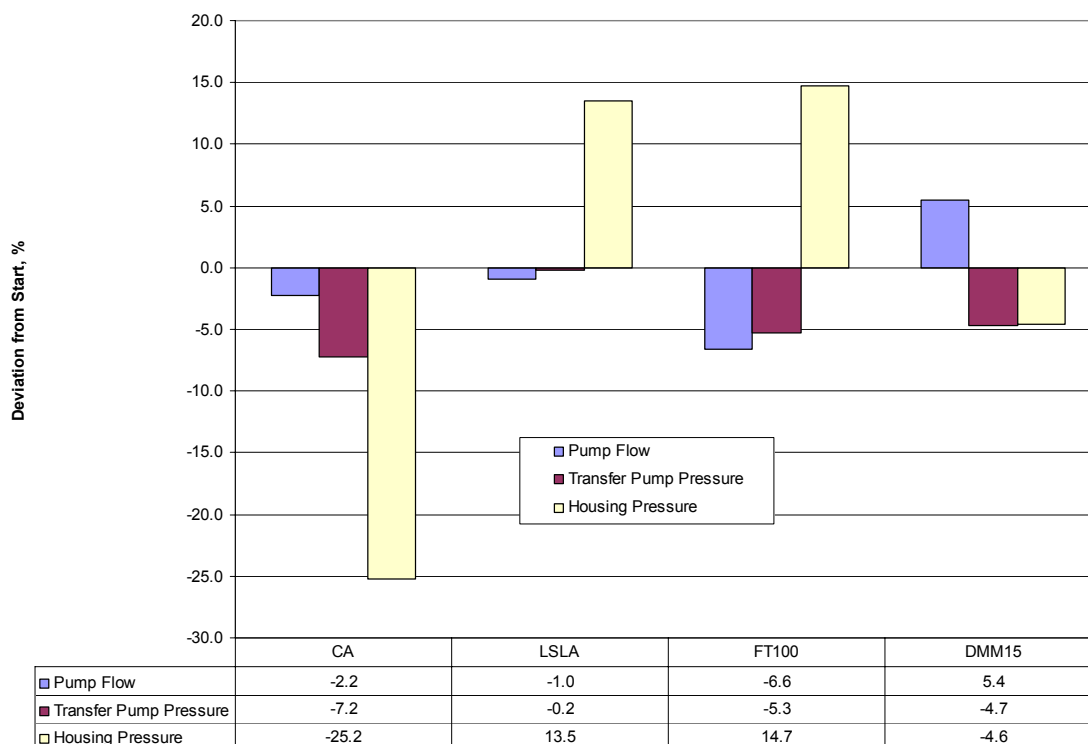
The average pump performance deviations for the two pumps from the durability stand measurements for each test fuel are shown in Figure 1-10 for the 500-hour tests. The decreasing pump flow variations reflect wear in the transfer pump, plunger and bore, and rotor and housing areas for reduced flow. Increased pump flow with DMM15 indicates an increase of the roller-to-roller dimension due to wear between the roller shoe and leaf spring. Increased roller-to-roller dimension results in a greater injection quantity. The transfer pump pressure for each fuel showed a decrease after 500 hours, due to wear on the pump vanes and pump liner. Reduced transfer pump pressure usually results in reduced metering pressure, and a concomitant decrease in pump flow. The housing pressure increase is due to increased leakage, and is associated with wear between the plunger and bore, and the rotor and housing. The housing pressure decrease with CA fuel is due to the presence of heavy deposits around the housing pressure supply orifice. The decrease in housing pressure with the DMM15 may be related to the increased injected flow, which results in a lower return flow.

Figure 1-10. Average Stanadyne Pump Performance Deviation after 500 Hours with Test Fuels.

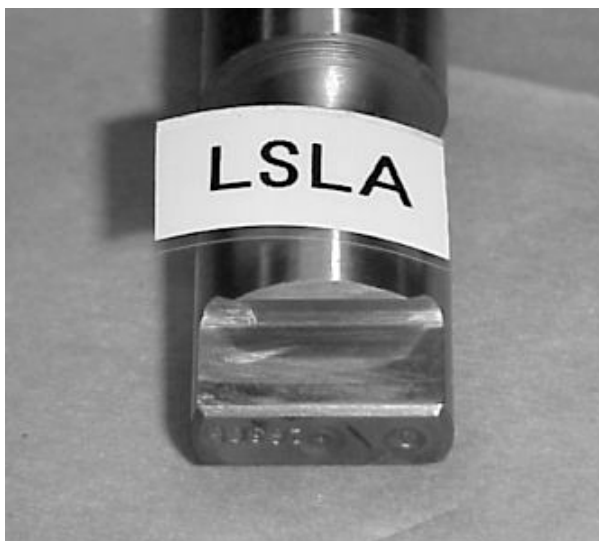
The drive tang of the Stanadyne pumps couples the distributor rotor to the engine drive, and is critical for injection timing. Significant wear on the drive tang effectively retards fuel injection timing, and increases backlash. The drive tangs shown in Figures 1-11 through 1-14 are the most worn of the two pumps tested on each fuel. The wear seen on the drive tang for the LSLA fuel shown in Figure 1-11 is minimal and would not likely cause operational problems.

**Figure 1-11. Drive Tang from LSLA Pump  
SN:8897758**

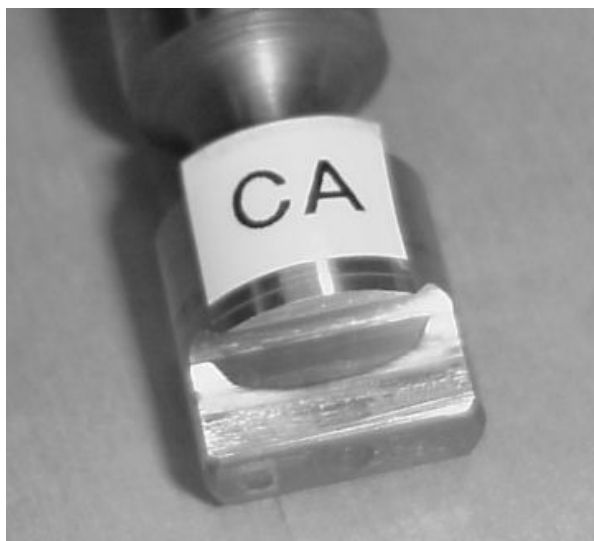
**Figure 1-12. Drive Tang from CA Pump  
SN:8897760**

The wear seen in Figure 1-12 for the CA fuel is similar to the LSLA pump, and again would not likely cause problems on an engine. Both the DMM15 (Figure 1-13) and FT100 (Figure 1-14) fuels revealed considerable drive tang wear. Both of these fuels revealed more drive tang wear than with any low lubricity fuels previously seen. The level of drive tang wear for the DMM15 and FT100 fuels would likely cause operability problems on an engine.

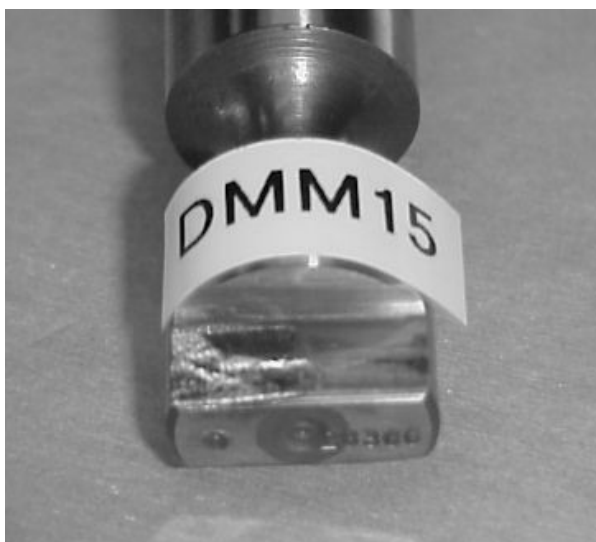
**Figure 1-13. Drive Tang from DMM15 Pump  
SN:8897772**

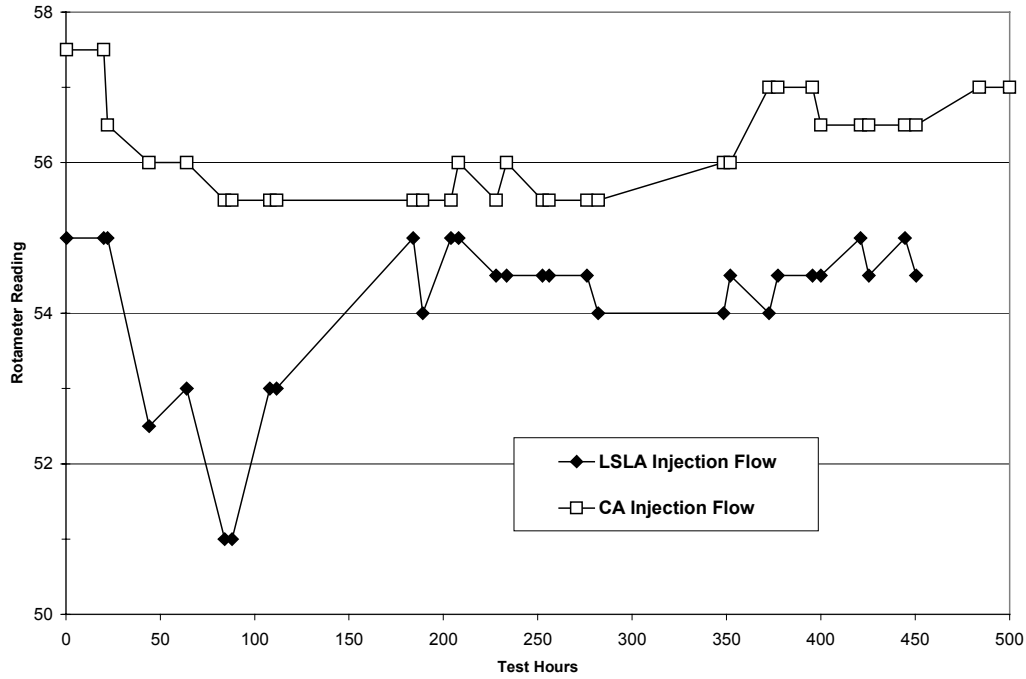
Figure 1-16. Bosch Common Rail Injected Flow Readings.

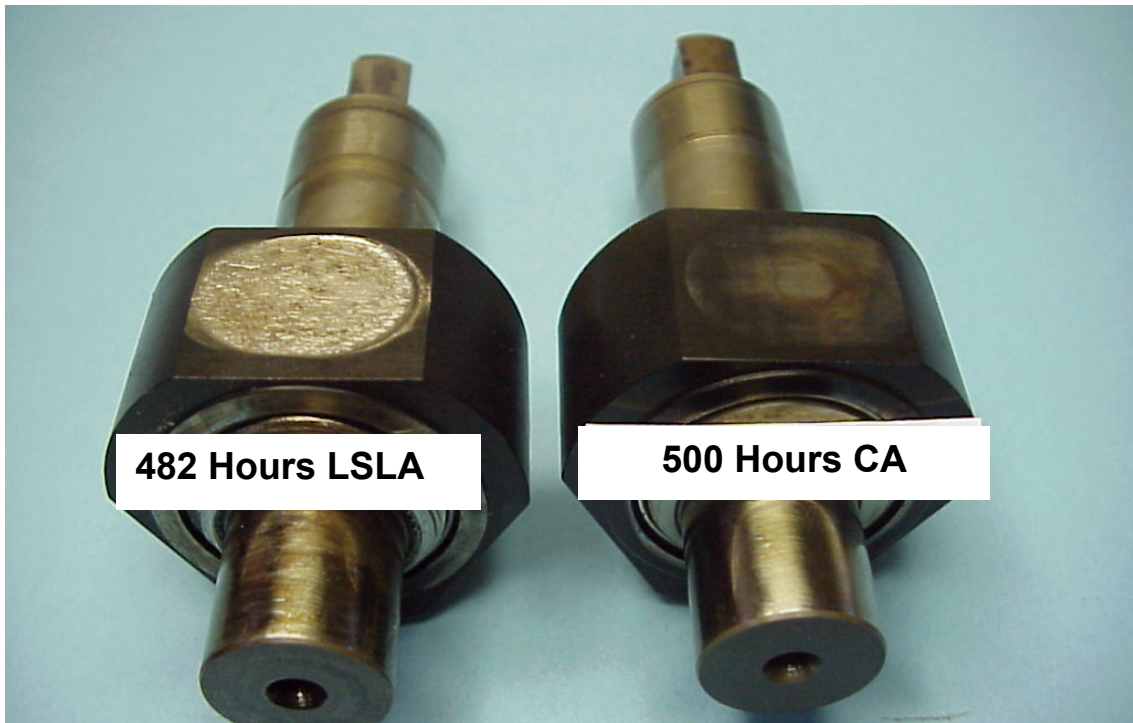
Figure 1-18. Common Rail Pump Eccentric Follower Wear for LSLA (Test 1) and CA (Test 2) Fuels.

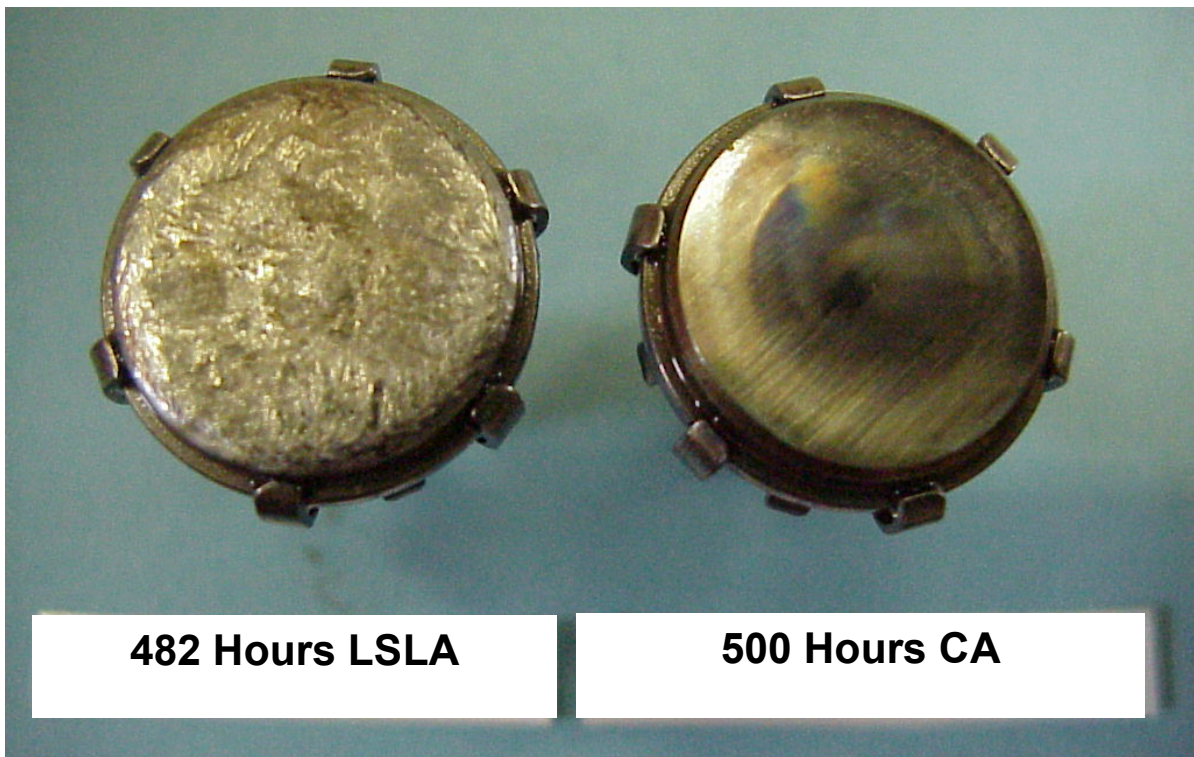
follower for both fuels. The pumping plunger follower, which slides on the eccentric follower, is shown for both fuels in Figure 1-19. The eccentric and plunger followers are fuel lubricated.

Figure 1-19. Rail Pump Plunger Follower Wear for LSLA (Test 1) and CA (Test 2) Fuels.

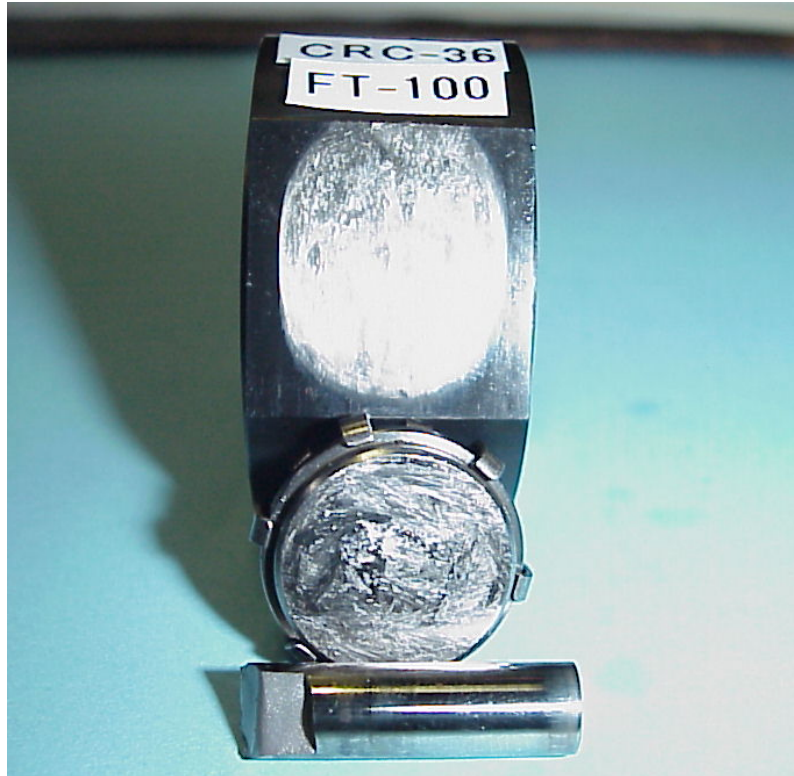
Figure 1-20. FT100 (Test 3) High-Pressure Common Rail Pump Cam Follower and Plunger Follower Wear Scars for Seized and Broken Plunger.

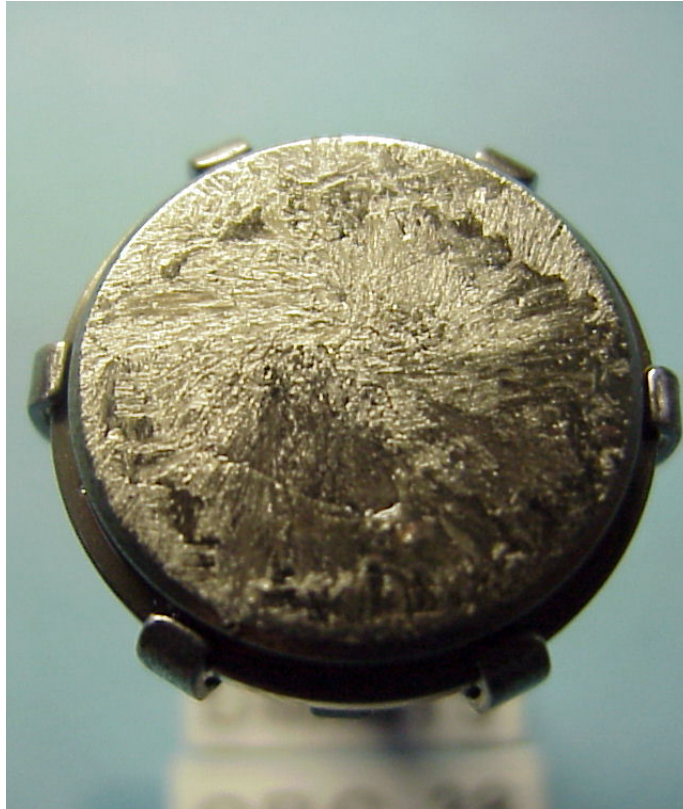
Figure 1-22. Wear Scar on DMM15 (Test 4) Plunger Follower.

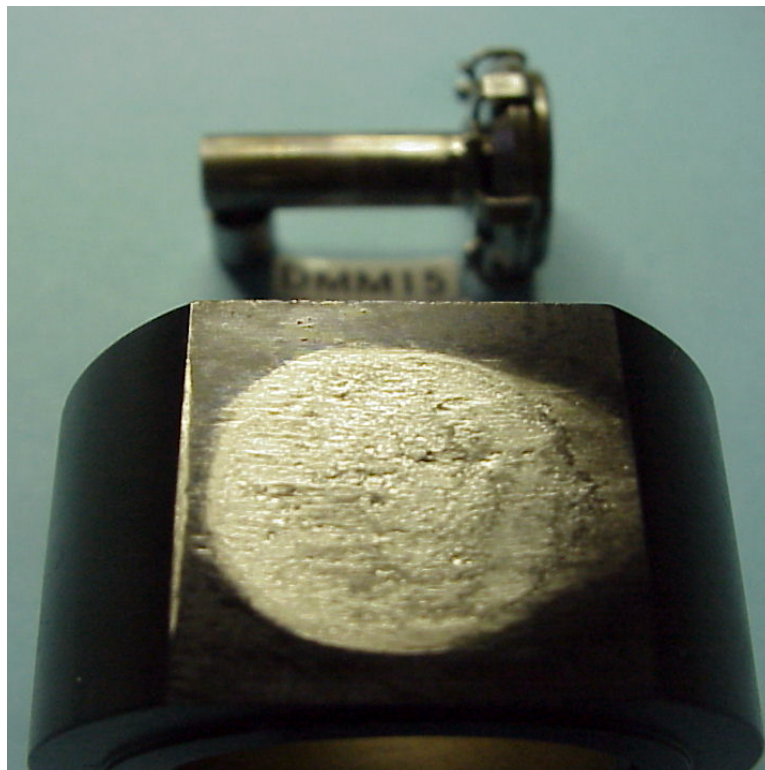
Figure 1-23. Wear Scar on DMM15 (Test 4) Cam Follower.

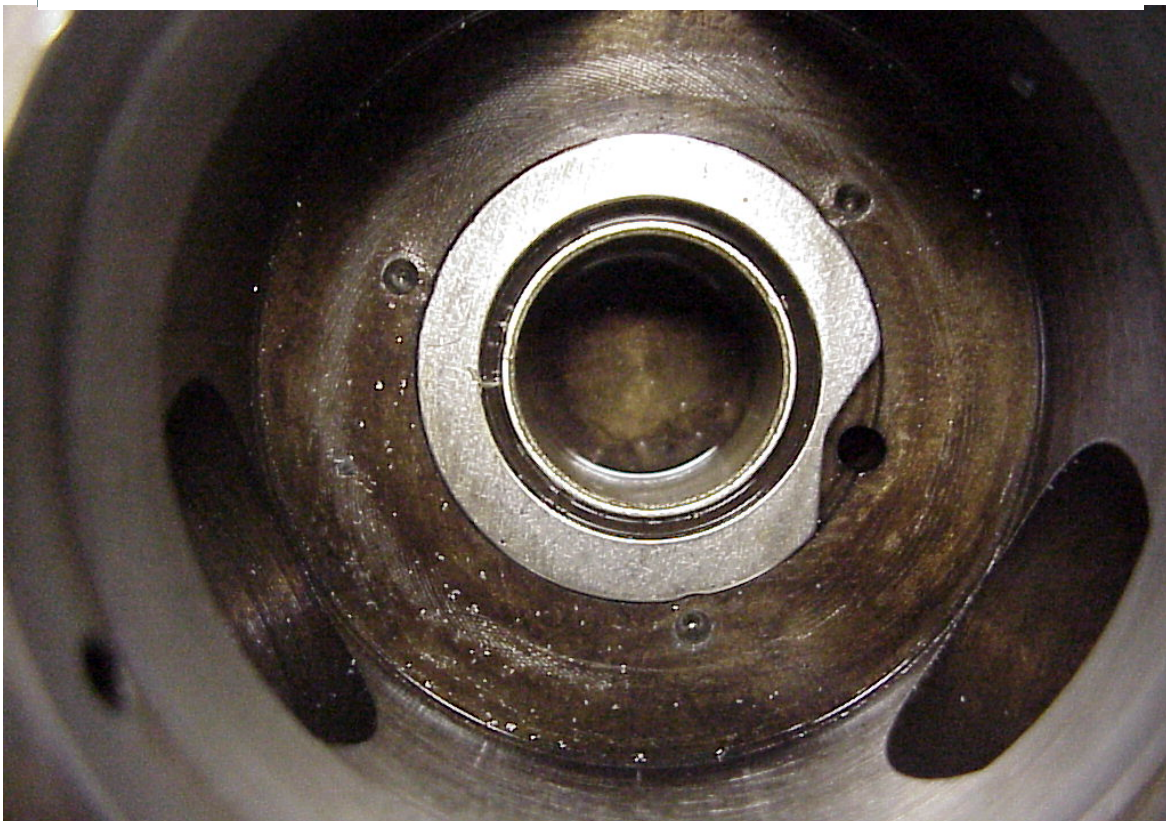
Figure 1-25. Bosch Test 4 with DMM15, Pump Housing Wear Debris.

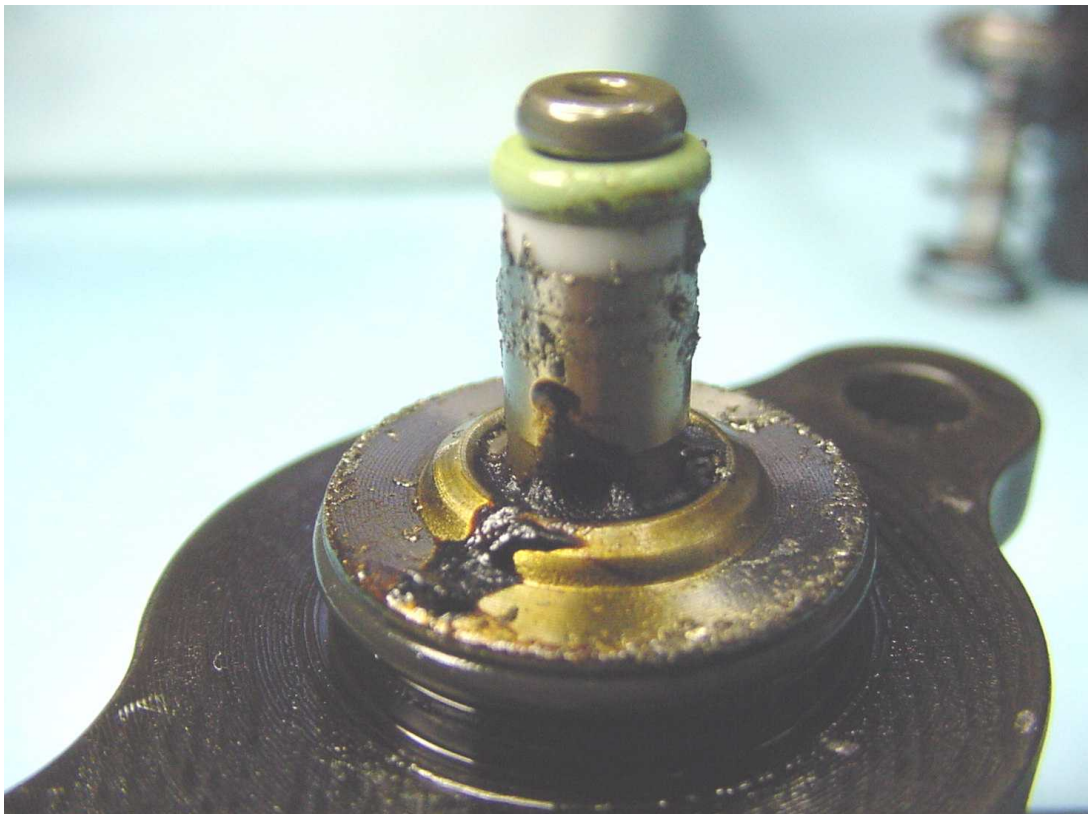
Figure 1-29. FT100 (Test 5) Rail Pressure Regulator with Deposits

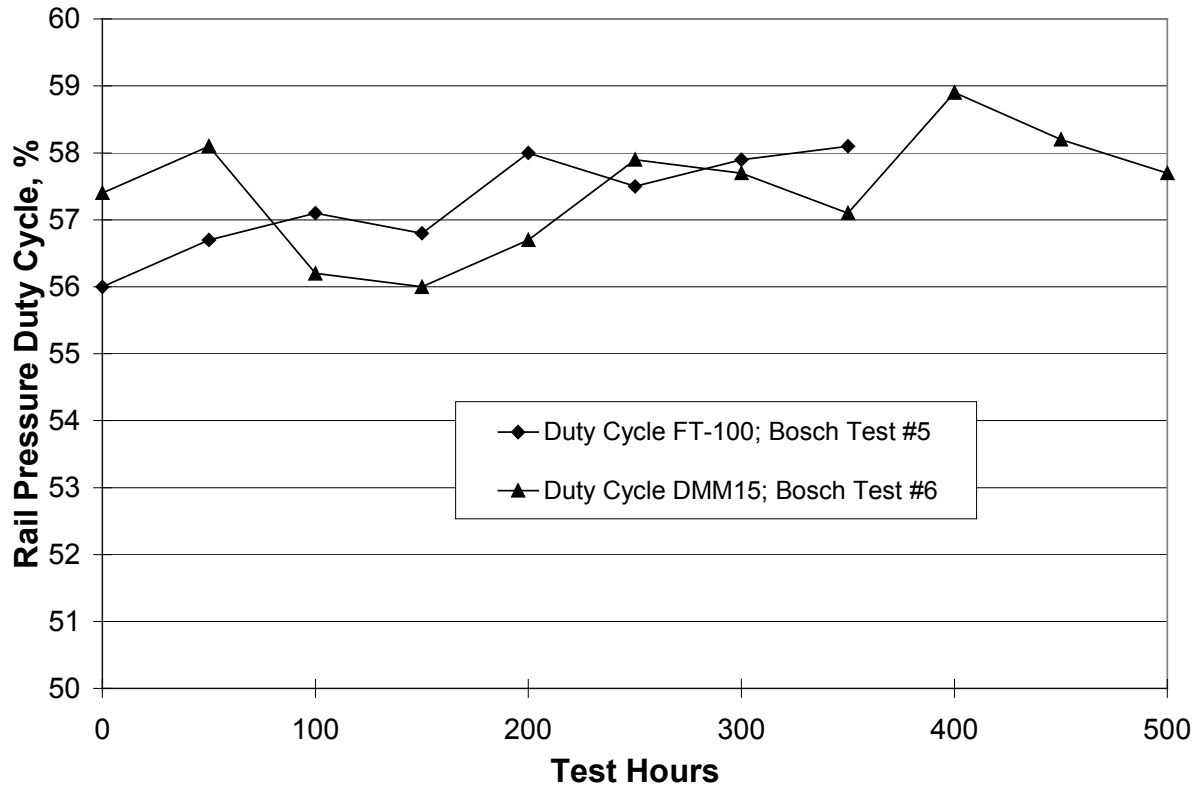
Figure 1-34. FT100 and DMM15 Rail Pressure Duty Cycle

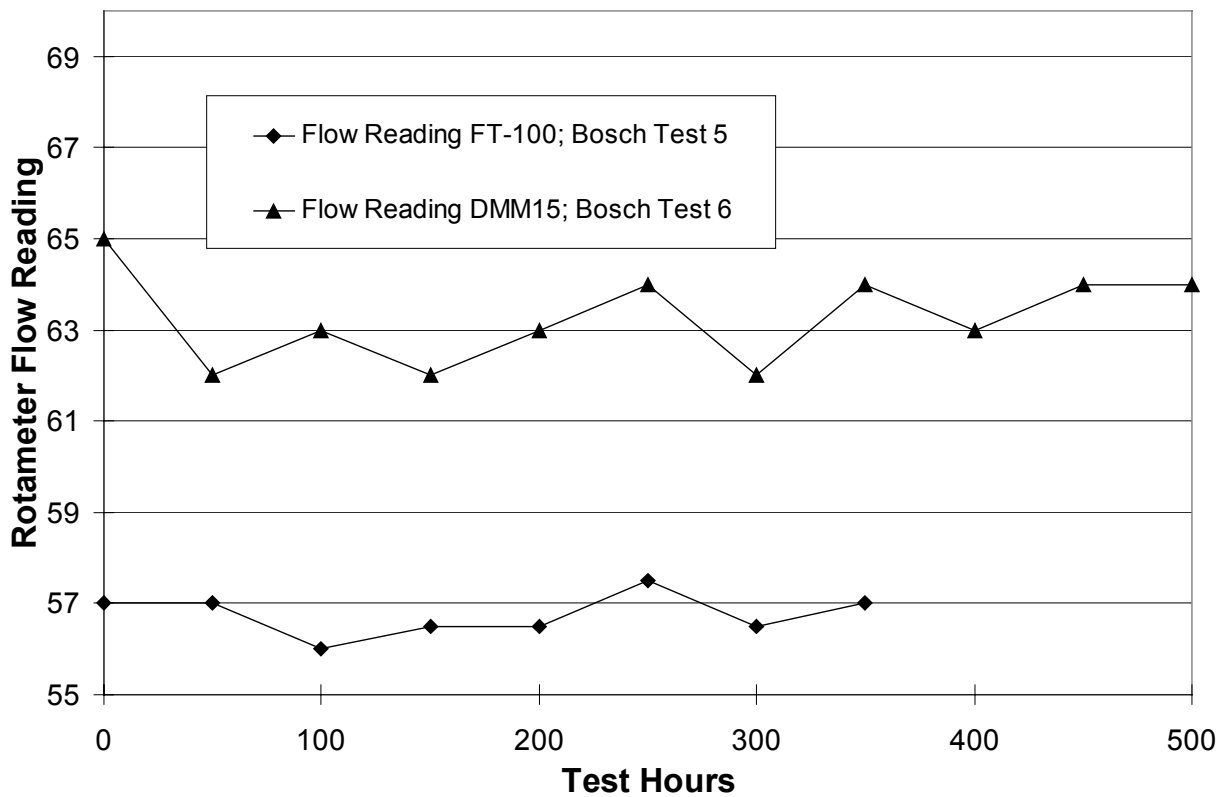
The rotameter flow readings for the injected fuel are shown in Figure 1-35. The FT100 data show minor variations of injected flow, which indicates the increase in duty cycle noted earlier is an indication of wear with the FT100 fuel. The DMM15 injected flow remained relatively consistent. It is suspected the flow number is higher with the DMM15 fuel due to volatilization of DMM in the rotameter. The operator noted it was hard to obtain a stable rotameter reading with the DMM15 fuel because the fuel was two-phase.

Figure 1-35. FT100 and DMM15 Injected Flow Reading

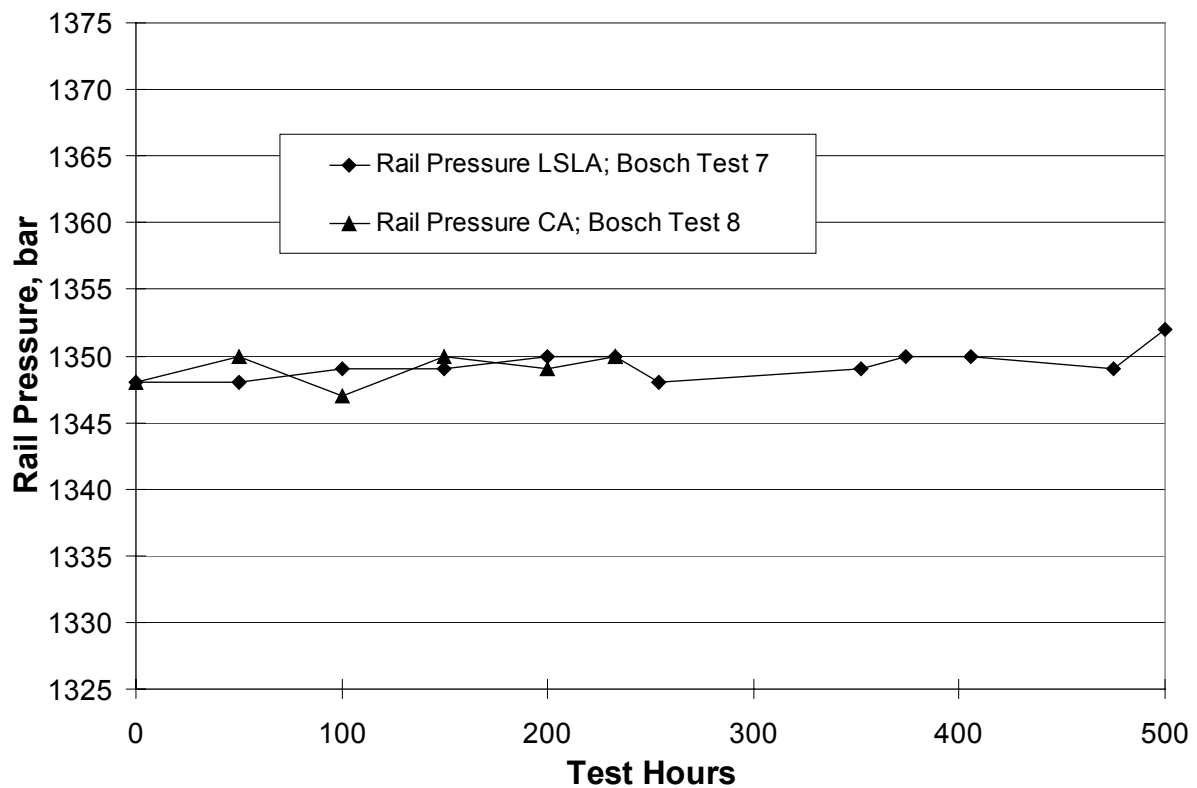
Figure 1-37. Rail Pressure for LSLA and CA Fuels

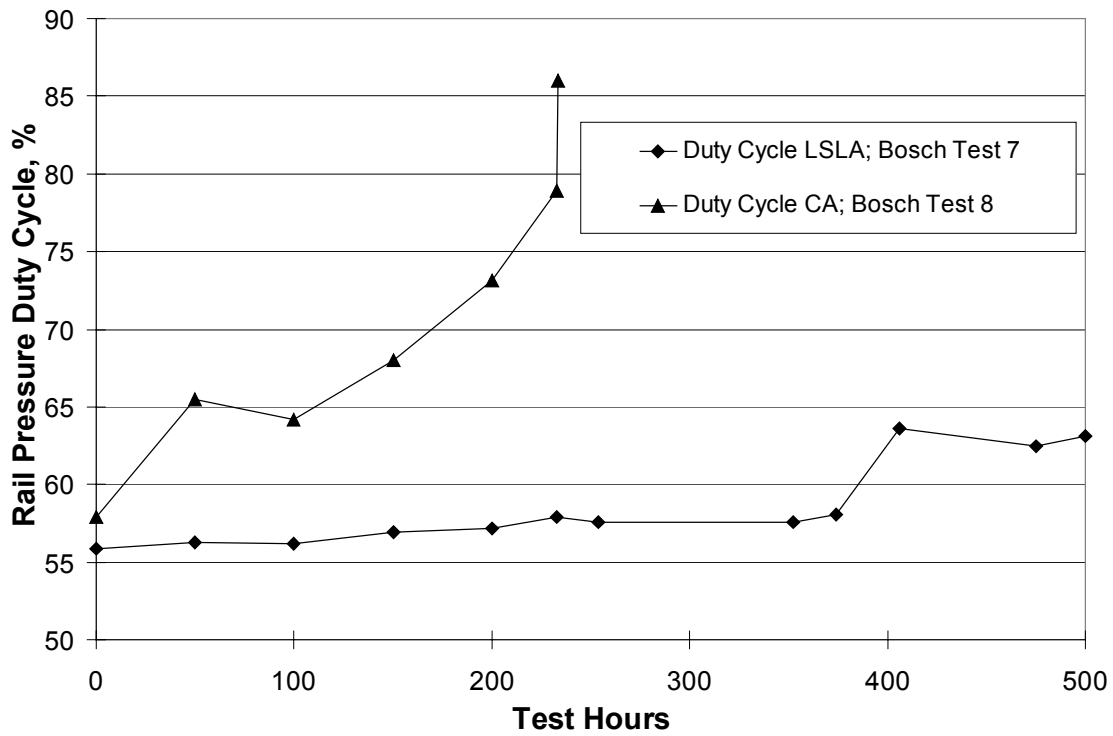
Figure 1-38. Rail Pressure Controller Duty Cycle for LSLA and CA Fuels

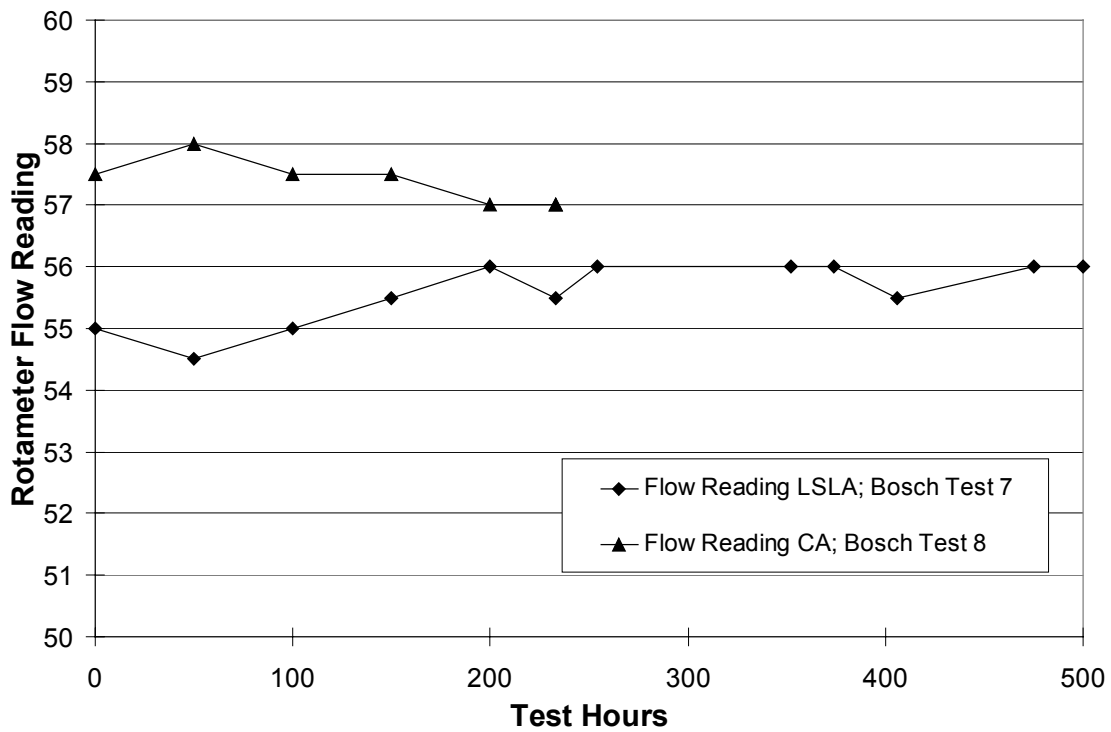
The LSLA pump testing continued after the controller circuit was reconfigured. The LSLA pump completed the 500 hours of testing. The rail pressure for the LSLA pump is also shown in Figure 1-37, and remained consistent throughout the test. The rail pressure controller duty-cycle increased slightly until 400 hours, when there was a 5% duty-cycle increase, Figure 1-38. The injected fuel flow remained consistent throughout the LSLA test as seen in Figure 1-39.

Figure 1-39. Injected Fuel Flow Readings for LSLA and CA Fuels

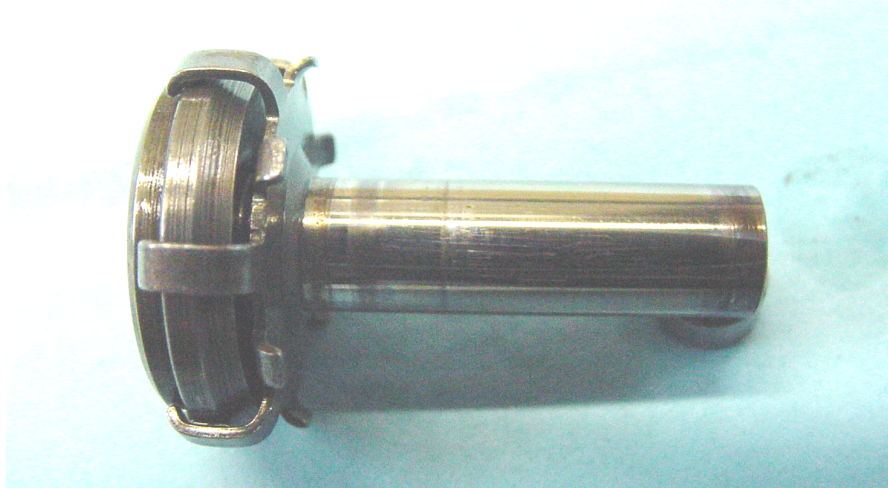
Pumping plungers from the test revealed light polish with some scratches and a light brown deposit, a representative plunger is shown in Figure 1-41. The cam follower for the LSLA test revealed pitting of the plain bearing, shown in Figure 1-42, which had not been seen in other tests. The common rail pump cam shaft revealed (Figure 1-43), brown deposits on the support bearing surfaces.

**Figure 1-41. LSLA (Test 7) Pump Plunger with Light Polish, Scratches, and Deposition**
