CRC REPORT NO. 662

DURABILITY OF AUTOMOTIVE FUEL SYSTEM COMPONENTS EXPOSED TO E20

Coordinating Research Council
CRC Contract No. AVFL-15

CRC AVFL-15 Project Panel
December 2011

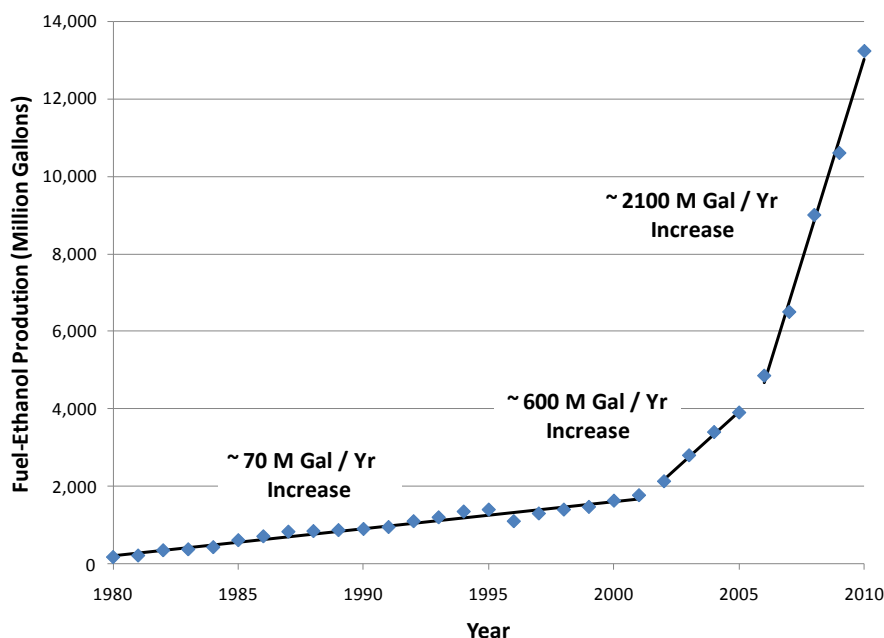
Figure I.1 graphically illustrates the trend in US ethanol fuel production over the past 30 years in response to the events described in the previous narrative. Ethanol production remained on a slow but steady increase from 1980 through 2001, with an annual increase of about 70 million gallons per year. From 2001 through 2005, that rate of increase jumped to about 600 million gallons per, and from 2006 through 2010 the rate of increase jumped again to roughly 2,100 million gallons per year. Although this chart does not differentiate between ethanol production for E85 and E10, the E85 market penetration has remained modest over this same time period.

Figure I.1. U.S. Fuel Ethanol Production from 1980 to 2010

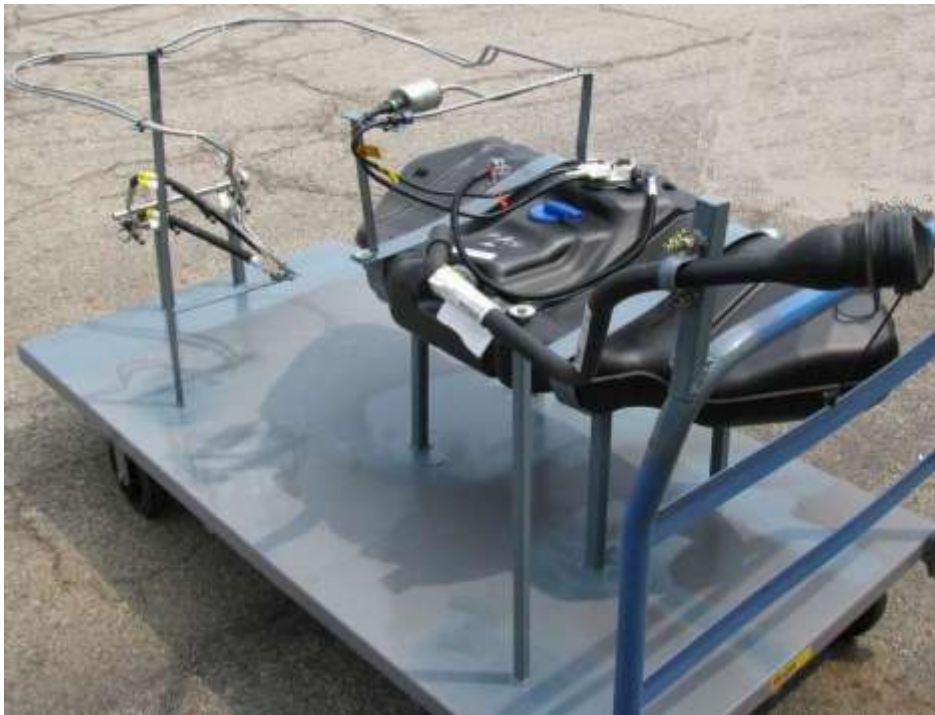
Figure I.3 is an example of the complete fuel system rig assembly for one design. Attempts were made to position the system into a layout similar layout as would be found on that particular vehicle. Where needed, fuel lines were adjusted to fit within the confines of the cart with the best attempts to maximize the diameter for any radius not found on the vehicle. As shown, the full fuel system included the fuel injectors, fuel rails, fuel lines, fuel filter, fuel inlet, fuel tank, the fuel pump and any other internals to the fuel tank.

Figure I.3. Example of Fuel System Rig Assembly

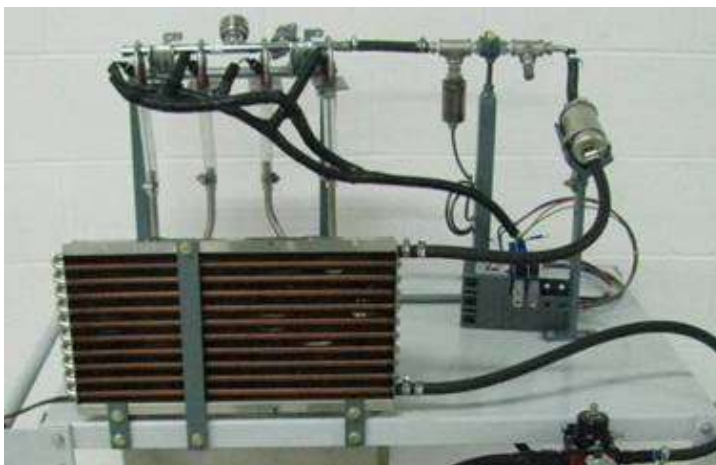
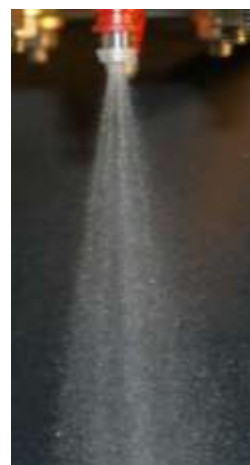
Figure I.4. Example of Fuel Injector Aging Assembly.

Figure I.4 shows an example of the fuel injector aging assembly on the left. The injectors were positioned such that the flow could be observed through the clear tubing. On the right is an example of a spray pattern from one of the designs.

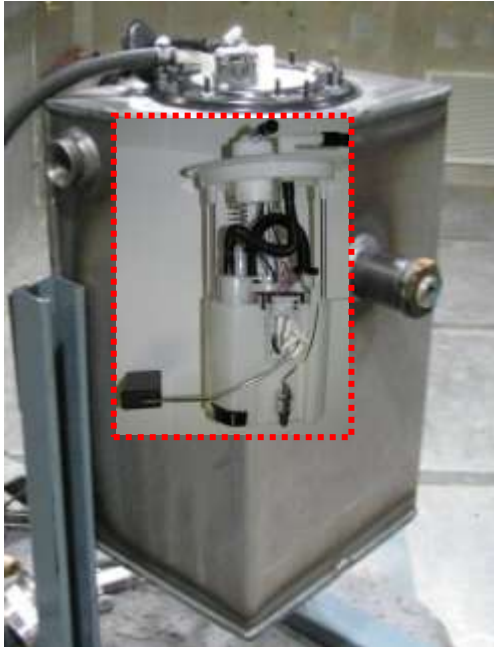
Figure I.5 shows an example of the fuel pump durability fixture. The fuel pump assembly was lowered into the top access and sealed; inlet and outlet hose connections were made to the OEM positions.

Figure I.5. Example of fuel pump durability fixture

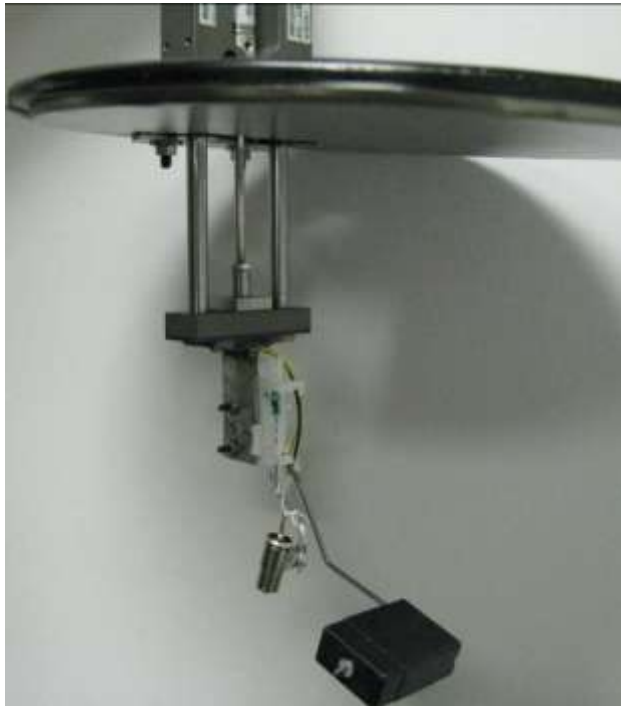
Figure I.6 is an example of the fuel level sender. The sender is mounted to the actuator which is then programmed to move up and down allowing full range of motion. This piece fits atop a cylindrical reservoir containing approximately three gallons of fuel.

Figure I.6. Example of fuel level sender

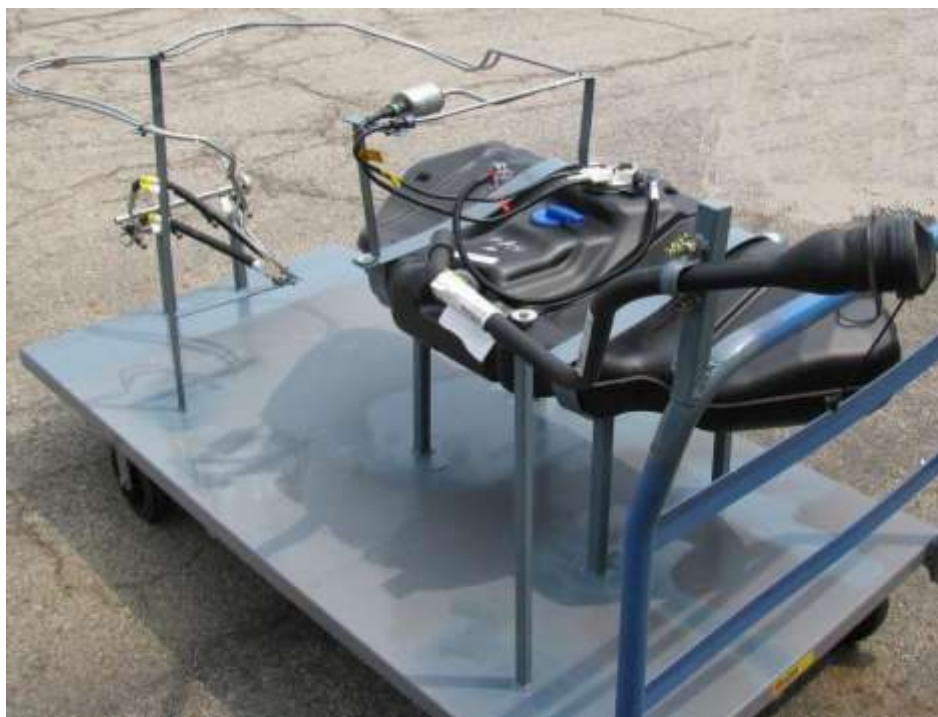
Parts for the rig assemblies were purchased from local automotive dealers and included items such as, but not limited to: fuel lines, tank, pump, fuel injection rail, injectors, return lines, pressure regulators, etc. Evaporative system components were excluded as these are designed typically to be only exposed to vapor and not wetted with fuel. However, the venting valves in the fuel tank assemblies were exposed to an ethanol/gasoline vapor blend. During rig assembly, bending of the fuel lines were added only as needed to fit within the dimensions of the test cart. Where bends were added, the radius was kept to as large a diameter as was possible, with a minimum radius of 12" maintained on all non-OEM bends. If the fuel system of the vehicle was return-less, a stainless steel return line was plumbed in from the injector rail to the vehicle fill hose. This allowed for the fuel to circulate through the entire rig when the in-tank fuel pump was operated. A sample fuel system rig is shown in Figure III-1.

Figure III.1. Vehicle Fuel Rig

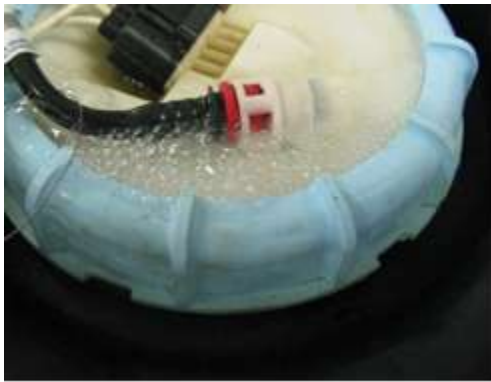
These leaks were attributed to a loosening of the retaining plastic nut on the fuel pump module. The torque on the nut was checked before the unit was disassembled. There was visible swell of the seal similar to the E10 seal. The torque applied to install the nut at the time the rig was assembled could not be verified. Debris was visually seen on the sealing surface of the fuel tank. After the nut on the fuel FDM was cleaned and re-tightened, the leak was eliminated.

Figure III.2. Fuel Delivery Module and Retaining Nut

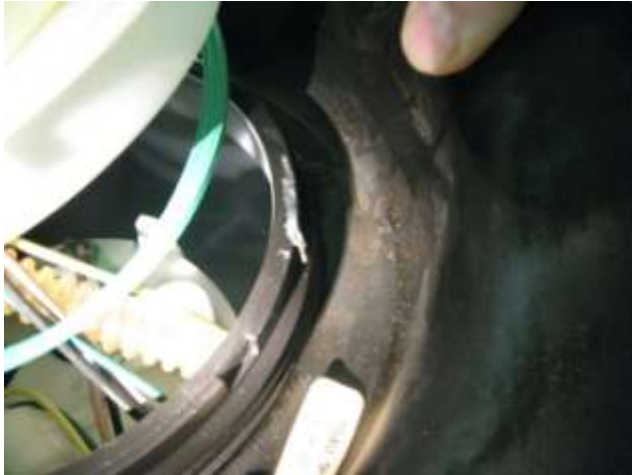
Vehicle A fuel tank rig also had a leak at the pressure sensor seal due to mechanical damage, most likely during installation of the pressure sensor onto the fuel tank at the test facility when the rigs were assembled. No other leaks were evident.

Figure III.3. Fuel Tank Opening and Seal - Plastic

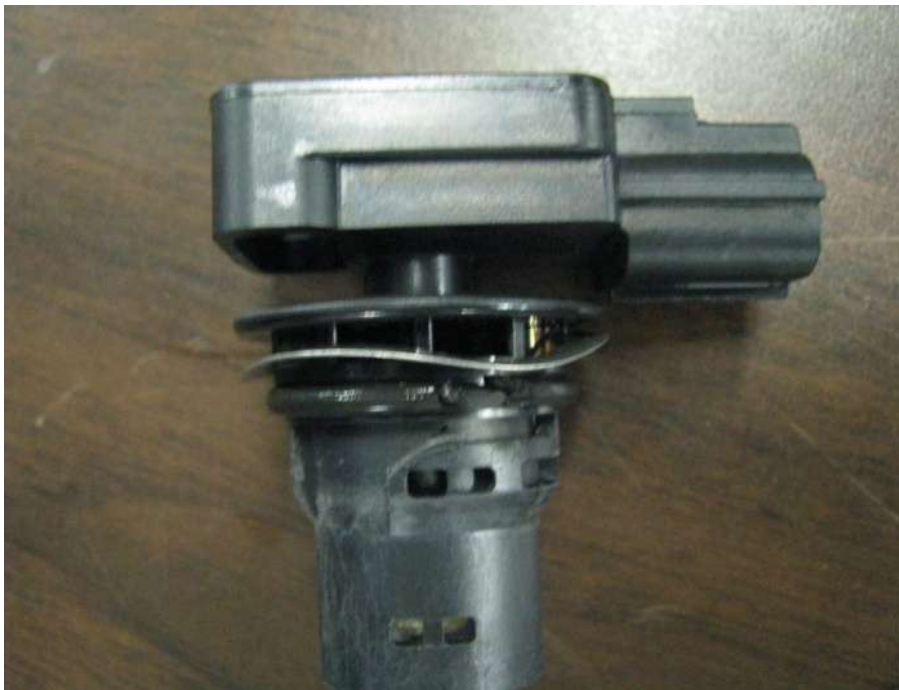
Figure III.4. Fuel Tank Pressure Sensor

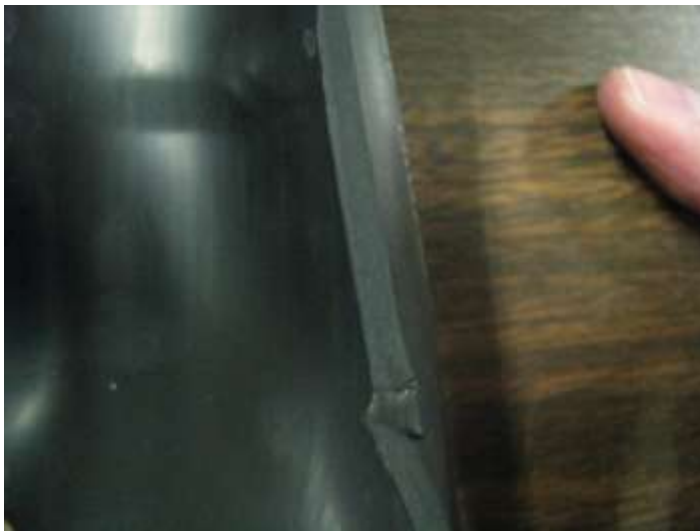
E20_A - The fuel filler hoses appeared to be stiffer and have some inner wall discoloration as compared to E10 Test Rig.

Figure III.5. Fuel Filler Hose – Interior Section

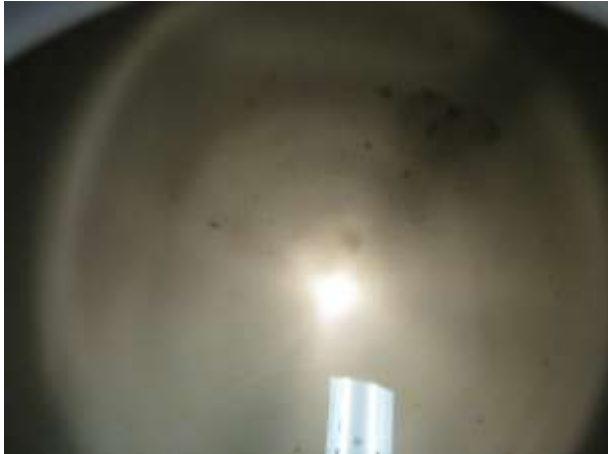
The E10 and E20_A rigs both exhibited leaks that were due to loose FDM lock-nuts attaching the fuel delivery module. This can be attributed to the test facility assembly procedures, but it is possible that thermal cycling and differential swell between the tank and nut were a factor. Both seals had visible swelling.

Figure III.6. Fuel Tank – Interior Surface - Plastic

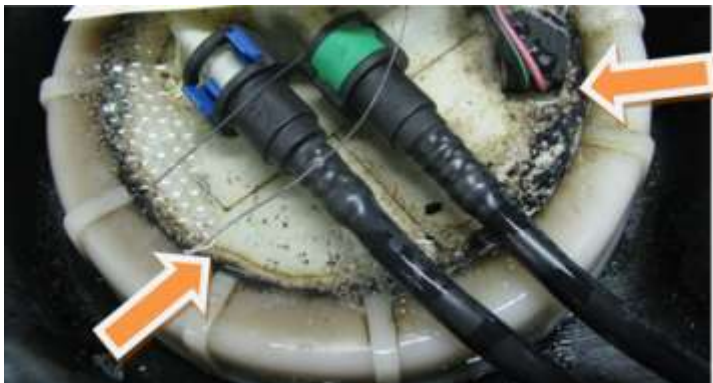
E20_A – The seal had appeared to have changed physical properties and was very soft and pliable. There was a build-up of black soft material around the FDM area (notice arrows pointing to black material between the module flange and retaining interface). It was believed to be leaching of a rubber polymer from the compound. Analysis was not completed on the sample.

Figure III.7. Fuel Delivery Module and Retaining Nut

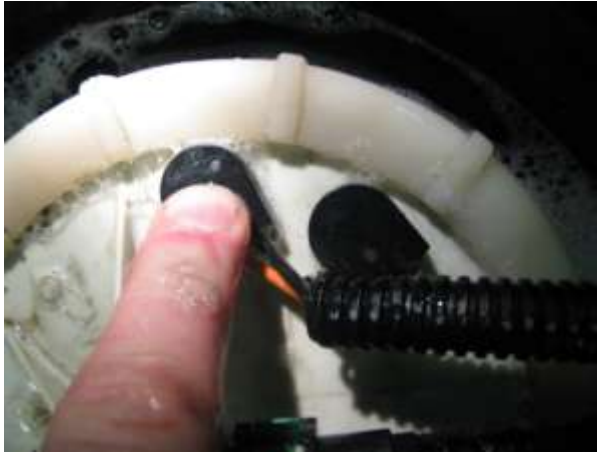
E10 – E20_A - Both E10 and E20_A FDMs were stuck in the compressed condition and did not travel freely. The E10 and E20_A FDMs electrical connectors also had visible leak on the FDM flange surface.

Figure III.8. Fuel Delivery Module and Retaining Nut – Wire Terminal

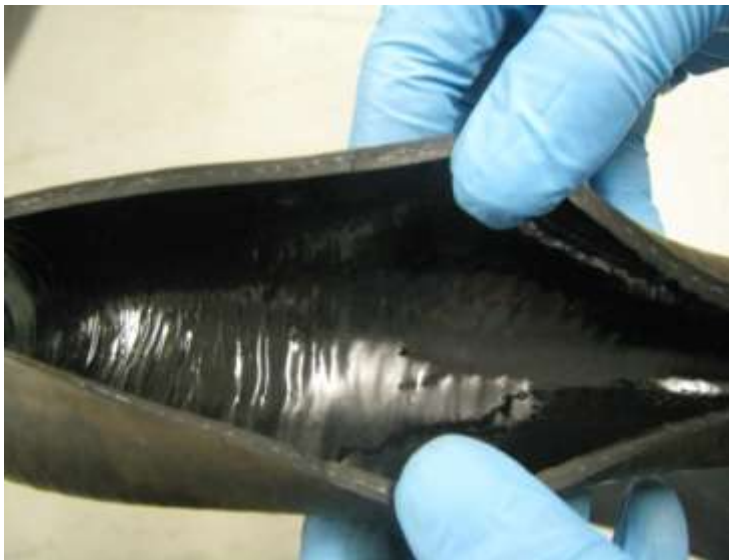
E10 - The fuel filler hose inner wall was shiny. The material did not appear compromised and no degradation or predictable performance loss is expected.

Figure III.9. Fuel Filler Hose – Interior Section

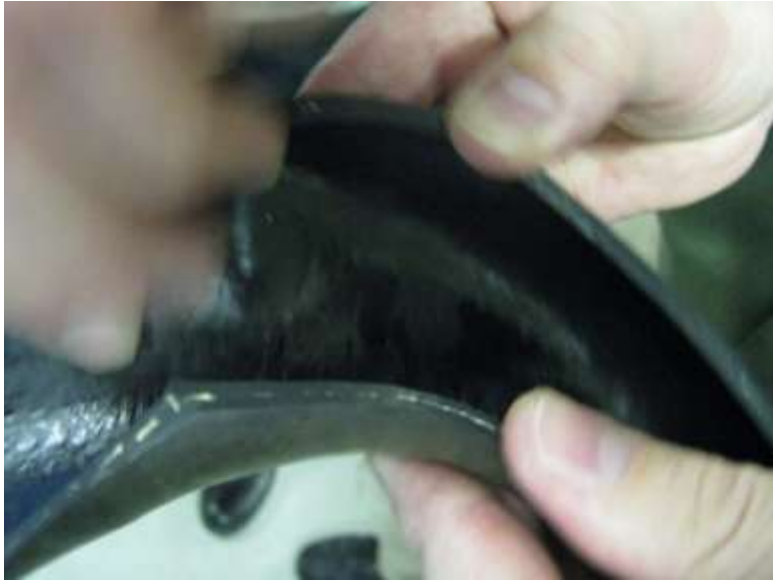
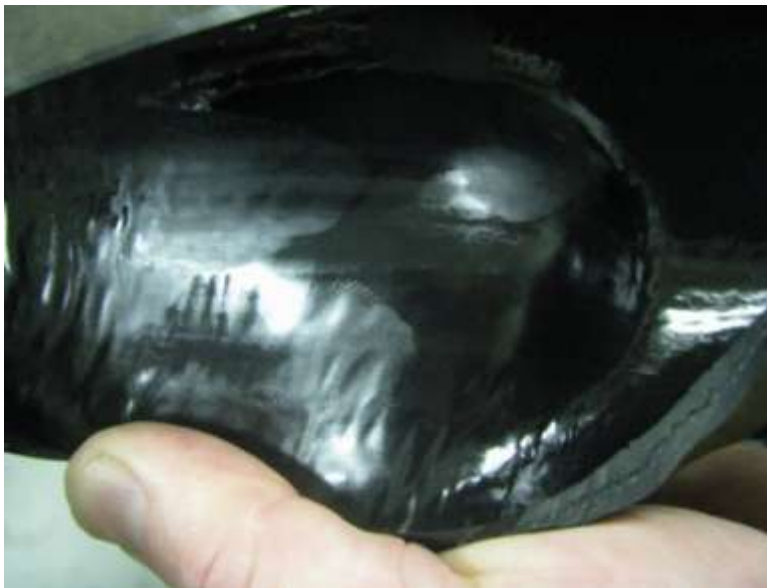
E20_A . The inner wall of the fuel filler hose was shiny and seemed somewhat sticky. The material of the inner wall could be removed with a finger. Analysis of the hoses indicated no fuel-related concerns, however. No significant material degradation was observed.

Figure III.10. Fuel Filler Hose – Interior Section

Figure III.11. Fuel Filler Hose – Interior Section

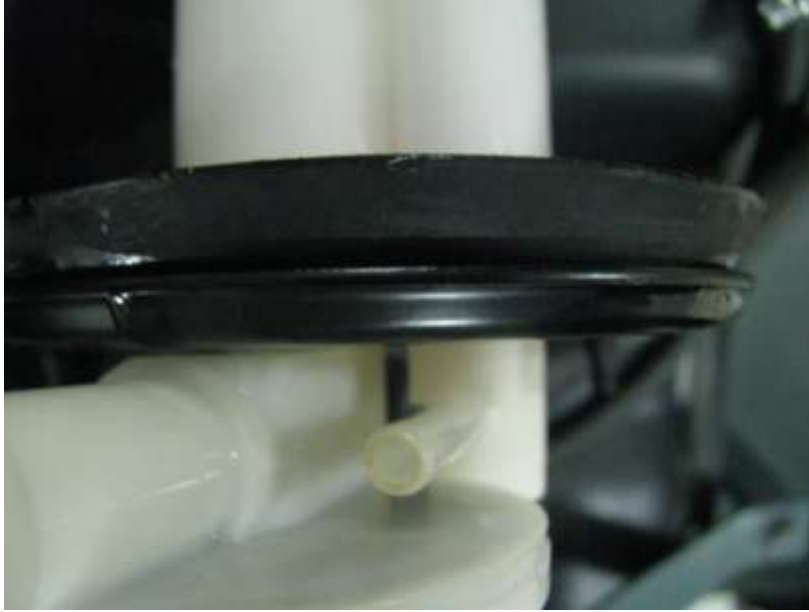
E20_A – The seal for the Fuel Fill Vent Valve (FLVV) was swollen but did not leak.

Figure III.13. Fuel Fill Vent Valve with Seal

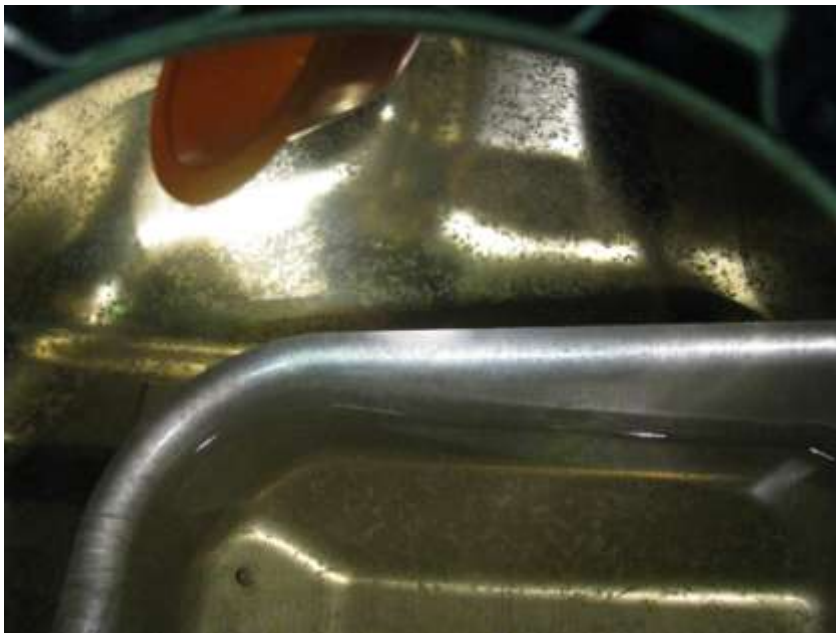
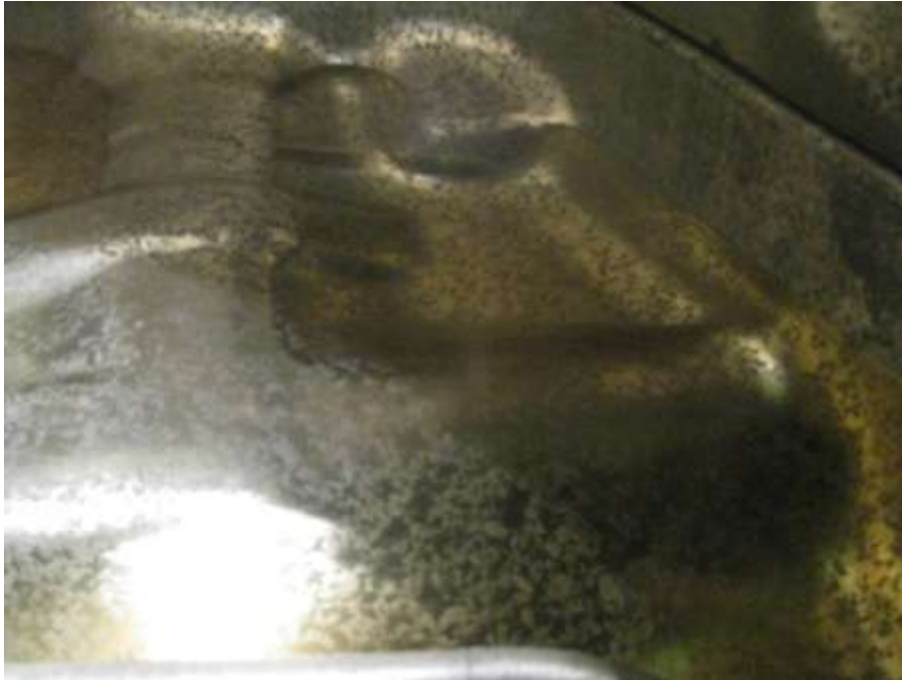
There was white corrosion noted on the inner surface of the metal fuel tank coating.

Figure III.14. Fuel Tank Interior Surface - Steel

Figure III.15. Fuel Tank Interior Surface - Steel

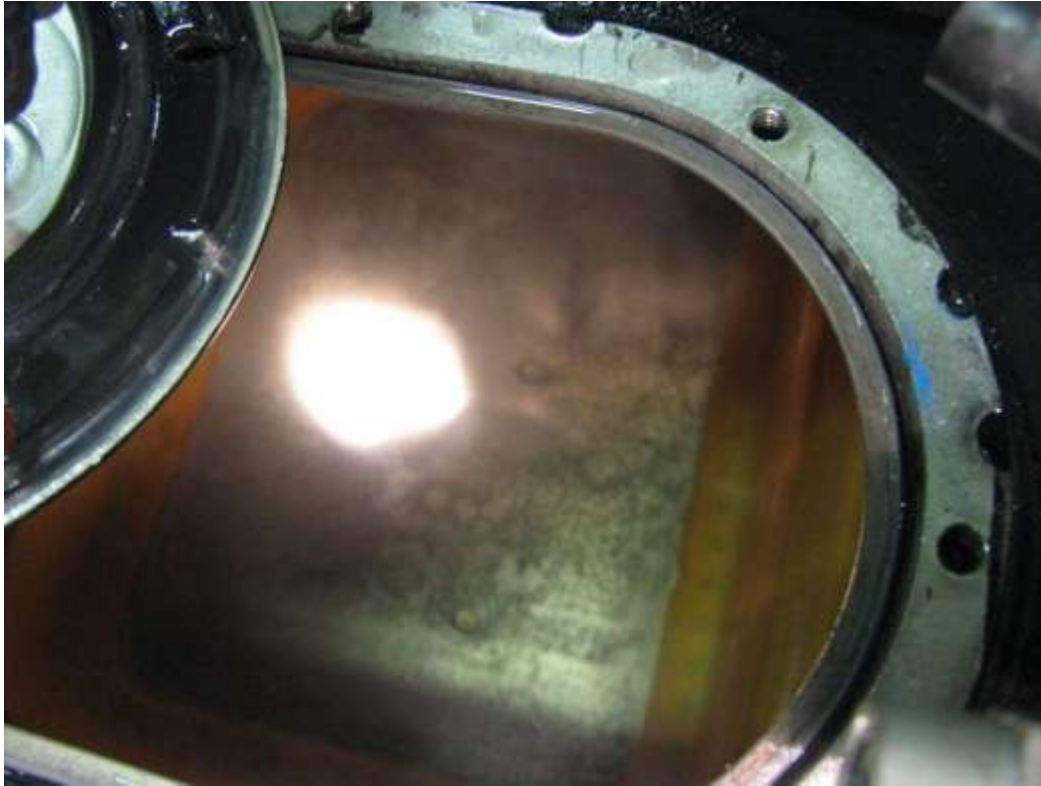
E20_A – The FDM seal had signs of cracking around the outside edge of the seal. Over-compression due to swell can lead to cracking on the inside or outside edge. There were no leaks when the fuel tank assembly was pressurized. There seemed to have been a change of physical properties as compared to the E10 Rig.

Figure III.16. Fuel Delivery Assembly with Seal – Fuel Tank Opening – Steel Tank

Figure III.17. Fuel Delivery Assembly with Seal – Fuel Tank Opening – Steel Tank

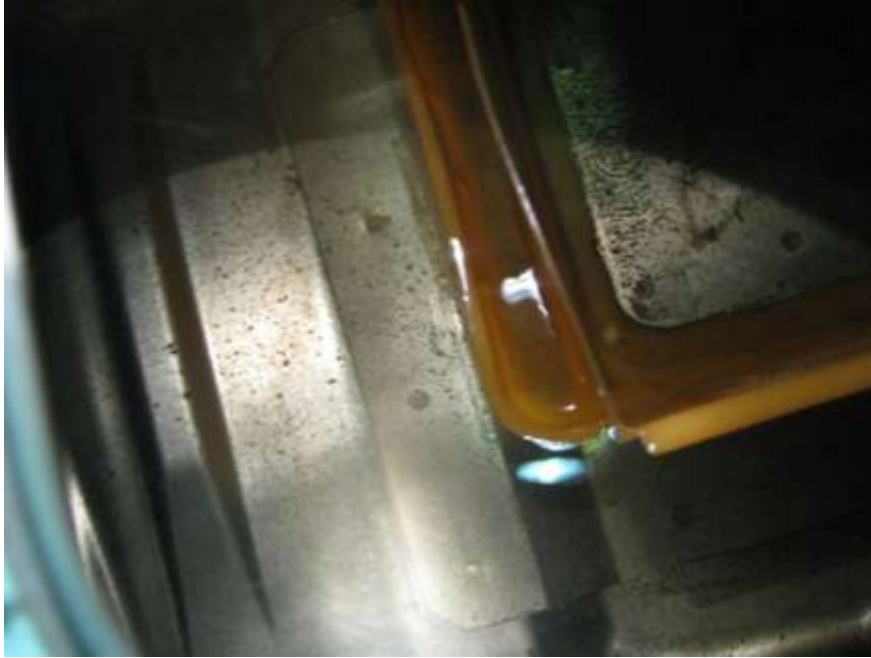
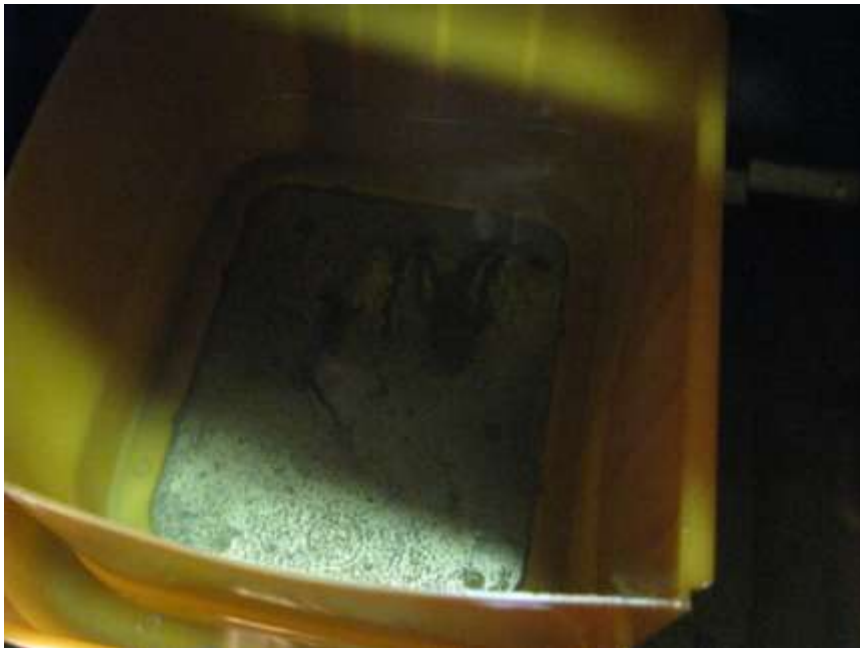
E20_A. There was corrosion noted on the inner surface of the metal fuel tank coating. The fuel tank held pressure when testing. No leaks were noted. The FDM seal showed signs of deterioration and polymer bleed out.

Figure III.18. Fuel Tank Interior Surface - Steel

Figure III.19. Fuel Tank Interior Surface - Steel

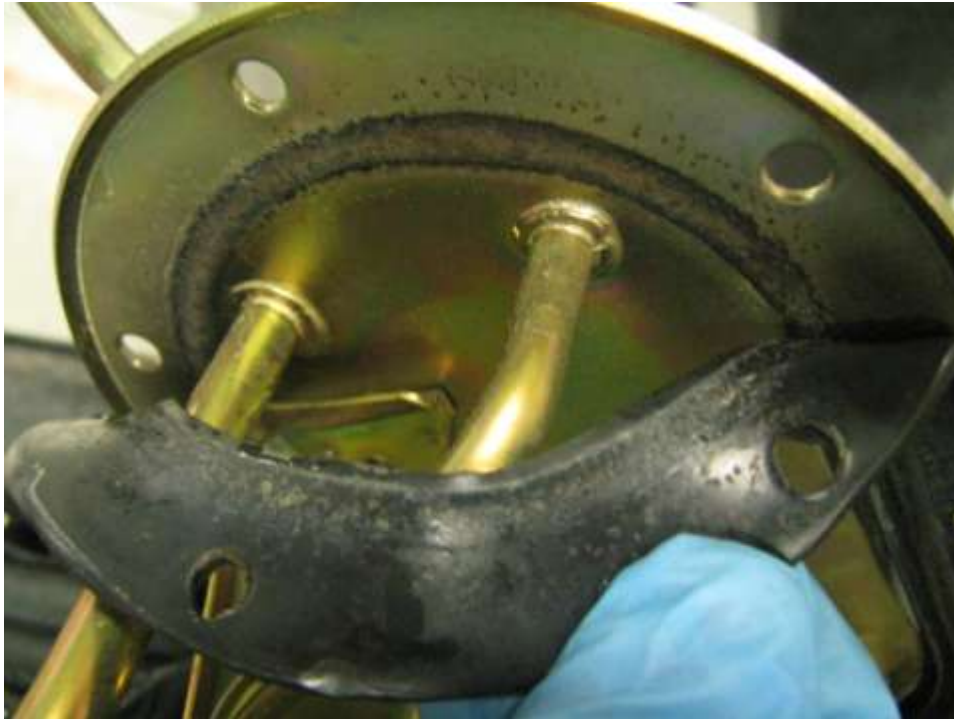
E20_A – Corrosion was seen on the underside of the metal fuel pump hanger flange.

Figure III.20. Fuel Delivery Assembly with Seal - Steel

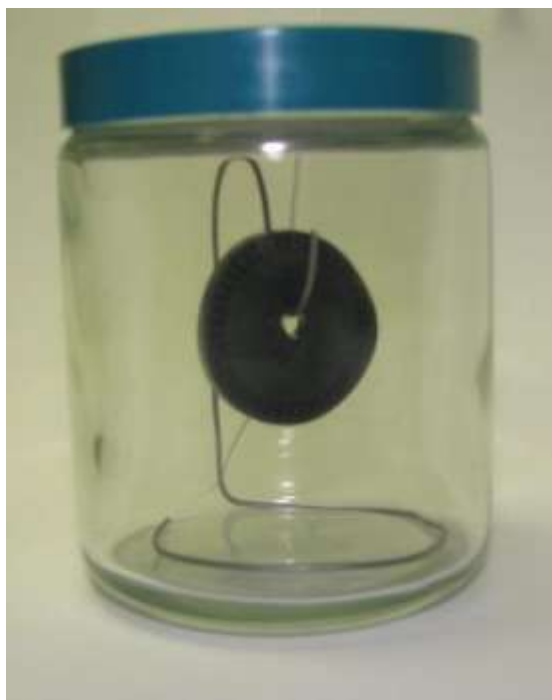
Figure IV.1. Example of Fuel Pump Impeller in Soak Container

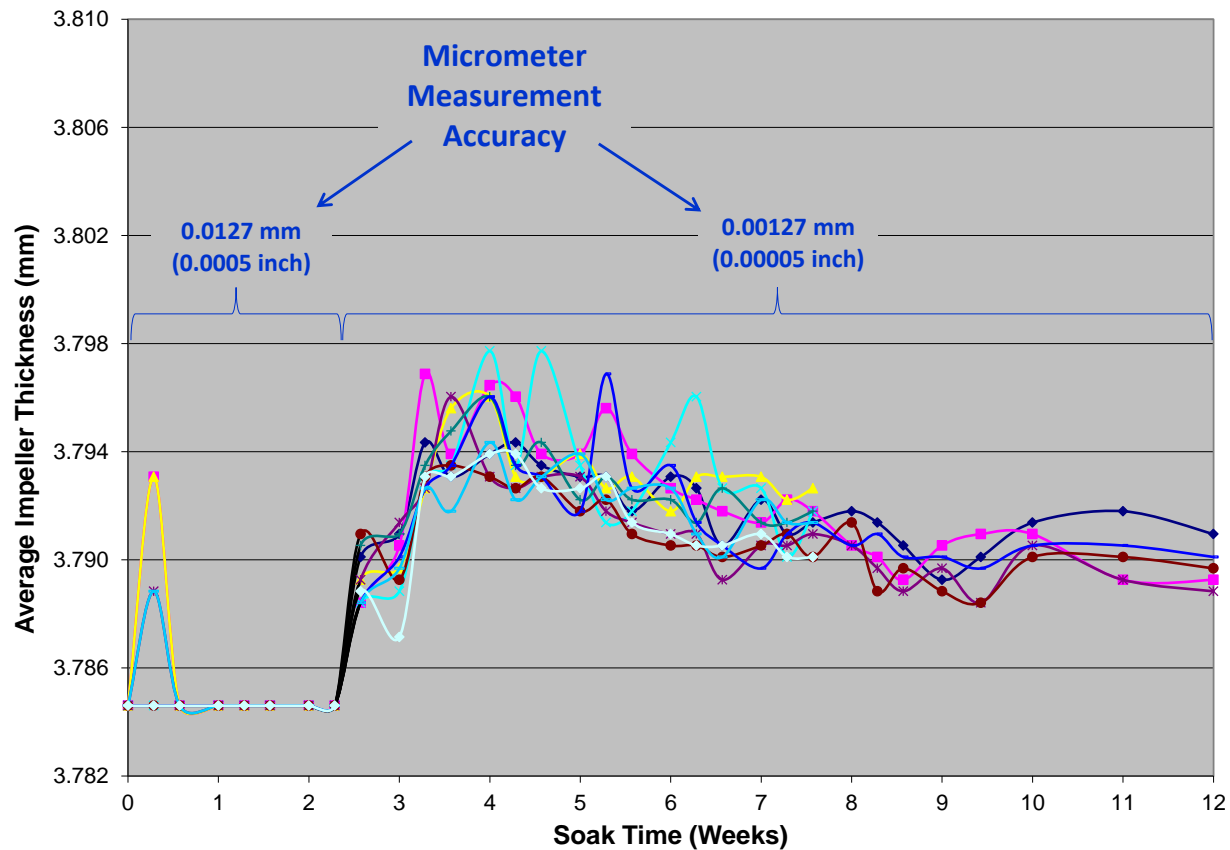
At every measurement cycle, each impeller was measured at three random locations for thickness and diameter. At the beginning of the test, the micrometer being used was only accurate to 0.0005" (12.7 μm). Because no change in thickness was observed for several of the impellers after the start of testing (suggesting that the amount of swelling or shrinkage was below the accuracy of the micrometer), this tool was replaced during the third week of soak with a new micrometer with an accuracy of 0.00005" (1.27 μm). Impellers were measured three times per week for the first nine weeks and then twice per week until the end of soak. Results of impeller thickness measurements are shown in the appendix. An example is shown in Figure IV.2.

Figure IV.2. Impeller Swell during Soak – Vehicle C

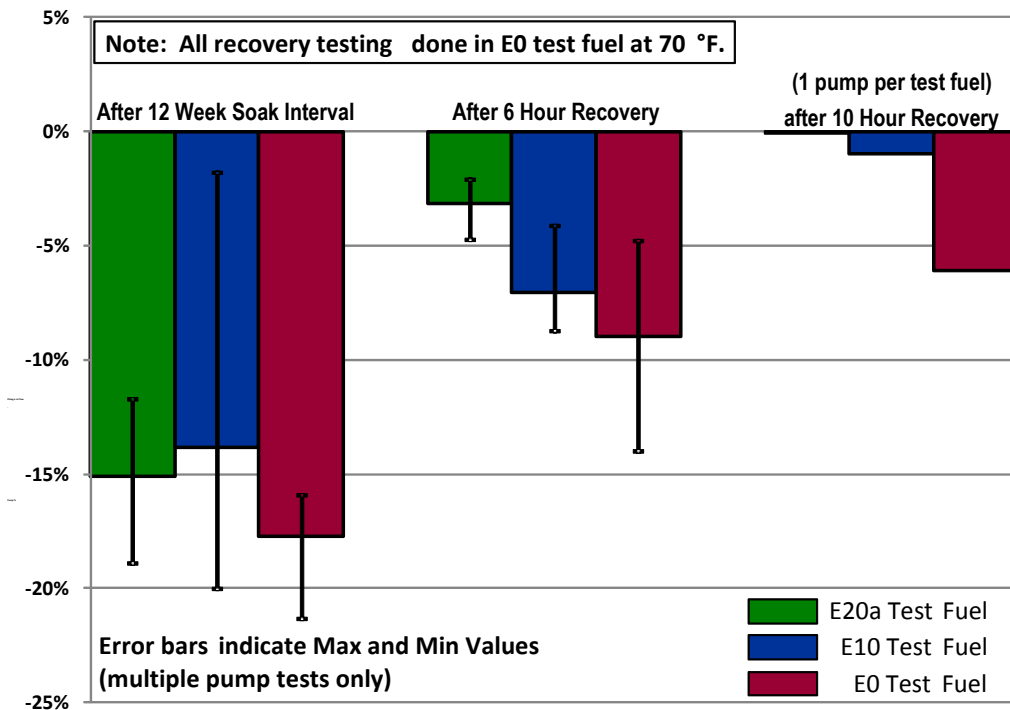
¹² Following their last flow test on E0 (at week 12), pumps were stored in sealed plastic bags in a fuel-wet condition and placed in room temperature storage. Pumps remained in storage for about 1 week before being flow tested as described.

Figure IV.5. Flow Recovery from Soak Durability – Vehicle M

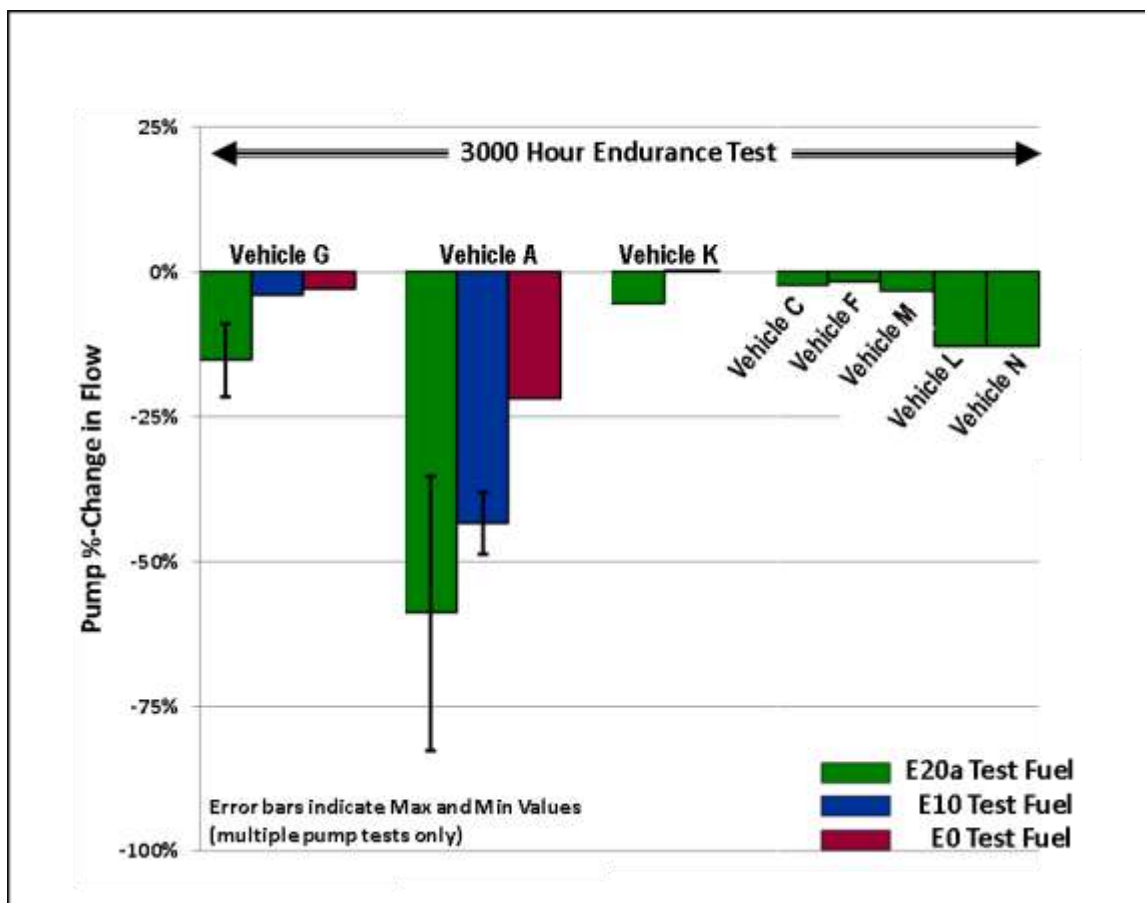
Figure IV.6 shows the endurance aging results with percent change in flow charted from start-of-test to end-of-test for each of the eight pumps. As the figure shows, both the Vehicle G and Vehicle A pumps were tested in all three test fuels (E20_A, E10 and E0), with multiple samples tested in E20_A (Vehicle G and Vehicle A) and E10 (Vehicle A only). The Vehicle K and Vehicle L pumps were both tested in E20_A and E10 test fuels; however, because the E10 Vehicle L pump failed prior to completing the test (non-fuel related) only the E20_A data is shown in the chart. The remaining four pumps were tested only in Phase 1 using E20_A test fuel. Error bars depicting maximum and minimum flow loss values are shown for the three pump types with multiple samples per test fuel at the completion of testing. The E20_A Vehicle G, the E20_A Vehicle A and E10 Vehicle A data were all based on sample populations of two data points each.

Figure IV.6. Endurance Aging Summary Results – All Pumps

Four pumps failed during the endurance aging test. The two Vehicle G pumps tested in Phases 1 and 2 (E20_A and E10 respectively) both failed due to errors in testing procedure. One appeared to have been run dry while the other had a clogged inlet screen due to excess debris in the test vessel. Neither failure was considered to be fuel-related. The E10 Vehicle L pump also failed due to errors in testing procedure after a plastic piece from the fuel pump module flange fell into the fuel line during one of the flow test cycles. The fourth failed pump, a Vehicle A pump tested in E20_A, failed during Phase 3 testing due to high resistance at the brush-commutator interface. This failure was believed to have been caused by excessive deposits on the brush contact face (see Figure IV.7). The observed deposits, believed to be either chloride or sulfate, are consistent with experience from similar pumps exposed to higher levels of ethanol blends in gasoline (e.g., E85, which is expected to contain higher levels of chlorides and sulfates). Based on analysis from the vehicle manufacturer's fuel pump lab, this failure was believed to be fuel-related and caused by the higher ethanol content in the E20_A test fuel.

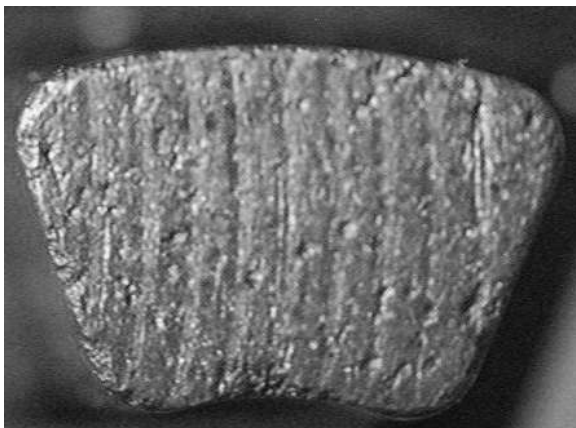
New brush contact face showing finishing lines from final machining

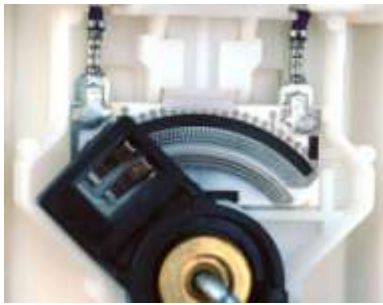
A typical fuel level sender consists of a float, constructed of a fuel resistant material, mounted on a lever arm. The lever arm is constructed to allow a range of motion to measure the fill level over the entire range of the fuel volume. The lever arm is connected to a wiper assembly with a set of contacts. Common styles for the contacts are ribbon (Figure V.1) or button (Figure V.2.). The contacts slide on a conductive ink which is deposited on a printed circuit board with a ceramic substrate. Both the contacts and ink may be made of various blends of metals such as silver, platinum, palladium, and gold. The ink also may have glass beads for strength. The formula for the ink as well as the contacts are chosen to be resistant to corrosion, wear, and attack by fuel impurities, such as free (elemental) sulfur.

Figure V.1. Level Sender Contacts: Ribbon Style System

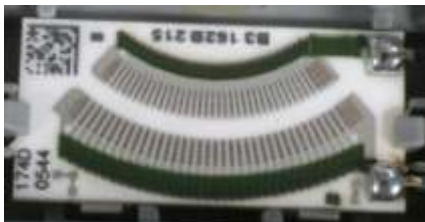
Figure V.3. Typical Circuit Board

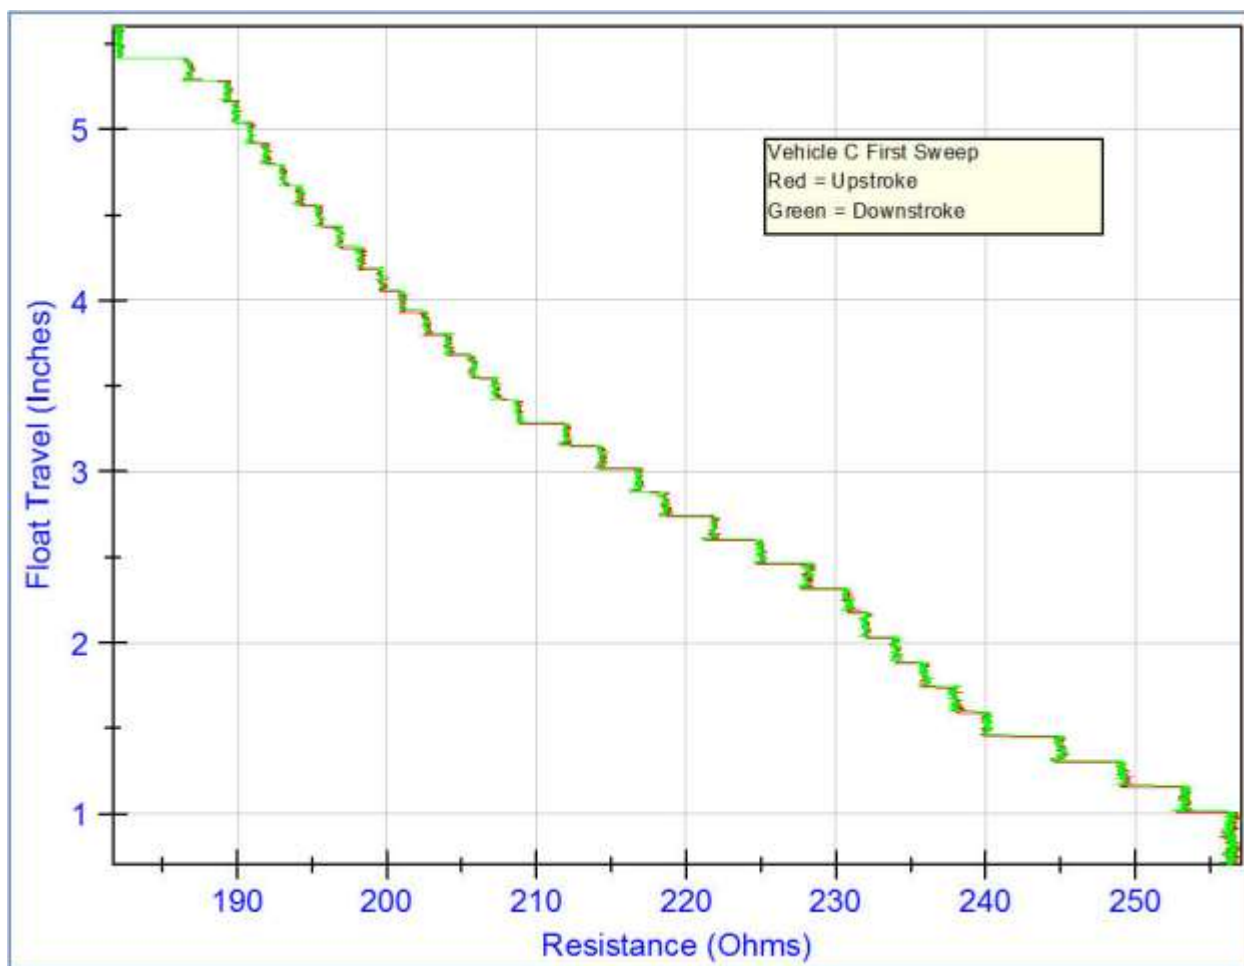
Figure V.6. Vehicle C Level Sender Fuel Resistance Pre-aging First Sweep

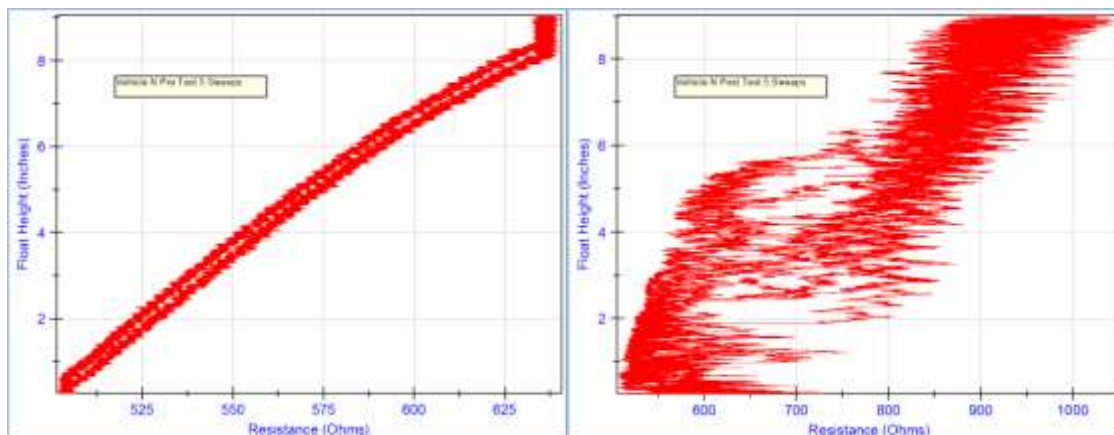
Vehicle N showed a signal shift (hysteresis) when initially tested with E20_A in the fuel resistance portion of the program, shown in Figure V.3. This test showed a shift in the resistance values from the initial to the post test and a change in the range of values observed. Subsequent testing, however, was free from any signal defects after the measurement apparatus was changed. The fuel resistance testing with E10 showed minor noise initially, but also produced clean results when retested. Vehicle N was also tested on E0 using the fuel resistance protocol and showed no issues.

Figure V.8. Vehicle N E20_A Level Sender Fuel Resistance Pre-aging & Post-aging test (initial)

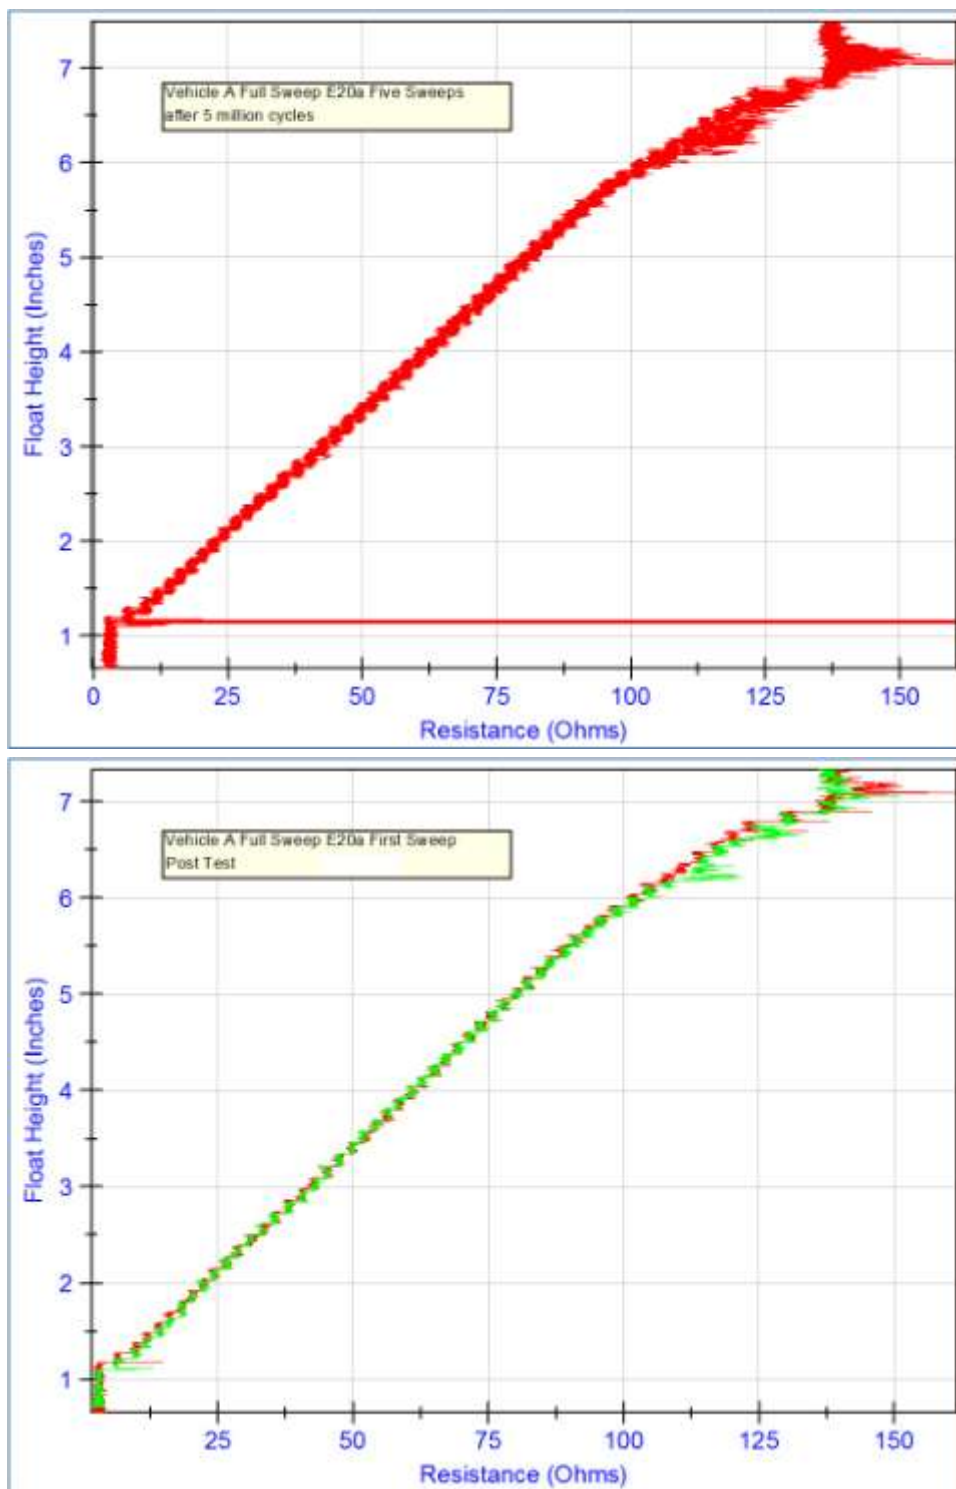
Vehicle A was tested with E20_A and E10 fuel in the full sweep portion of the test. In the E20_A test fuel, Vehicle A showed an open circuit and noise on the first sweep at the end of the test. When additional sweeps were done, the open circuits did not appear, but the signal remained noisy. Figure V.13 shows the sweeps at end of the E20_A test.

Figure V.13. Vehicle A Full Sweep E20_A Endpoint

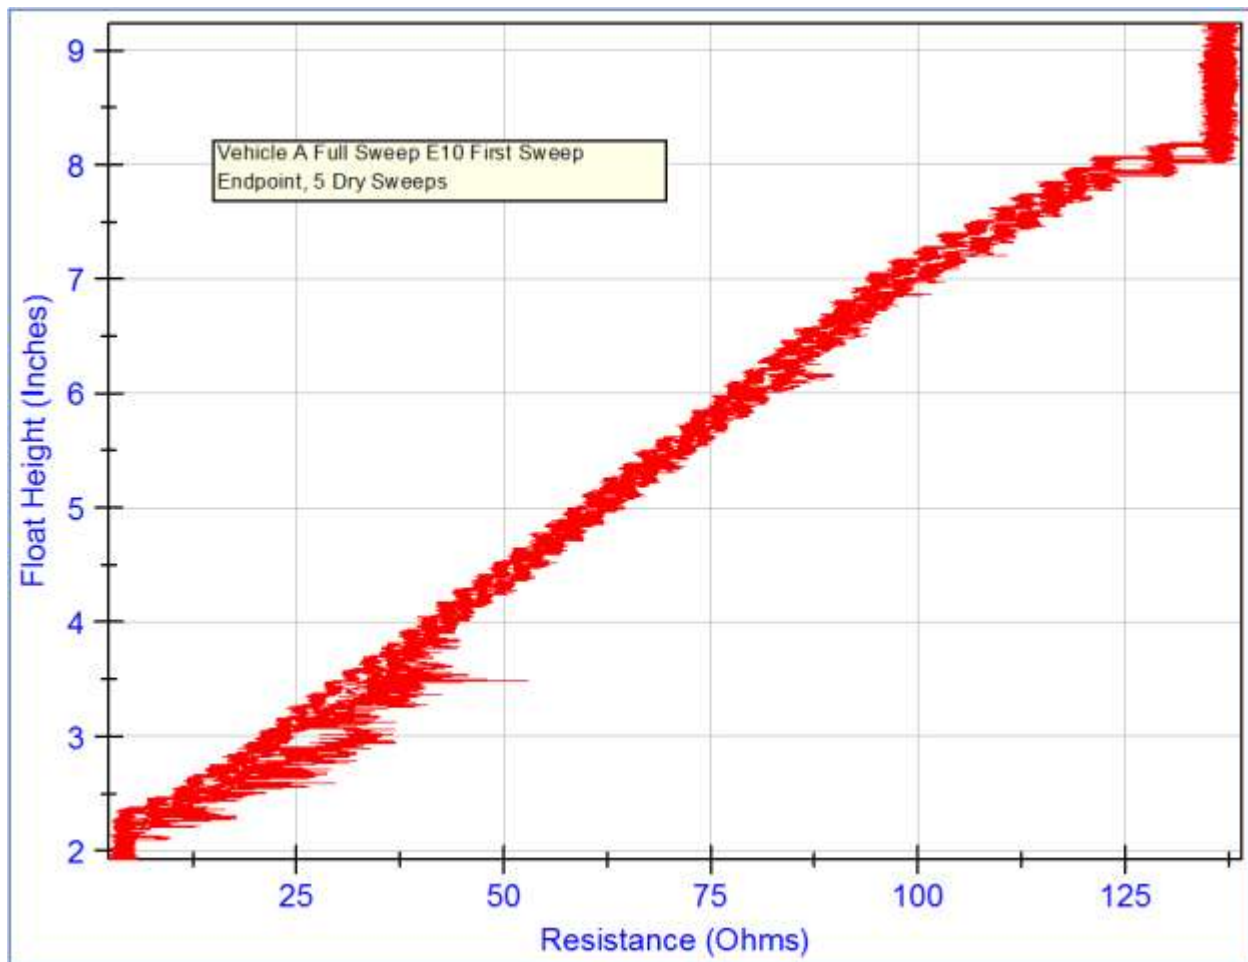
Vehicle A's test with E10 fuel showed some noise in the signal, illustrated in Figure V.14.

Figure V.14. Vehicle A Full Sweep E10 Endpoint
