CRC REPORT NO. 662

DURABILITY OF AUTOMOTIVE FUEL SYSTEM COMPONENTS EXPOSED TO E20

Coordinating Research Council
CRC Contract No. AVFL-15

CRC AVFL-15 Project Panel
December 2011

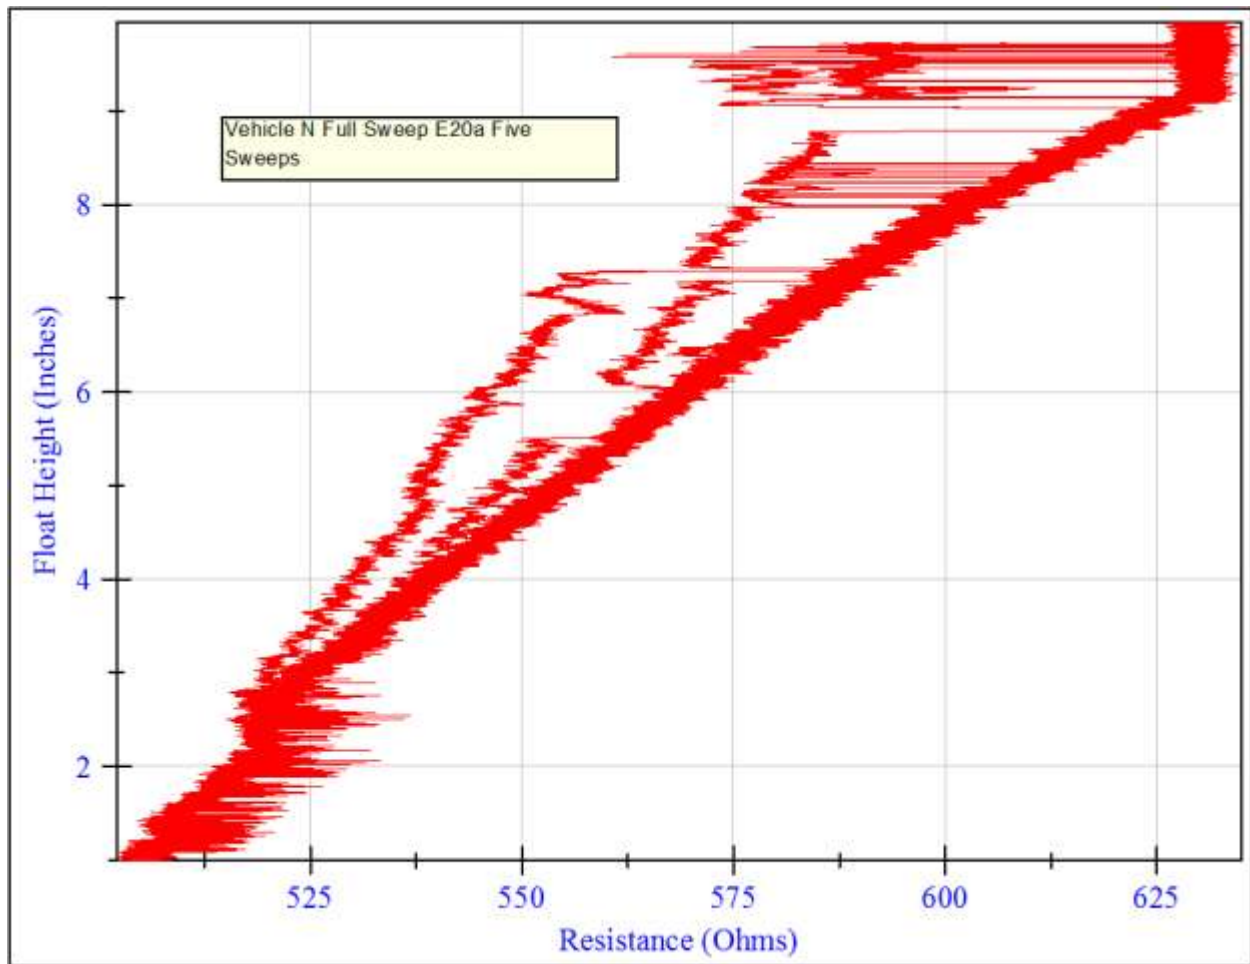
Vehicle N was tested with E20_A in the full sweep portion of the test. The initial tests showed a noisy signal, with a shift in the resistance value in the midpoint of the sweep. Figure V.15 shows the results at the end of the test for five test sweeps.

Figure V.15. Vehicle N Full Sweep E20A Endpoint (initial test series)

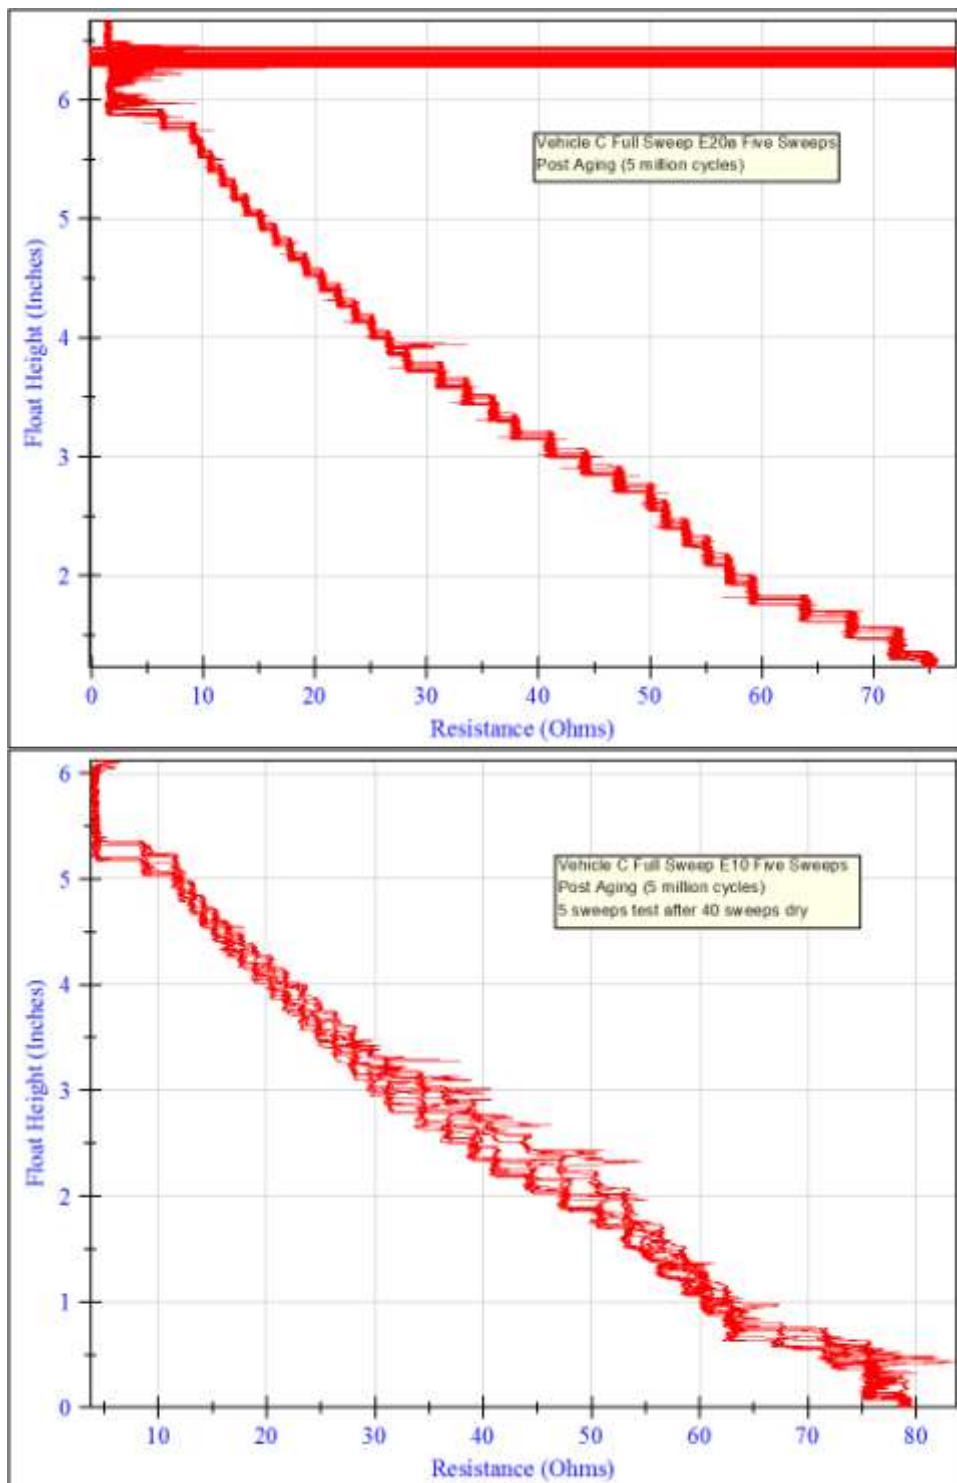
Figure V.17 shows the results of Vehicle C at the end of the full sweep tests.

Figure V.17. Vehicle C Full Sweep E20_A (top) and E10 Endpoint

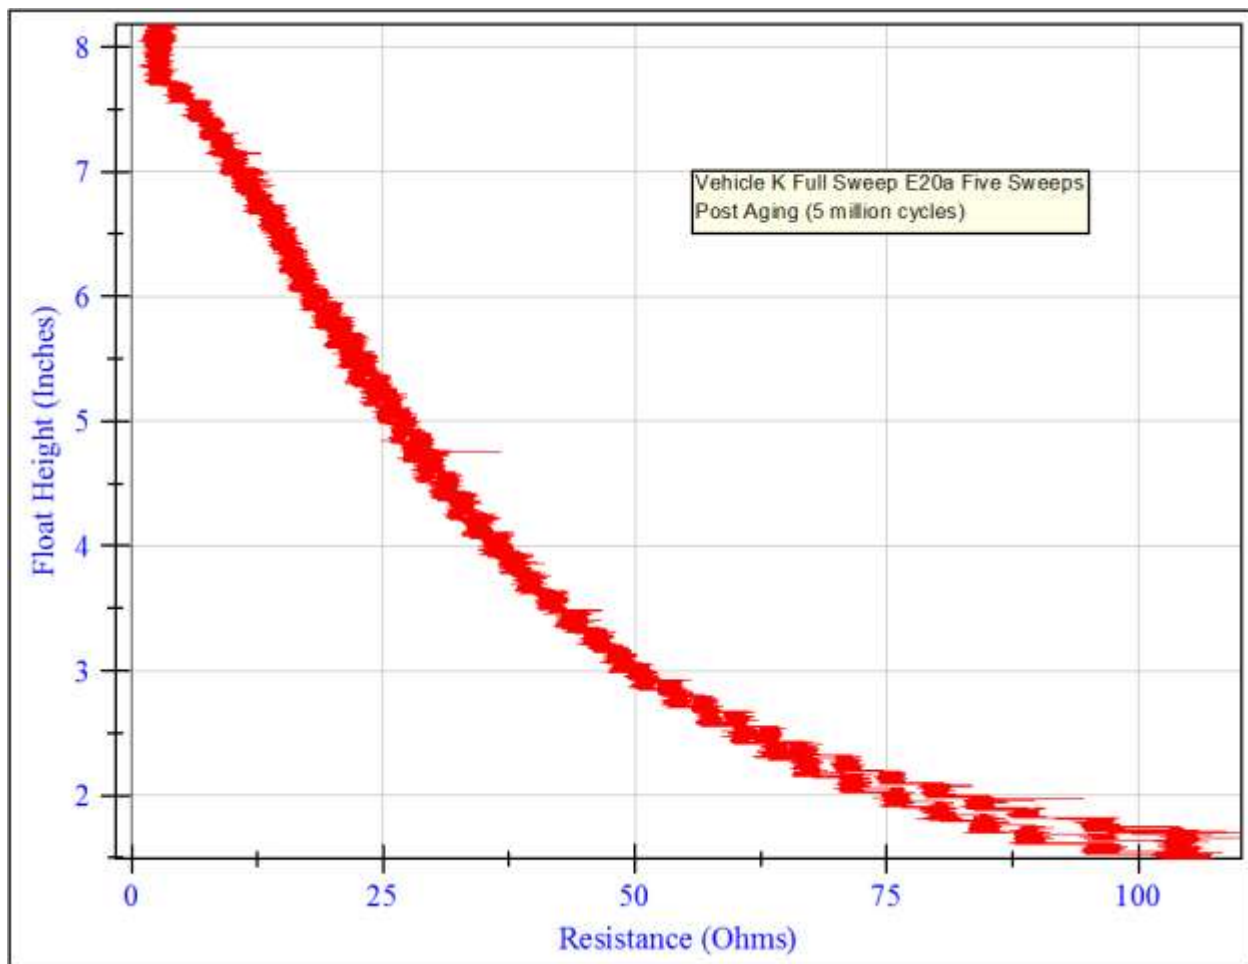
Figure V.19. Vehicle K Full Sweep E20_A

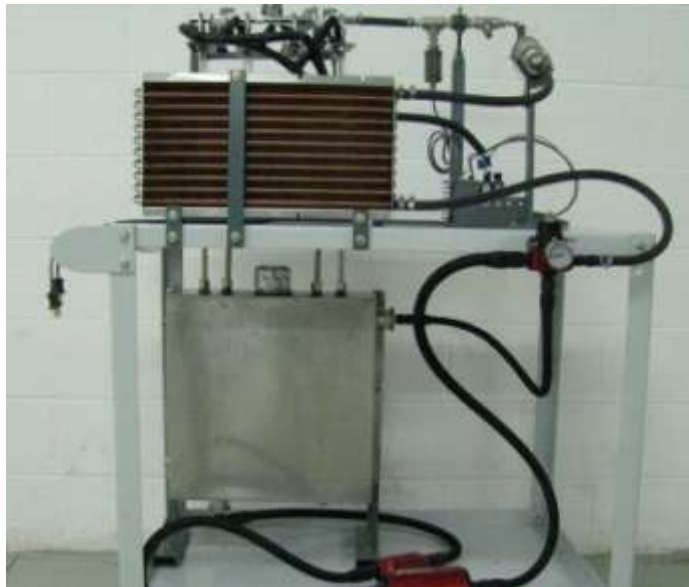
Figure VII.1. Fuel Injector Testing and Aging Stand
