CRC Project CM-136-09-1B

**INTERMEDIATE-LEVEL ETHANOL
BLENDS ENGINE DURABILITY STUDY**

Report FEV09-430F1

**Henning Kleeberg
FEV, Inc.**

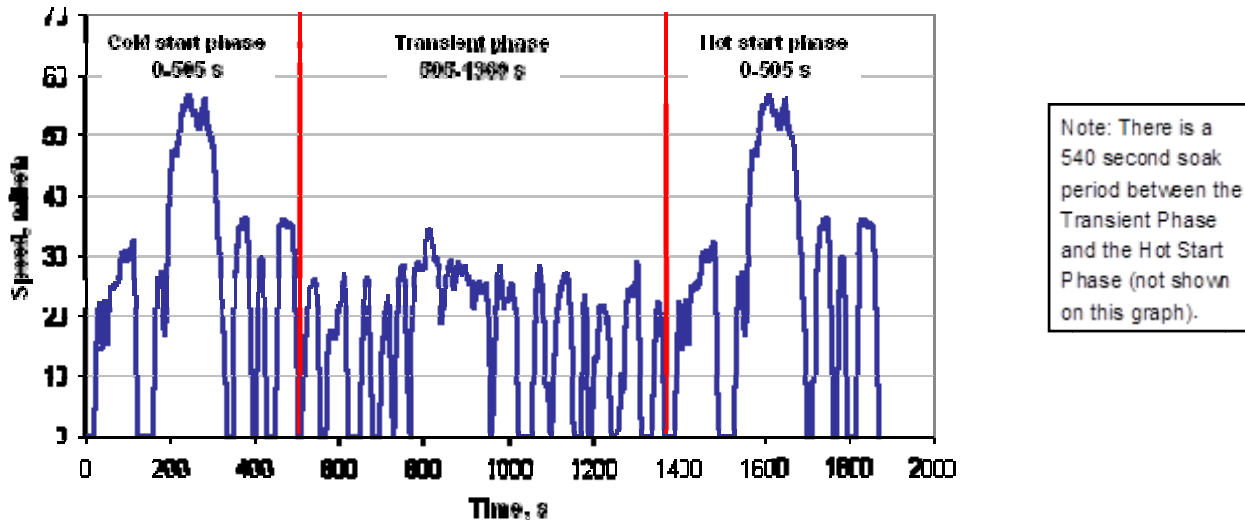
Figure D.3.2.1: FTP75 Schedule

The schedule for the FTP75 emission test is shown below. A 540 second soak period between the transient phase and the hot start phase was also included for the testing, but is not shown in Figure D.3.2.1.

An end-of-test (EOT) FTP75 emissions measurement was performed after the engine was reinstalled in the vehicle following the 500 hours of durability testing. This was done only after Rounds 1 and 2. In Rounds 1 and 2 the FTP75 tests were not done and only the engine dynamometer method (discussed in the following sections) was used to determine EOT emissions. After Rounds 1 and 2 (with the exception of Sample A of Vehicle 7 in Round 3), the program switched to an EOT vehicle FTP75 test to have a direct correlation to the one performed at SOT.

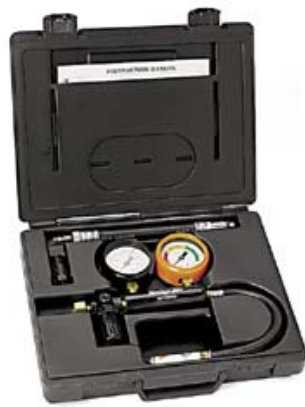
Figure D.3.5.1: Snap-On® EEPV309A Leakage Tester

Compression and leakdown were measured throughout the whole program with the same measurement equipment and methods on all investigated engines. In the beginning of the study, FEV investigated the repeatability of measurements with several leakdown gauges and with several technicians. As a result, it was determined to utilize the Snap-On® leakage tester model EEPV309A for all measurements within this program (see Figure D3.5.1). The tool was stored in a defined location at FEV and all technicians involved in this study were instructed to only use this Snap-On® tool for the leakdown measurements. Leakdown measurements were always conducted with a warm engine.

Compression was measured on all cylinders at intervals of every 50 hours during the durability test cycle; if the measurement did not meet the criterion specified in the service manual, the OEM technical contact was immediately notified. Similarly, leakage was also measured on all cylinders every 50 hours of testing. If any of the leakdown values exceeded the ten percent threshold, the OEM technical representative was notified immediately.

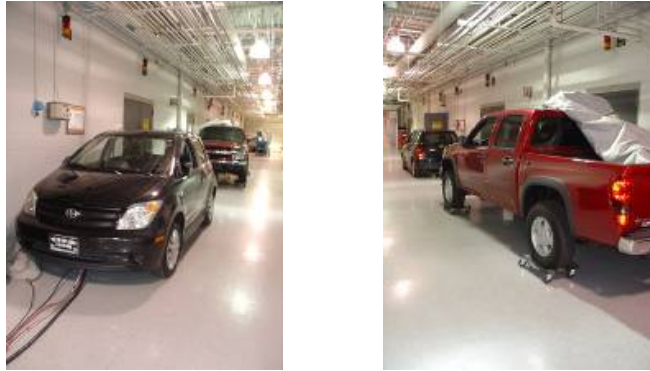
Figure D.5.1.2: Umbilical Cord Vehicle to Engine Setup

The vehicle was left intact with an “umbilical cord” used to connect the vehicle to the engine in the test cell. The vehicle was parked outside the test cell to allow communication with the engine ECU. This ensured the engine would function through its operation range without limiting power output due to DTCs.

Figure D.5.1.2 shows example vehicle setups used during the project. The cables routed underneath the cars are the “umbilical cords” which relay ECU information and other vehicle information from the vehicle to the engine present inside the test cell.

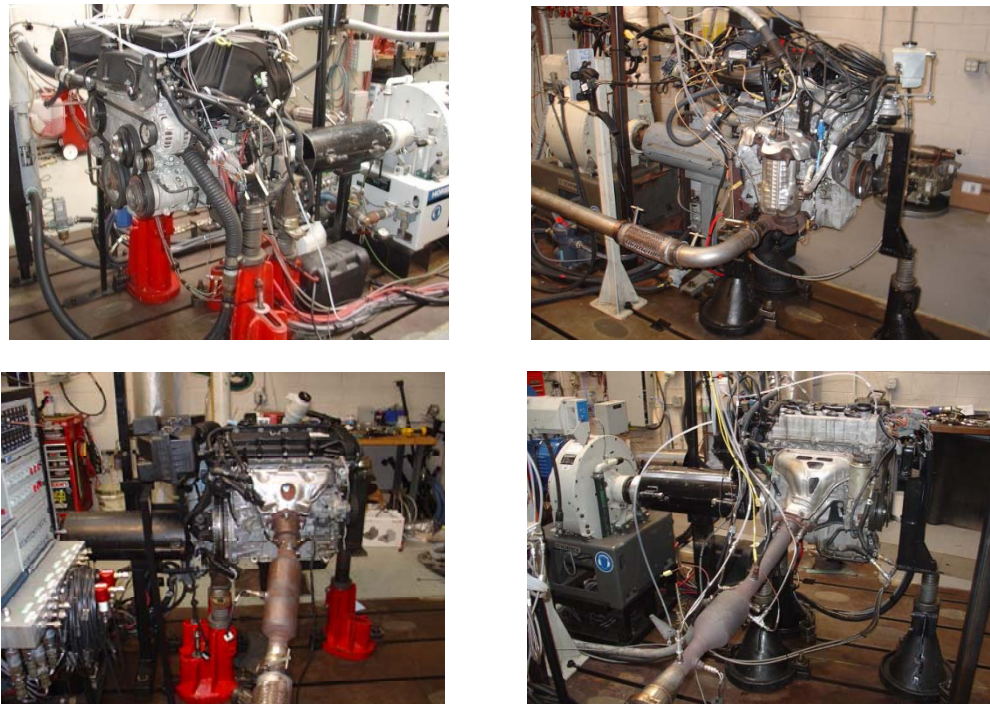
Figure D.5.1.3: Engine Setup in Test Cells

Examples of the engine setup in the dynamometer test cells are shown in Figure D.5.1.3:

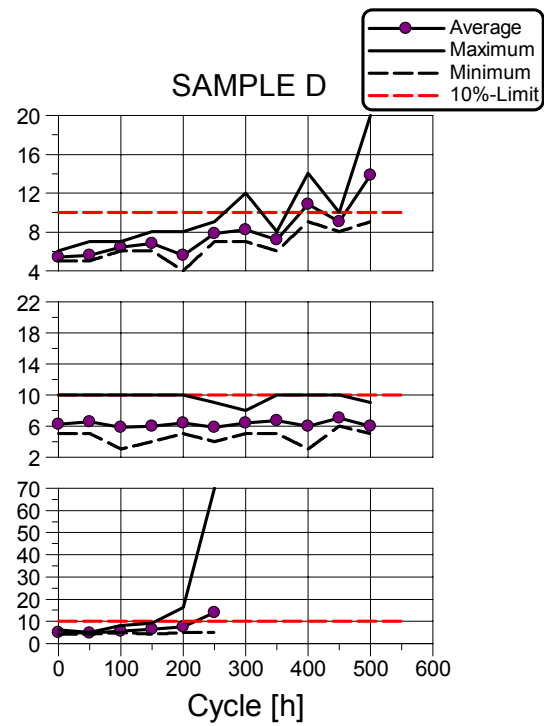
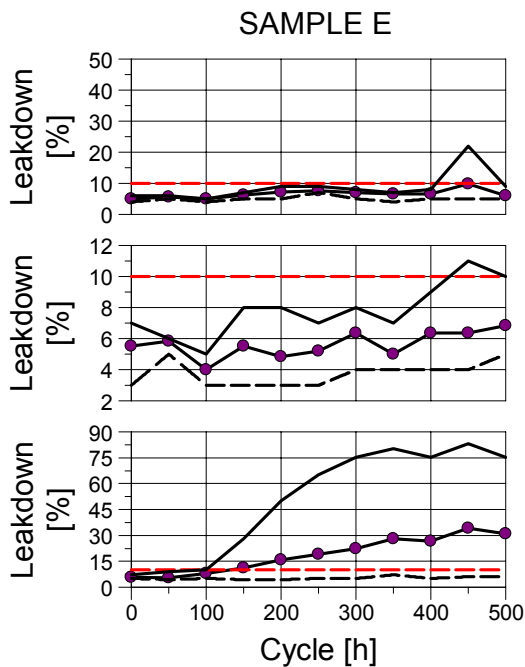
The following graphs summarize the leakage measurement results for all 28 tested engines.

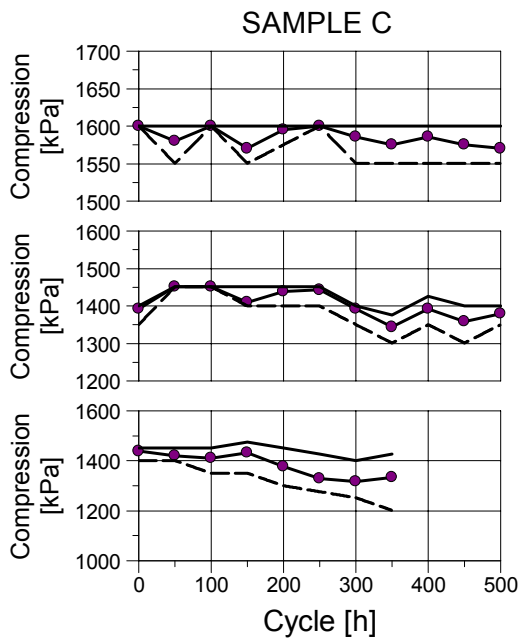
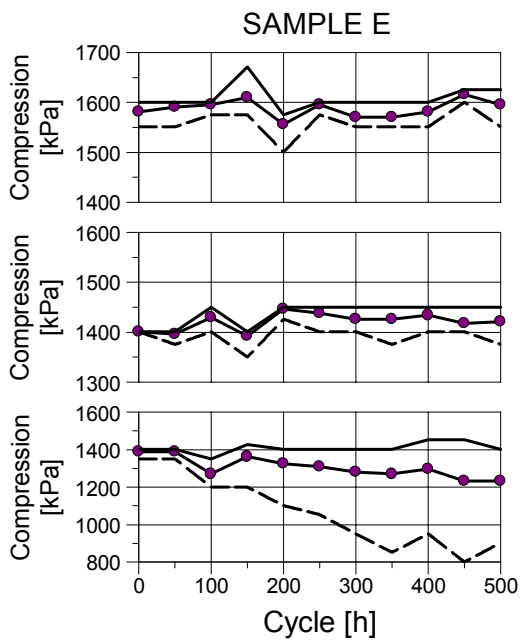
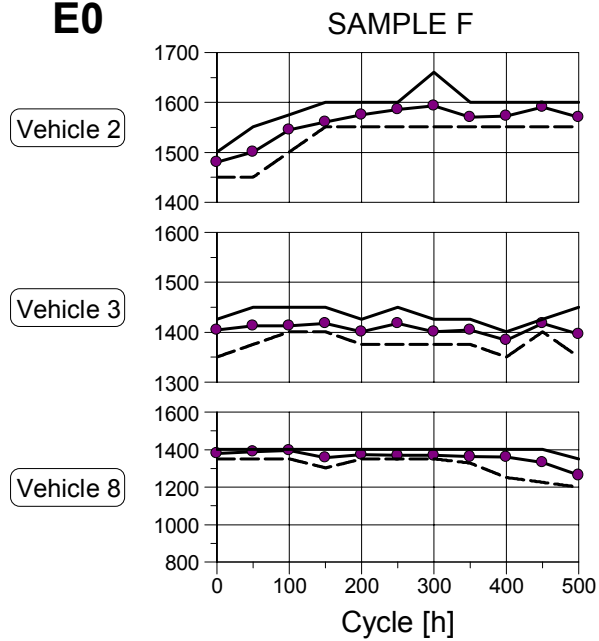
The following graphs summarize the compression measurement results for all 28 tested engines.
