# **CRC Report No. E-90-2b (Interim)**

## **IMPACT OF ETHANOL BLENDS ON THE OBDII SYSTEMS OF IN-USE VEHICLES**

## **CRC Project E-90-2b Phase 1 - Effects of Ethanol Blends on OBDII Systems of In-Use Vehicles**

SwRI Project 08.15995  
November 7, 2012

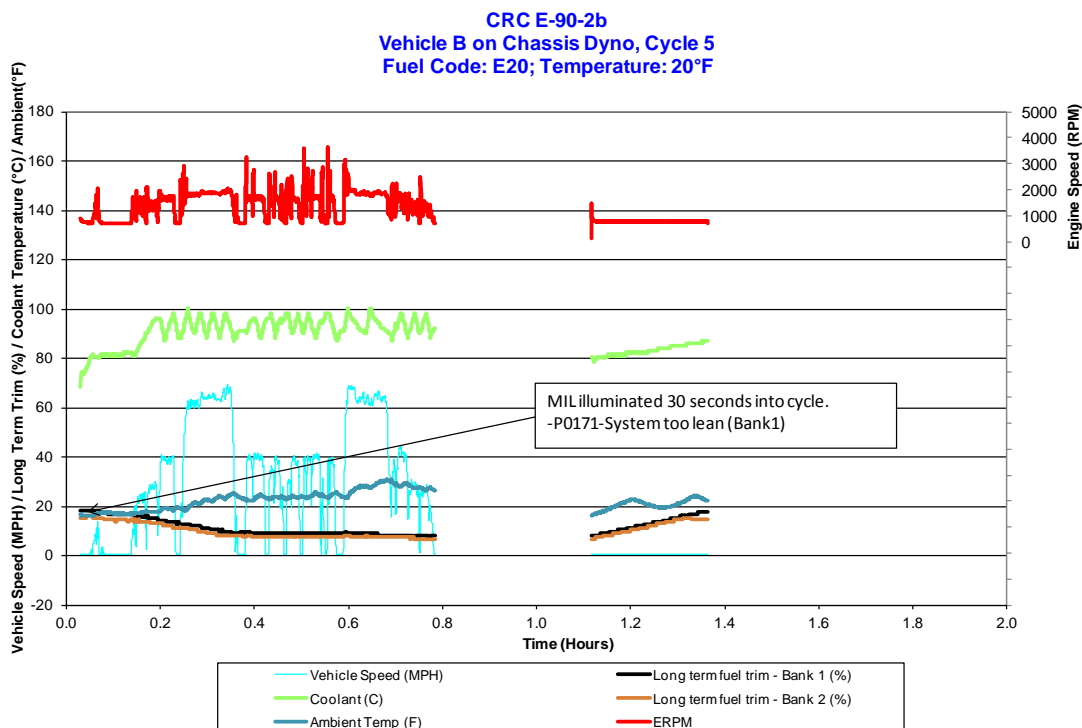
**Figure 10 – Vehicle B 20°F E20 Drive Cycle**

Lean bank operation MILs were set on Vehicle B at 20°F with both E20 and E30, and at 50°F with E30. Figure 10 shows the MIL-on event at 20°F with E20. Figures 11 and 12 show a comparison of Vehicle B bank 1 long term fuel trim at various test temperatures while running on E20 and E30, respectively.

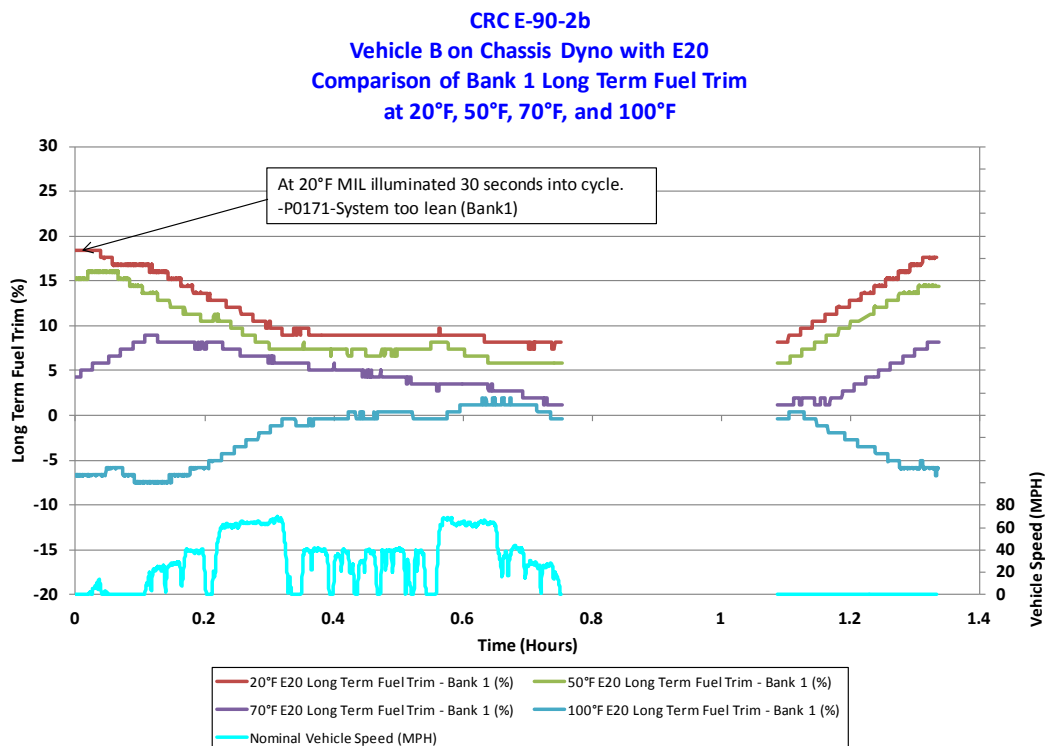
**Figure 11 – Vehicle B Comparison of Bank 1 Long Term Fuel Trim at Various Temperatures with E20**

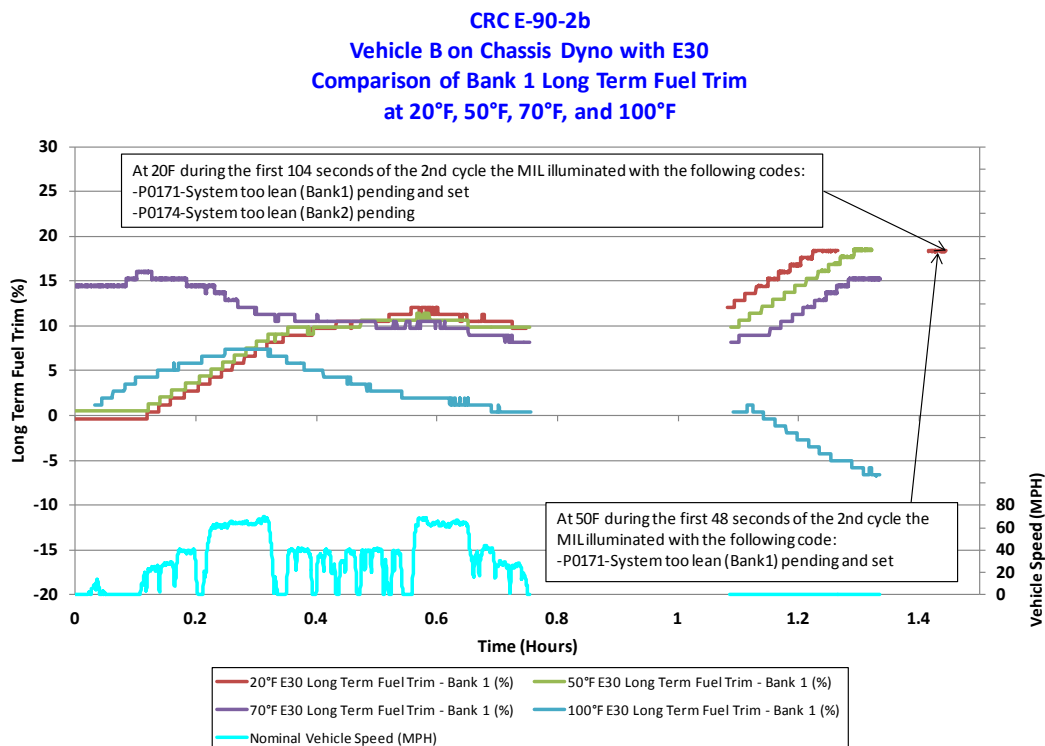
**Figure 12 – Vehicle B Comparison of Bank 1 Long Term Fuel Trim at Various Temperatures with E30**

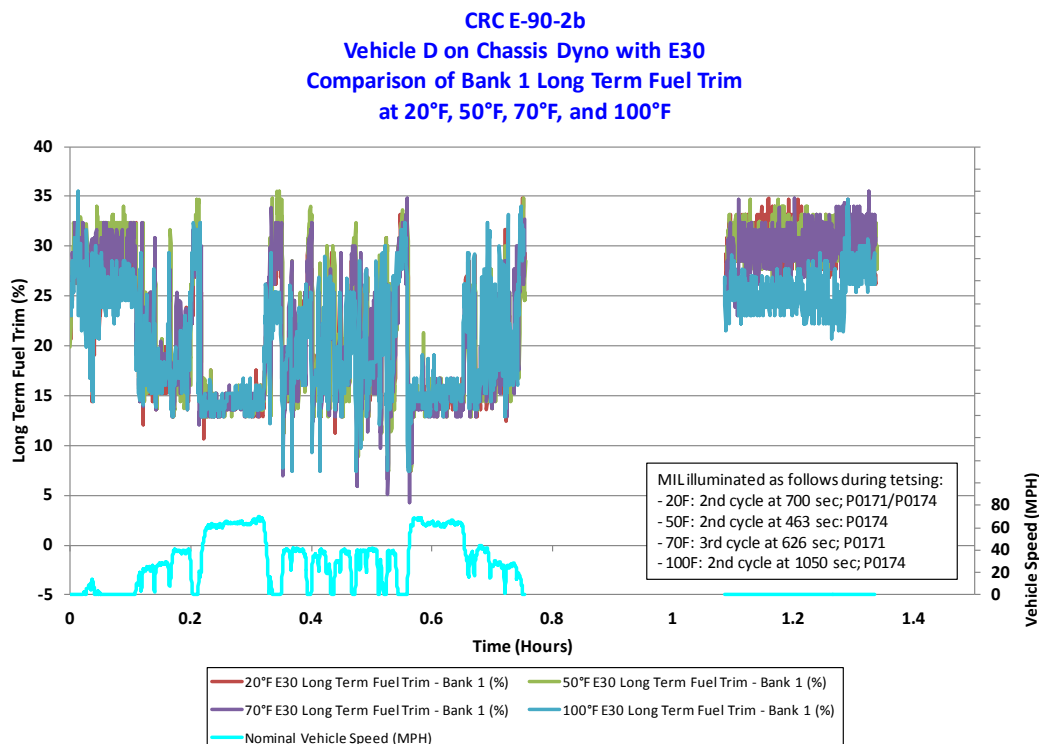
**Figure 13 – Vehicle D Comparison of Bank 1 Long Term Fuel Trim at Various Temperatures with E30**

To date Vehicle D has been tested on the dyno with only E30, and lean bank operation MILs were set at all temperatures. Figure 13 shows a comparison of Vehicle D bank 1 long term fuel trim at various test temperatures while running on E30.

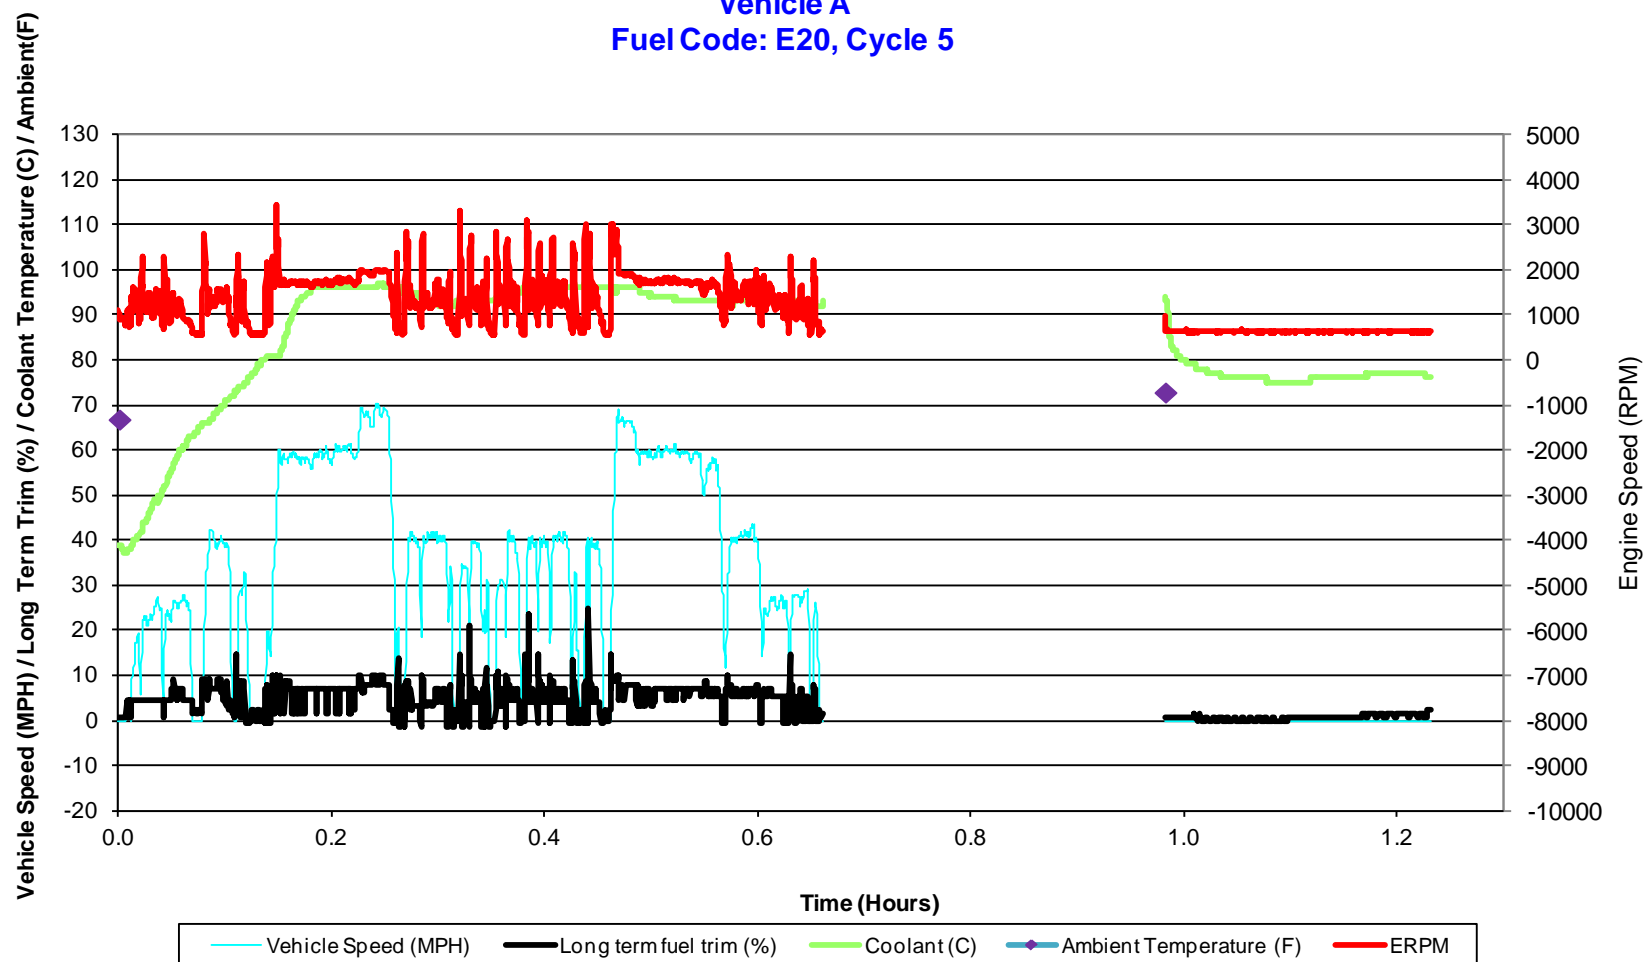
CRC OBD 90-2b  
Vehicle A  
Fuel Code: E20, Cycle 5

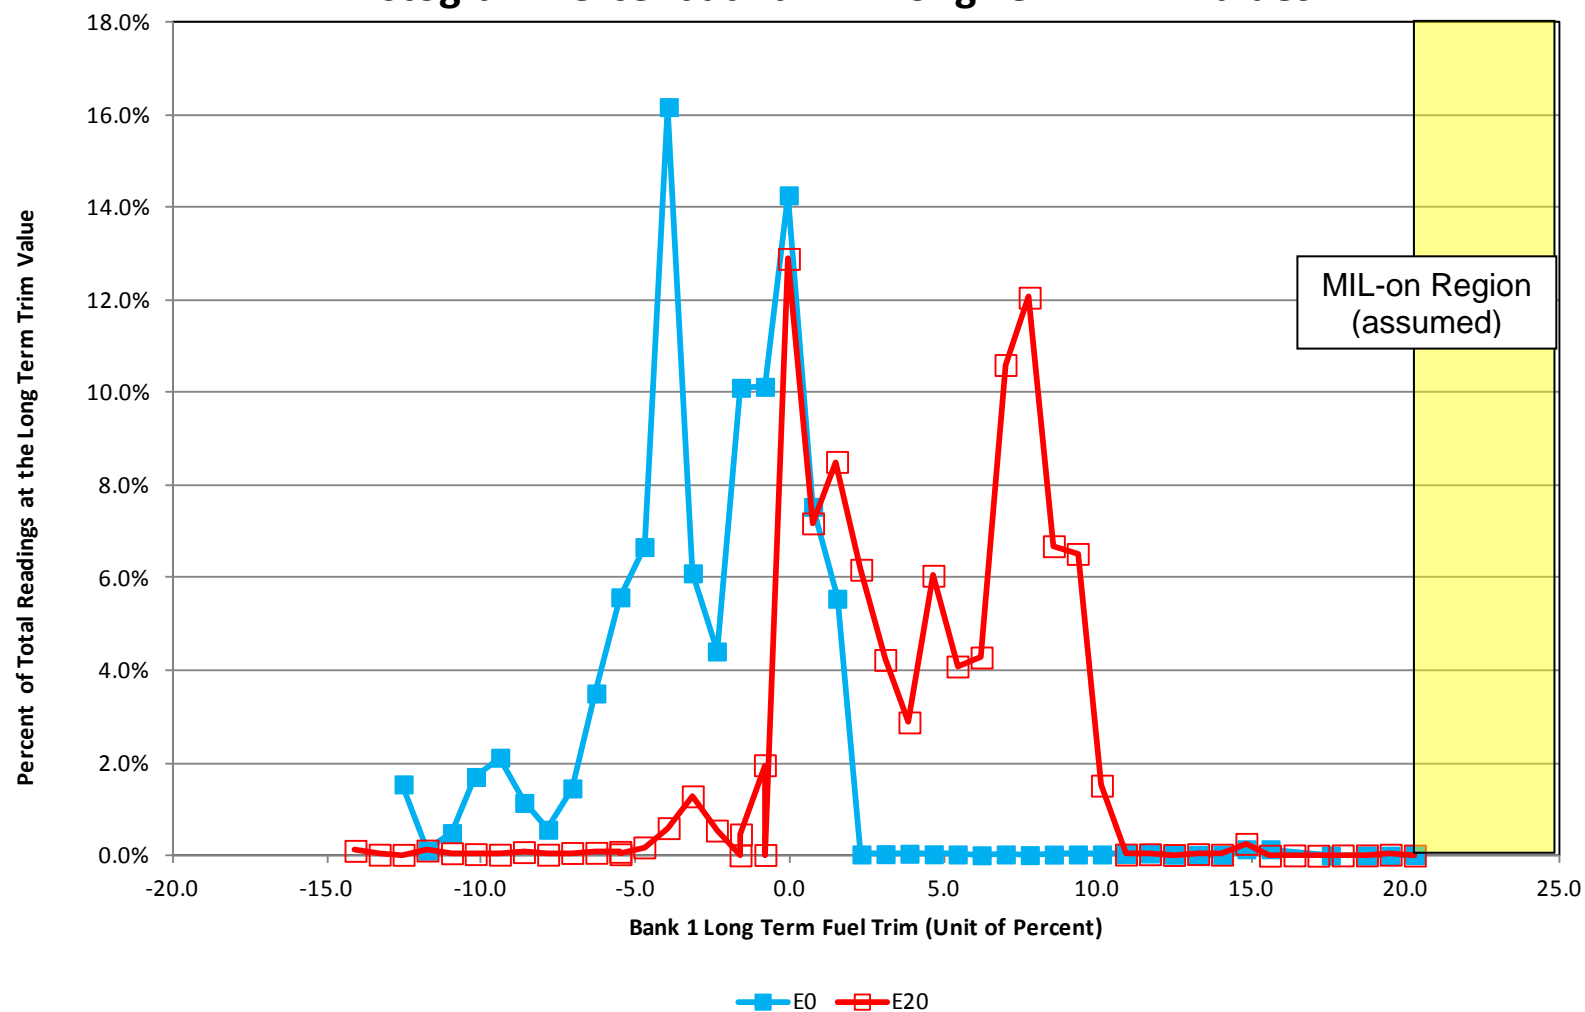
### CRC OBD Program 90-2b "Vehicle A" On-Road Data Cycles 1 - 10 Histogram Percent at Bank 1 Long Term Trim Values
