**JET FUEL CONTAMINATION
WITH DIESEL FUEL DYES**

CRC Report No. 639

(CRC Project No. CA-66-03)

CRC Aviation Fuel, Lubricant & Equipment Research Committee
of the
Coordinating Research Council, Inc.

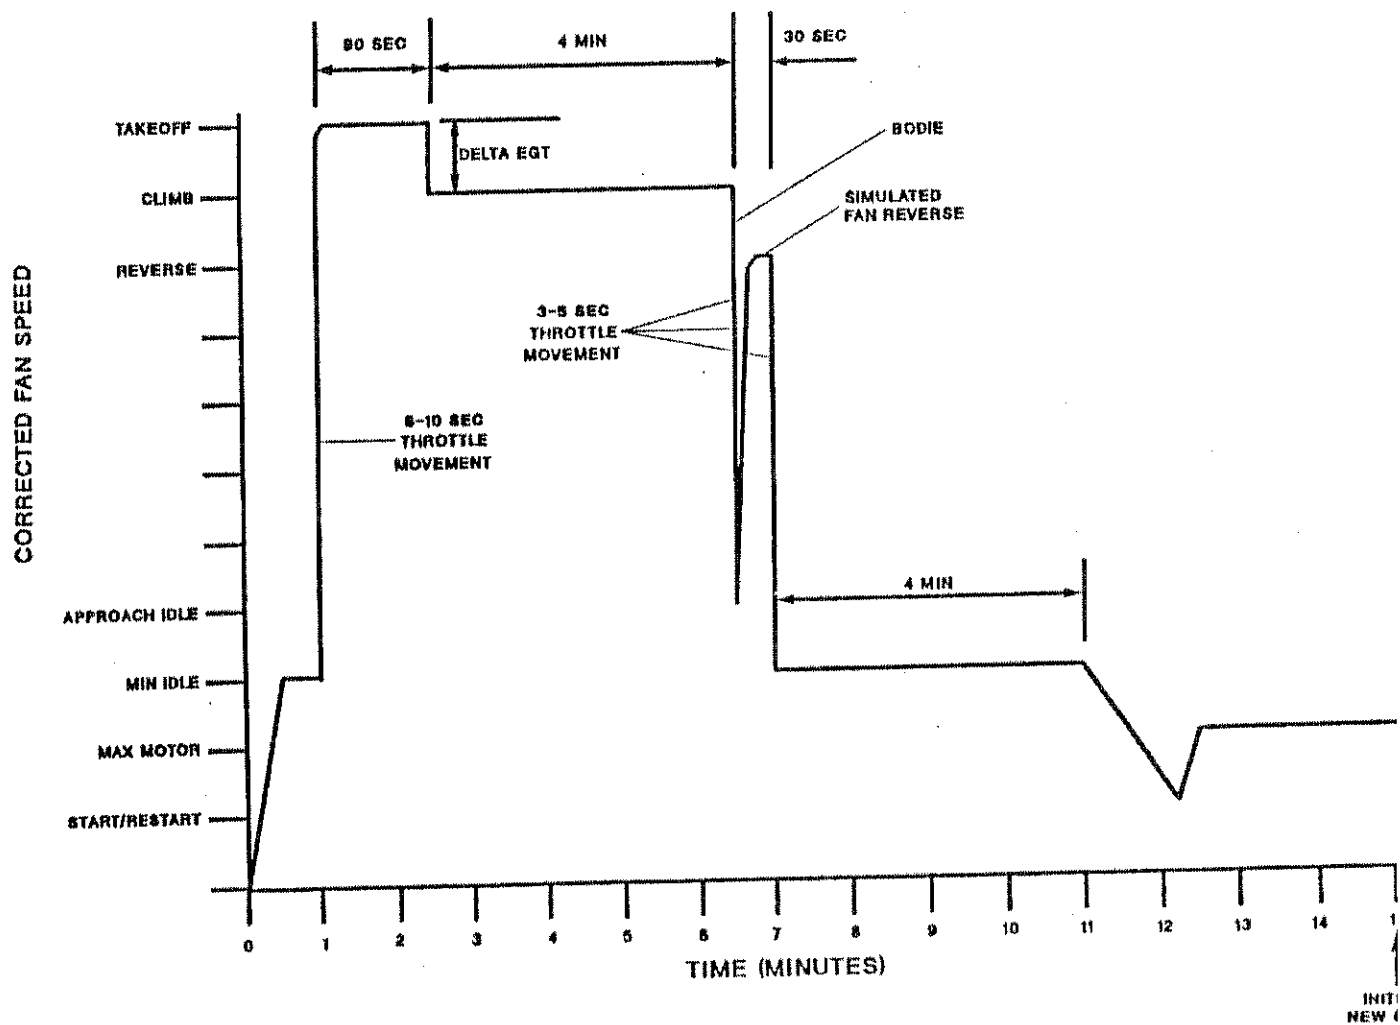
Figure 1 – Profile of GE Commercial Engine Operating Cycle

In reaction to these results and to answer the requests by the airline industry, General Electric conducted engine tests under cycling conditions intended to simulate accelerated flight patterns. The General Electric report is presented in Appendix D. The test fuel was Jet A containing twice the dye concentration requested by the airline for emergency use or 0.80 mg/L (5% of the IRS requirement). A series of "Commercial Operating Cycles" were conducted with the cycle conditions shown in Figure 1. A total of 45 such cycles were run on the dyed fuel in a GE CF60-80C2 engine. The test consumed 14,850 gallons of dyed fuel. Dye effects were detected by hysteresis changes during flow tests made on 15 fuel nozzles before and after engine operation on dyed fuel. In hysteresis testing the fuel nozzle flow rate is measured as nozzle pressure is increased from a minimum to a maximum level and when pressure is decreased from a maximum to a minimum pressure level. Hysteresis is defined as the difference in flow rate between the two test schedules. A clean nozzle shows little or no hysteresis effect; a used nozzle is allowed a band of permitted limits. A nozzle outside these limits has accumulated enough deposits to cause a significant loss in performance.

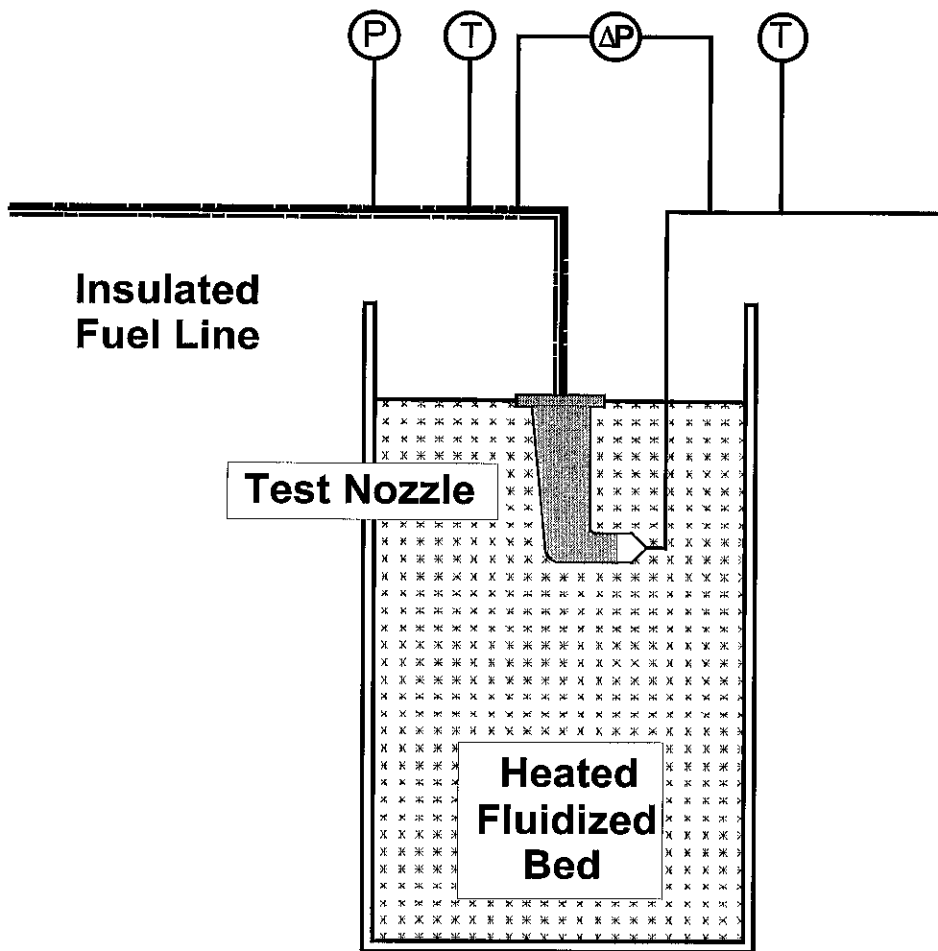
Figure 2A. Heated Fluidized Bed for Nozzle Fouling Tests

In the testing the nozzle is immersed in a fluidized sand bath for uniform heating. Fuel is pumped through a separate heater into the nozzle. Figure 2A illustrates the heating sand bath, while 2B shows the entire nozzle test apparatus. Fuel flow, pressure drop and temperatures are monitored. Fuel temperature is controlled independently of the sand bath temperature. The temperature of the nozzle's outer metal surface is at bath temperature. Each nozzle was modified to collect the entire fuel outflow which was discarded. (There is no fuel combustion in these tests.) Flow rates and temperatures of the outer wall of the component were set by the manufacturer. For the air atomizers the air flow and temperature were also specified. The nozzles as well as the operating conditions are not identified in the report. Both the mechanical nozzle modifications and the test operating conditions represented unavoidable compromises. The nozzle modifications probably resulted in temperature profiles somewhat different from the engine, while the fuel temperatures had to be set above maximum engine conditions to get deposits in a reasonable time but not so high that deposits were formed by a different mechanism.

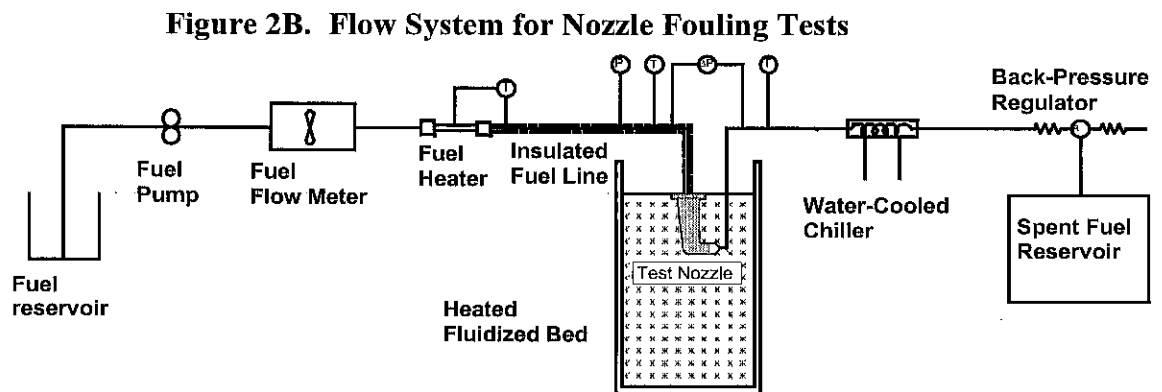
Figure 2B. Flow System for Nozzle Fouling Tests

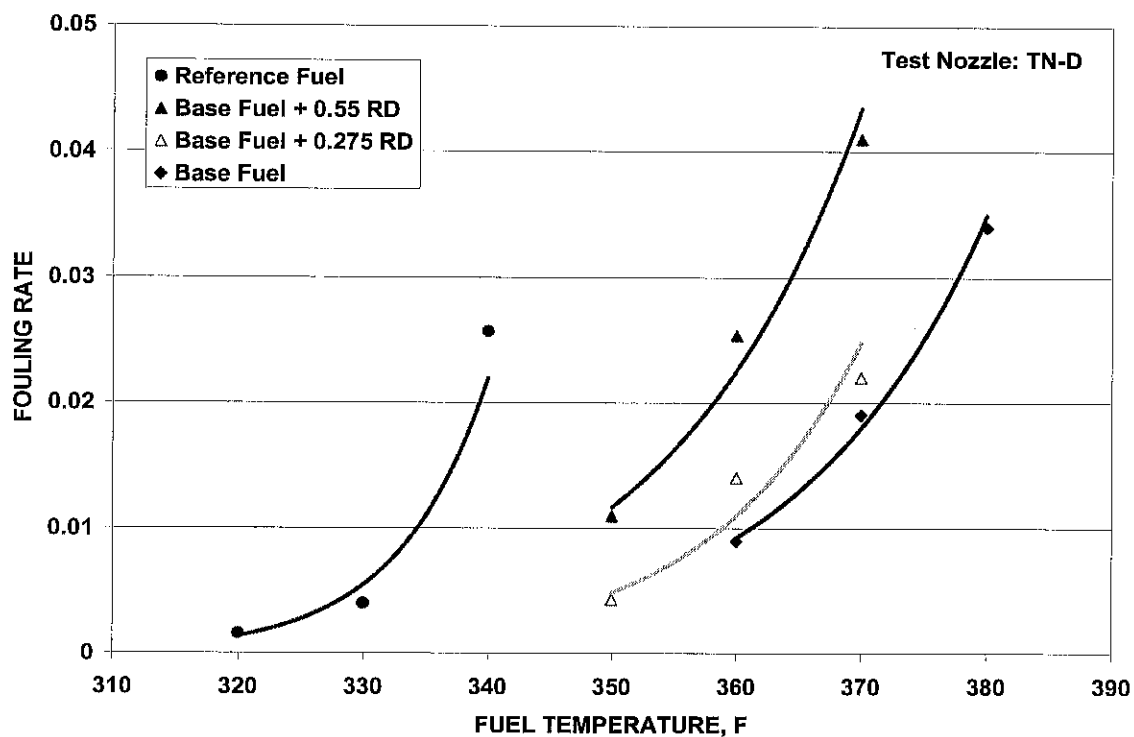
Figure 3. Fouling Rates for a Test Nozzle Sensitive to Red Dye (TN-D)

When the plot of flow number versus temperature showed significant degradation for the 5% red dye blend, the red dye tests were repeated with the dye at 2.5% concentration. An example of the results from one nozzle (Nozzle T-ND) tested at two concentrations is shown in Figure 3. The same results are repeated in Figure 4 as an Arrhenius plot where the data plot as parallel straight line, indicating a consistent degradation mechanism.

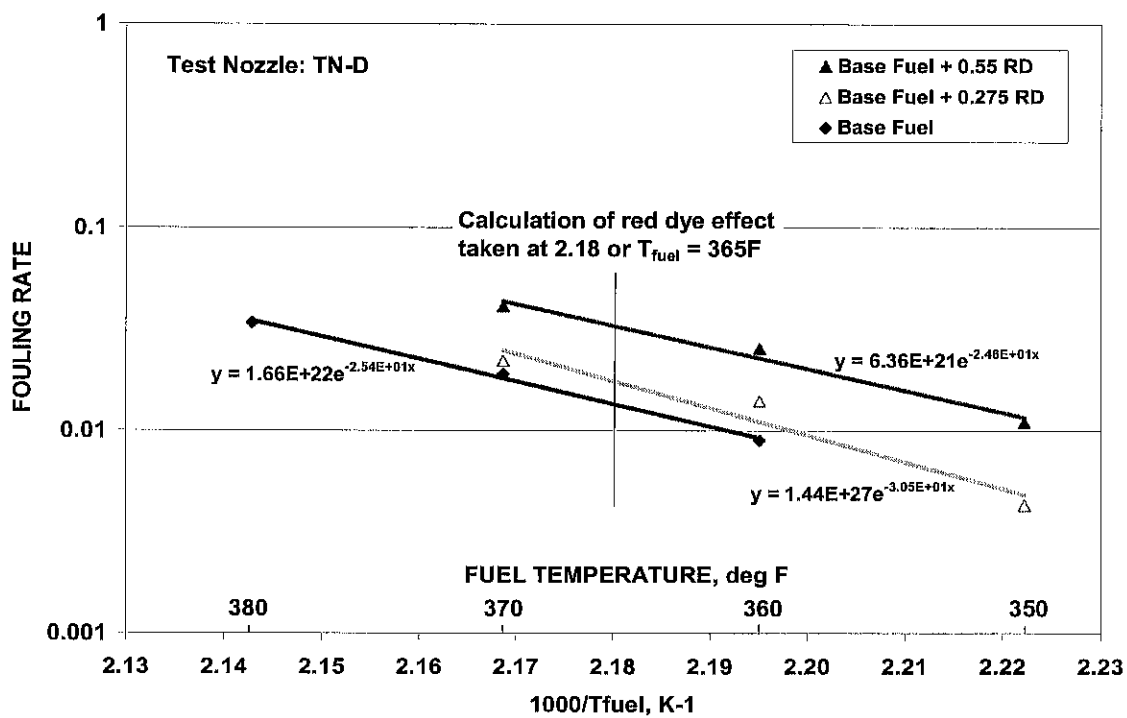
Figure 4. Arrhenius Plot of Fouling Rates for Nozzle Sensitive to Red Dye (TN-D)

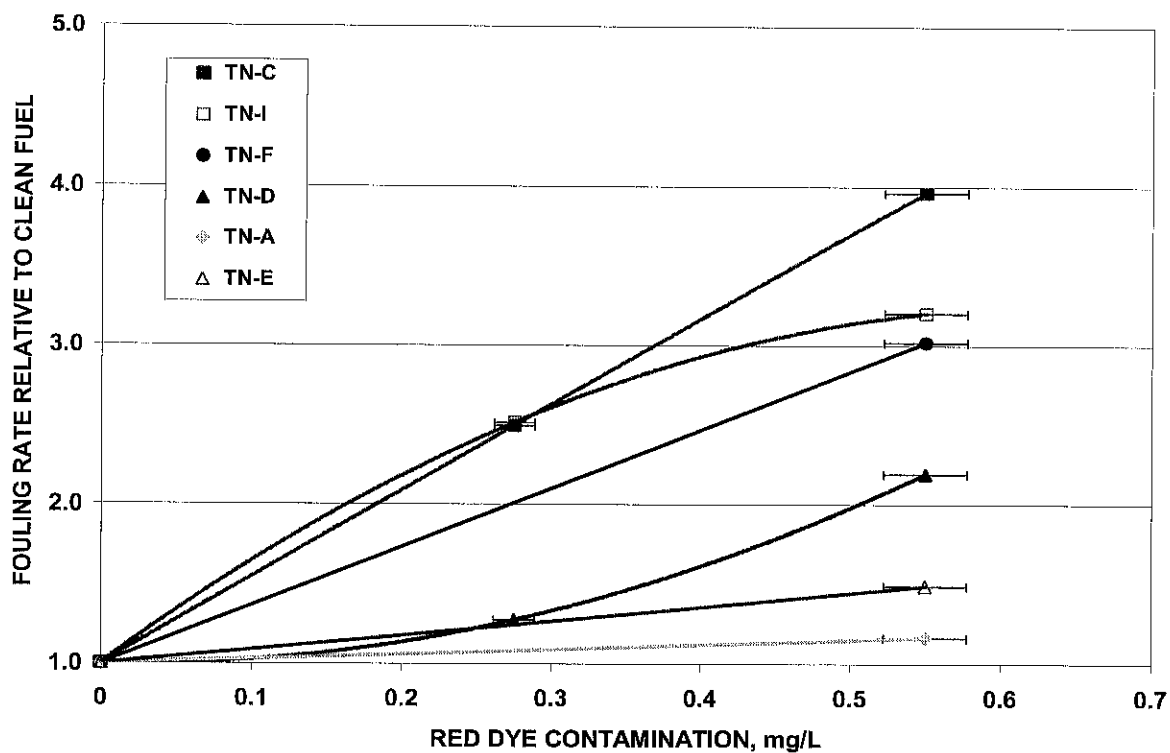
Figure 5. Effect of Red Dye on Relative Fouling Rates of Six Nozzles

Detailed results for all nozzles are given in the appendices of the cited report. However, results for 6 nozzles are summarized in Table 10 and are plotted in Figure 5. The differences in nozzle response to the red dye are readily apparent. It is worth emphasizing that the results represent the unlikely situation where the red dye is in all fuels at the given concentration. The more likely situation is plotted in Figure 6 which represents one measure of possible flights lost due to a single use of the red dye on an emergency basis.

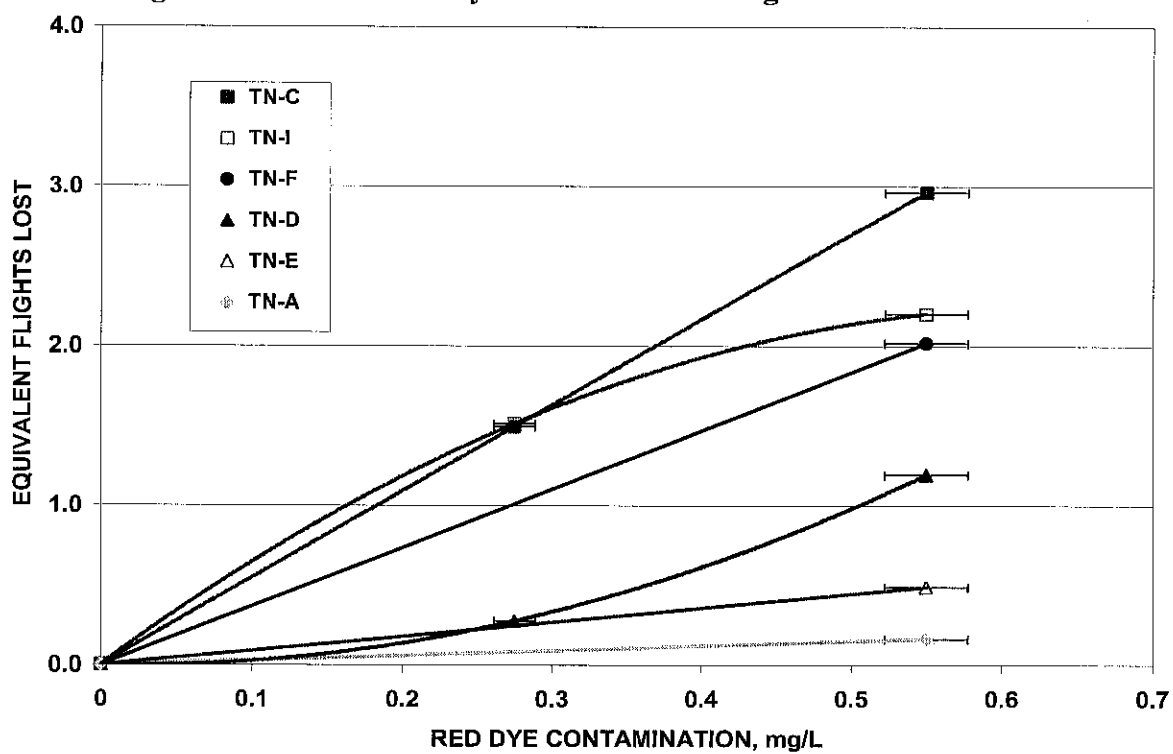
Figure 6. Summary of Effect of Red Dye Contamination on Equivalent Flights Lost

The conclusions which follow deal only with the effects of red dye on hot engine components and are based on the data shown in Figures 3 – 6, 8, 10 and 11. The effects of diesel fuel contamination on engine components as well as quantitative relationships between the component tests and small-scale laboratory tests have yet to be established.

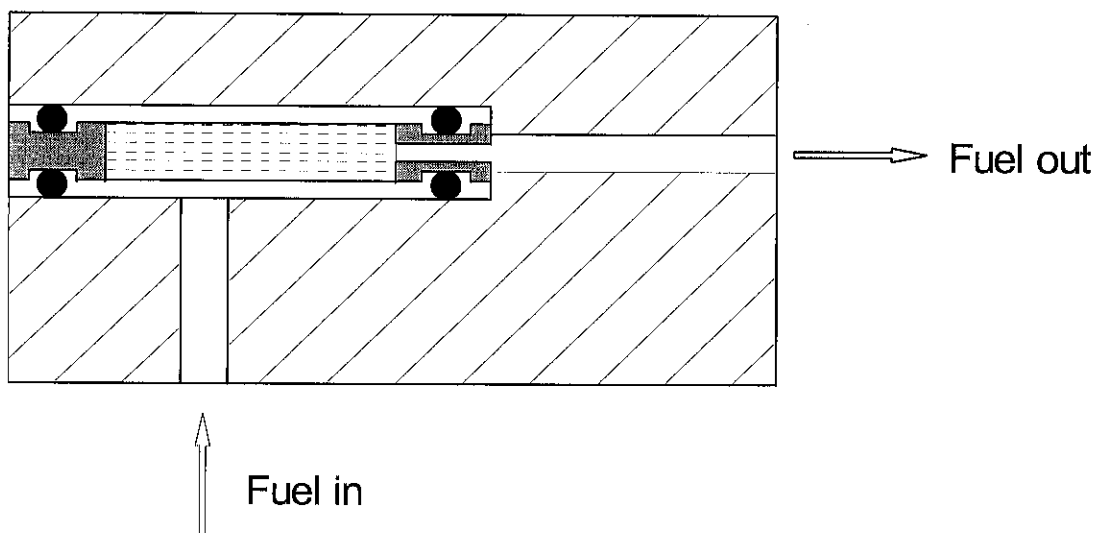
Figure 7. Schematic of Fixture for Torque-Motor Filter Screen Tests

The torque motor screen is a stainless steel mesh about one inch long and ¼ inch in diameter. Mesh size was not given in the report. For the test the screen was mounted in a heated block as shown in Figure 7. The block was insulated and heated by the fuel passing through the filter screen. Typically the block temperature was 3°C below the fuel temperature.

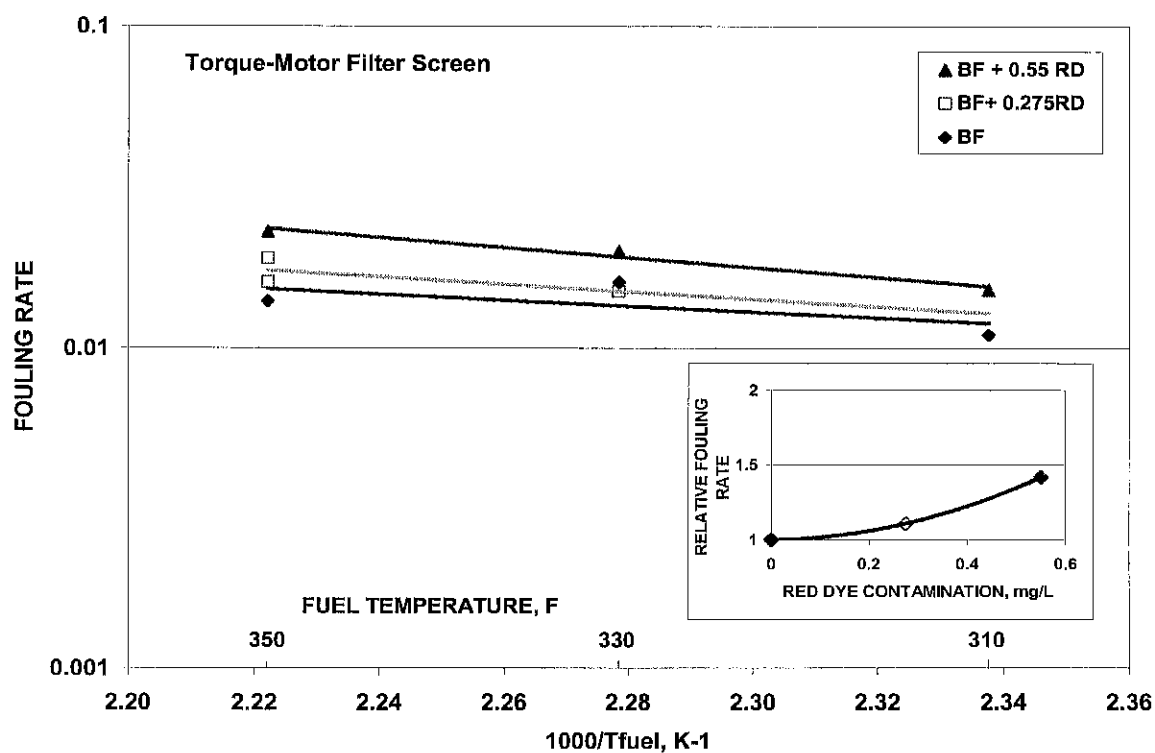
Figure 8. Effect of Red-Dye Contamination on the Fouling of Torque-Motor Filter Screens

The same test fuels were used as had been used for the nozzle tests. Eight hour runs were made at fuel temperatures of 154, 165 and 177°C. Data were analyzed in a similar fashion and the results are plotted in Figure 8. Clearly, the screen is much less sensitive to the red dye than were all but one of the fuel nozzles.

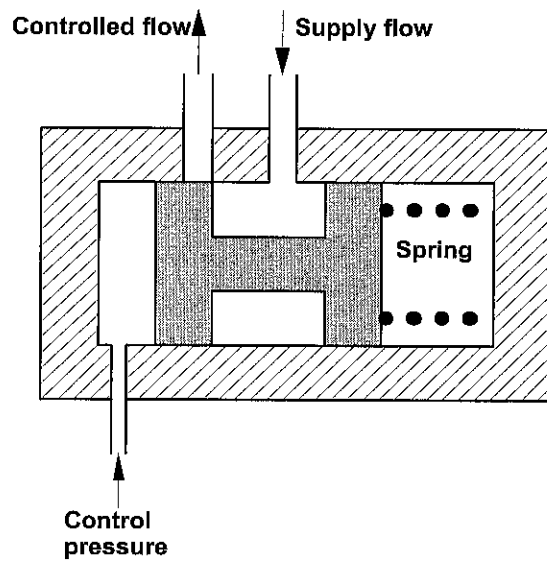
Figure 9. Schematic of Spool Valve

Spool valves are flow-controlling valves, which open and close ports with a spool sliding inside a sleeve. These valves operate under elevated pressure and depend on very tight clearances to seal the mating spool surfaces against the sleeve interior. A schematic diagram of a spool valve is shown in Figure 9. During operation line pressure is exerted against the spool on the fuel inlet side and is resisted by the spring on other end of the spool. Such valves operate by being in either of two positions, depending on whether the line pressure is greater or less than the spring force. Either position will cover and uncover different ports which will exert different hydraulic signals by changes in pressure. Deposits on the inner mating surfaces will increase the force required to move the spool and will cause erratic or intermittent valve operation resulting in unpredictable control response. A complete hang-up of the spool valve results in a loss of ability to properly schedule fuel flow. This inability to properly schedule the fuel flow results in no fuel flow, erratic fuel flow or full fuel flow to the engine in an unpredictable direction, causing unpredictable engine behavior.

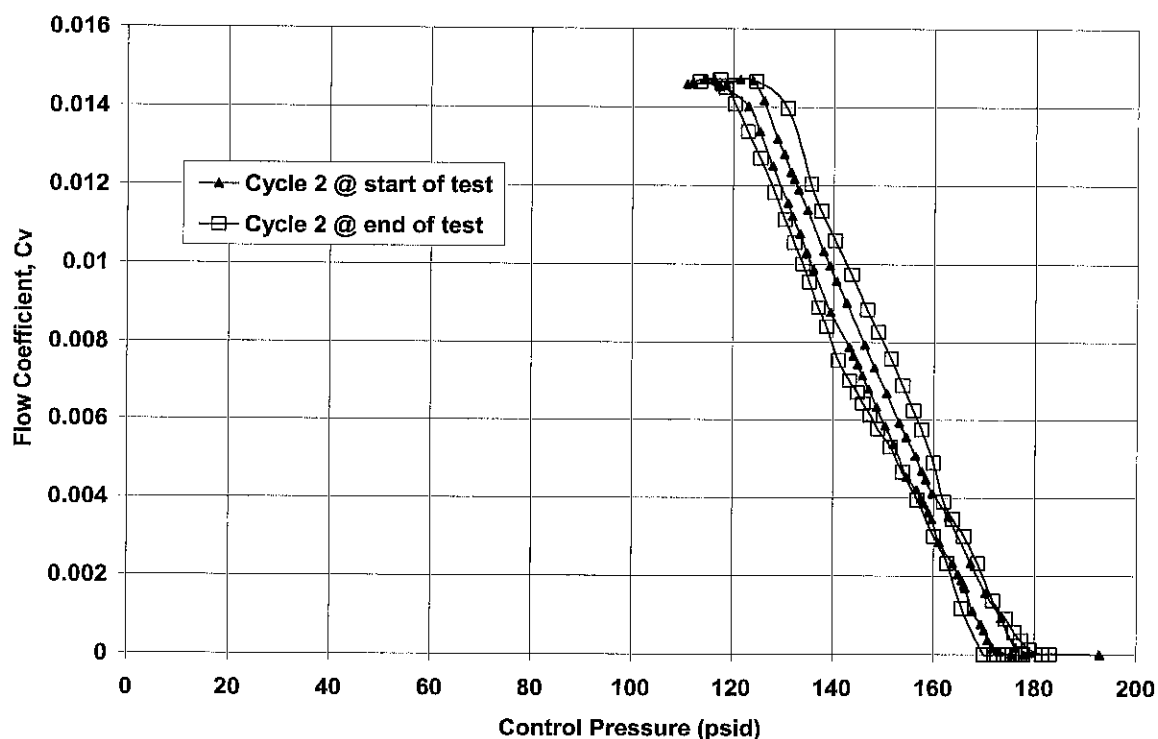
Figure 10. Cycle 2 Hysteresis Curves for Base Fuel plus Red Dye at 177°C

temperatures of 177°C. The results of Cycle 2 testing at the beginning and end of 100 hours are plotted in Figure 10, which shows a slight but significant degradation with the dyed fuel. On the other hand, valve performance was definitely poorer with the reference fuel even at test temperatures of 163°C., as reflected in Figure 11. Only when the test temperature was lowered to 135°C were the results comparable to the base fuel. The overall results, therefore, tracked fuel thermal stability as defined by the JFTOT because both the base fuel as well as the base fuel containing 0.55 mg/L had significantly higher breakpoints than did the reference fuel.

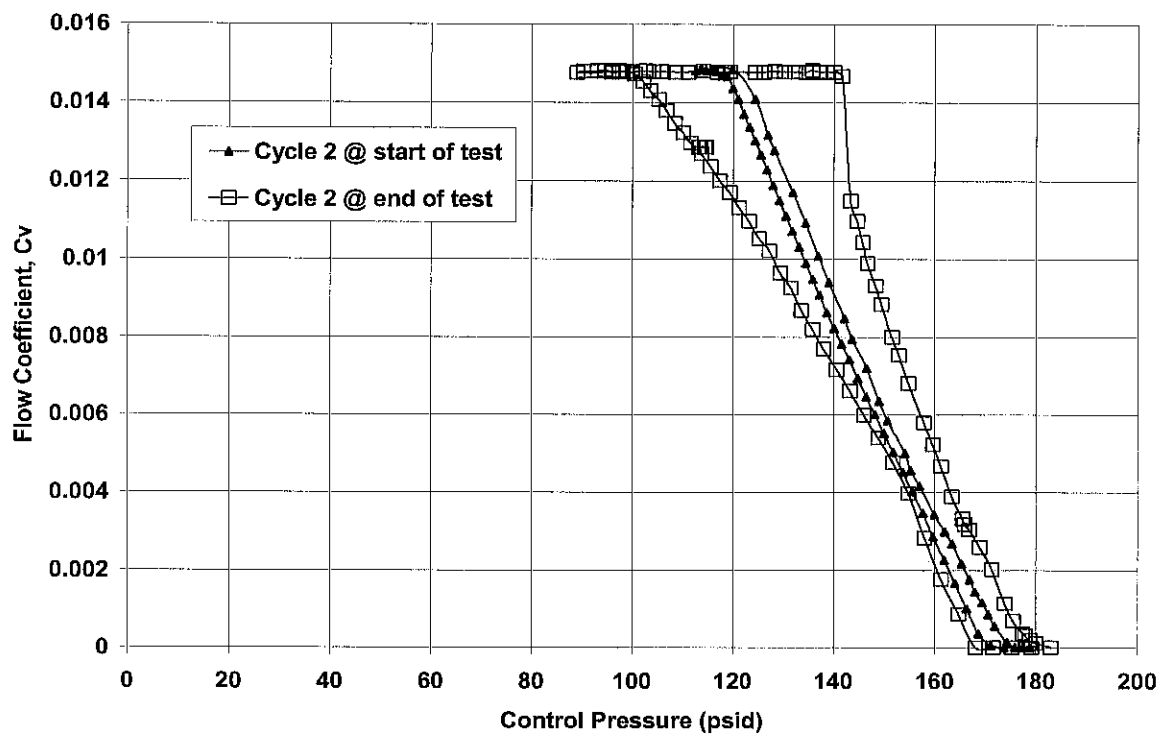
Figure 11. Cycle 2 Hysteresis Curves for Reference Fuel at 163°C

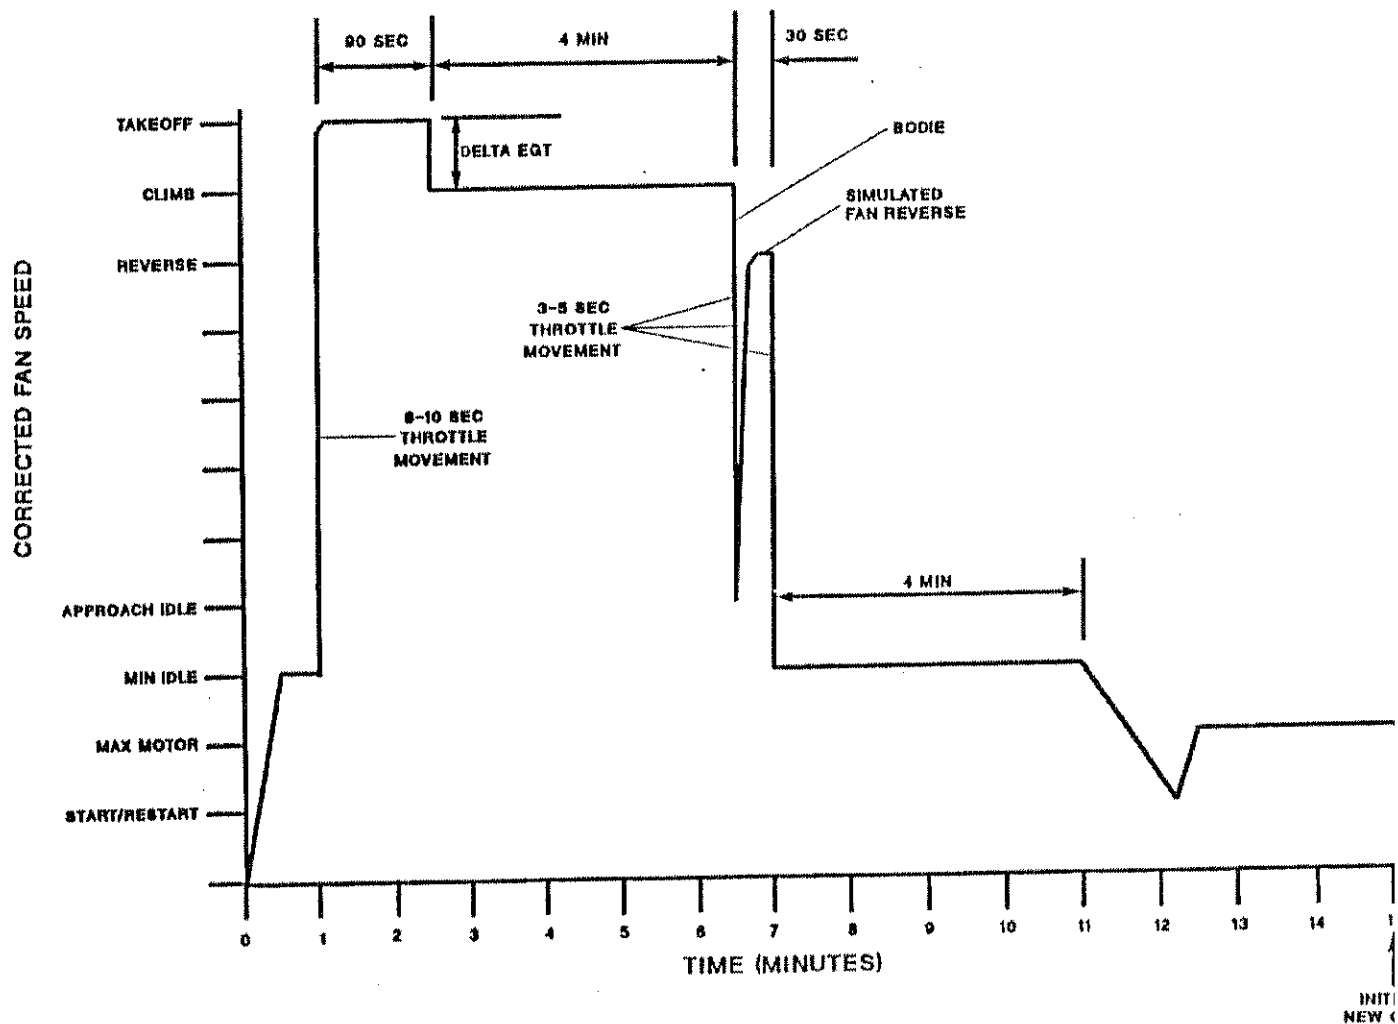
Figure 8 - Commercial Operating Cycle, C-Cycle

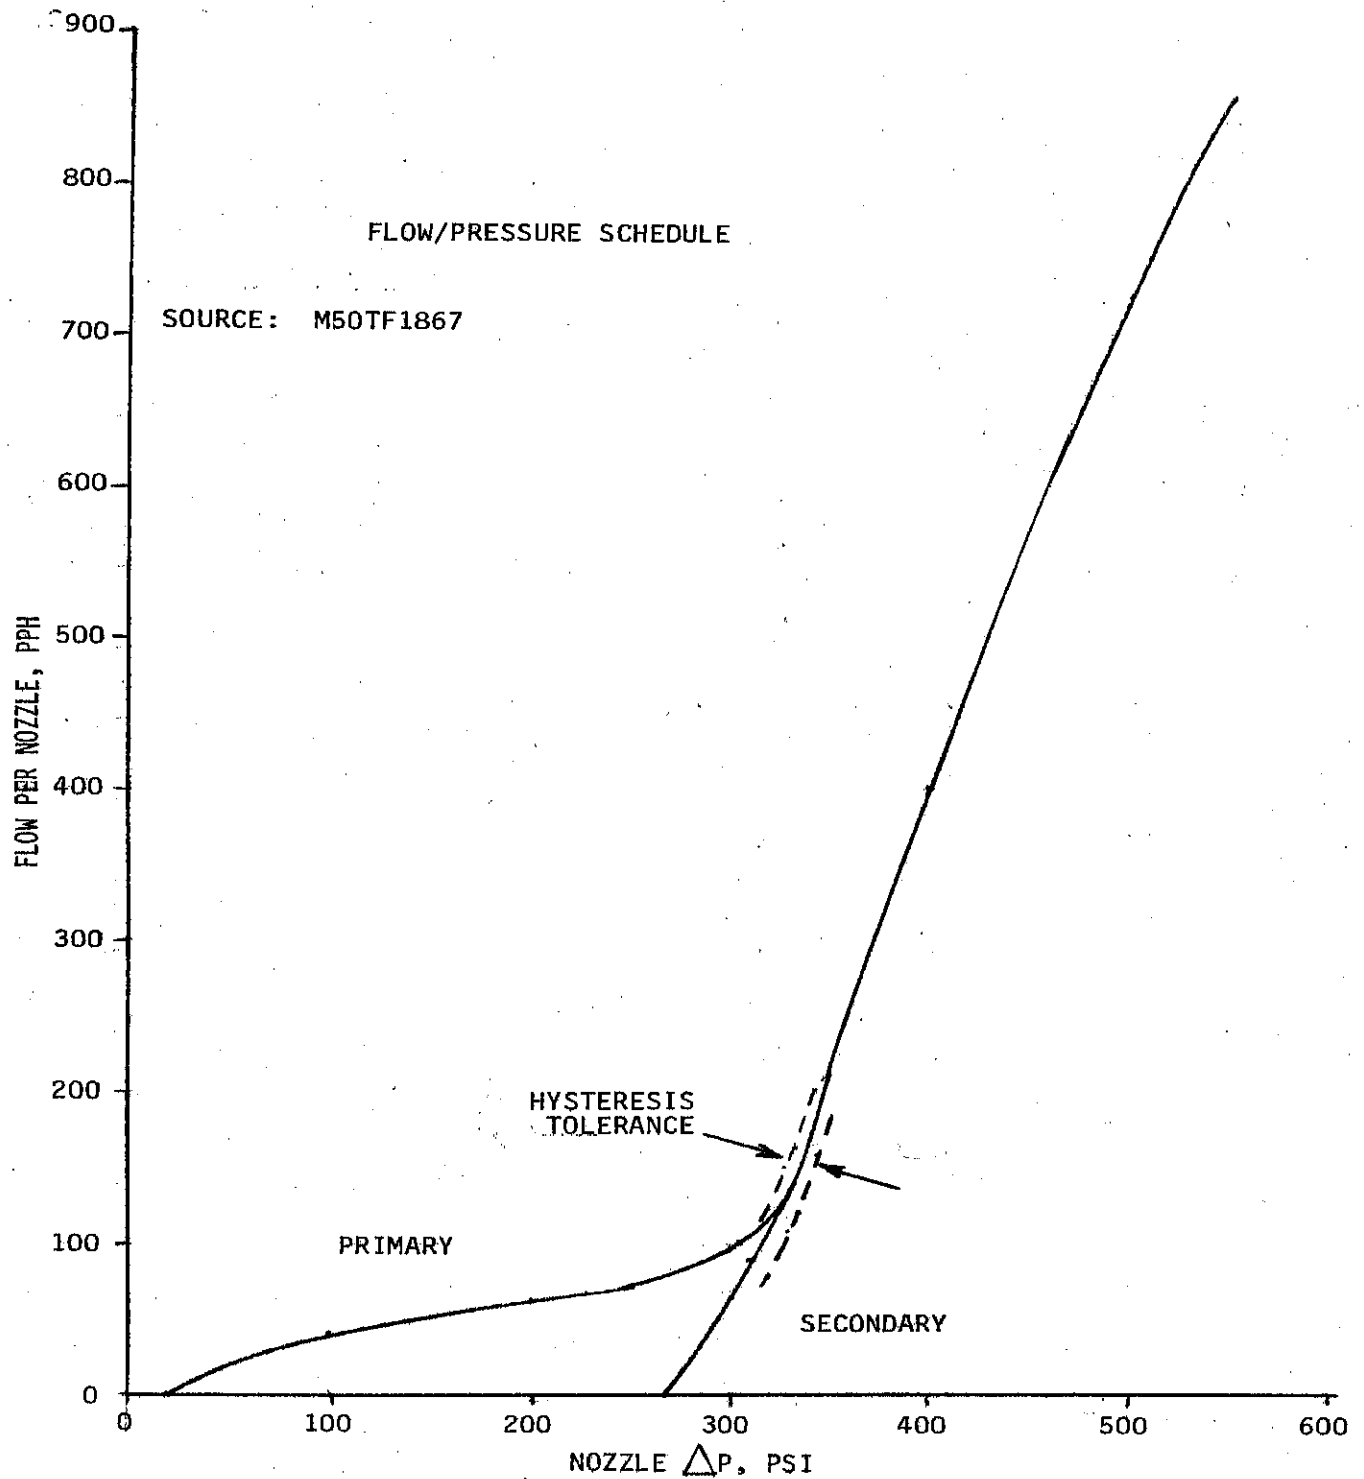
Figure 15 - Fuel Nozzle Flow Schedule with Hysteresis Limits Shown.
